# Traders Lake

## Bathymetry and Sediment Report

October, 2018

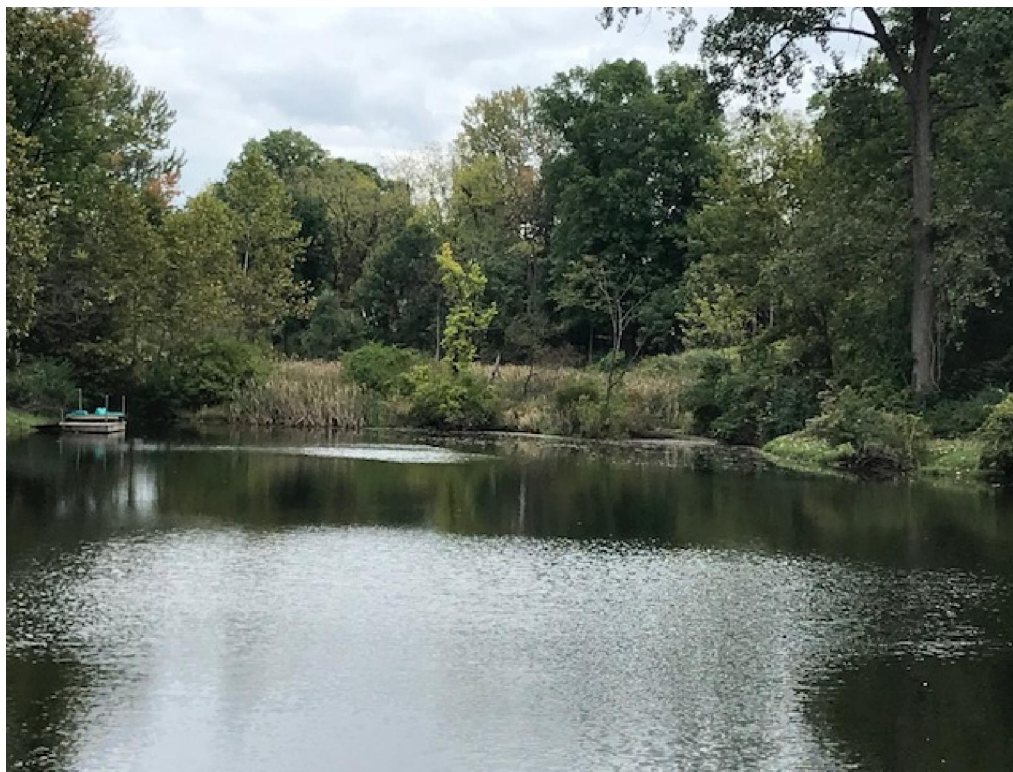
**Figure 2:** Inlet Structure located above bridge

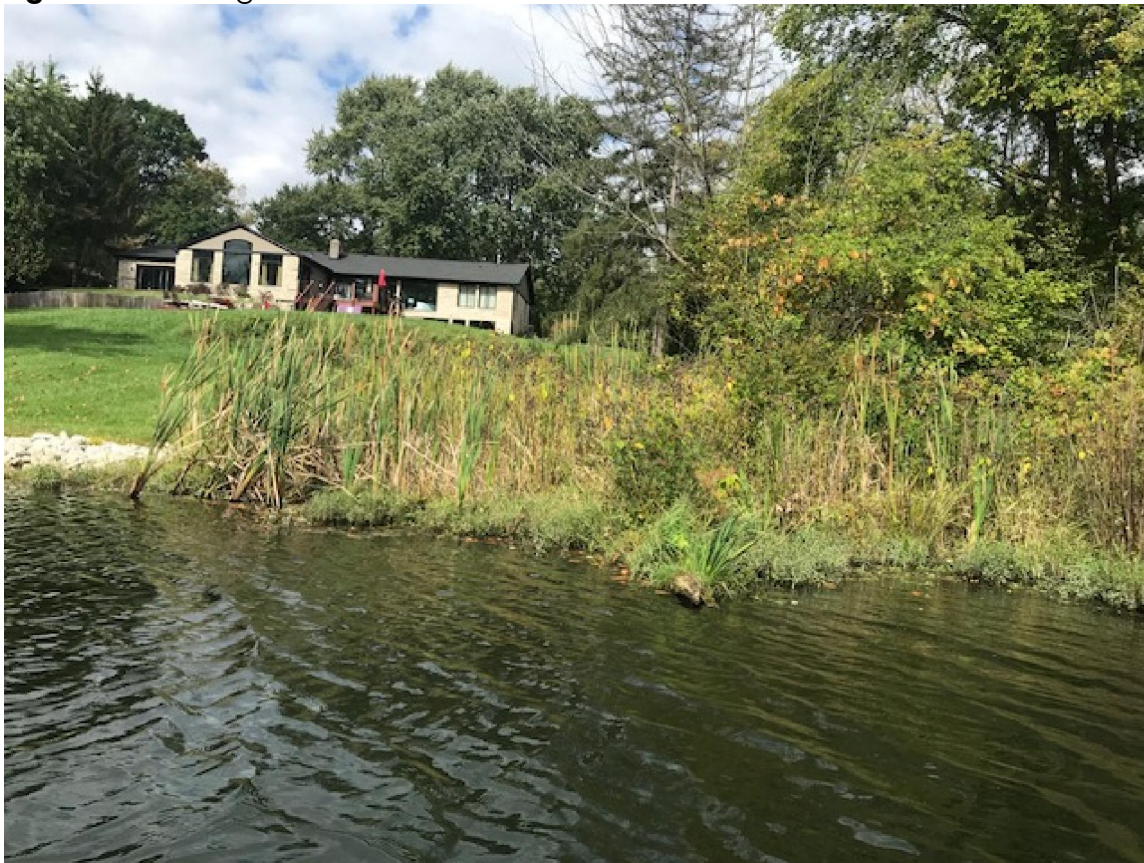
**Figure 3:** Cattail growth on shoreline

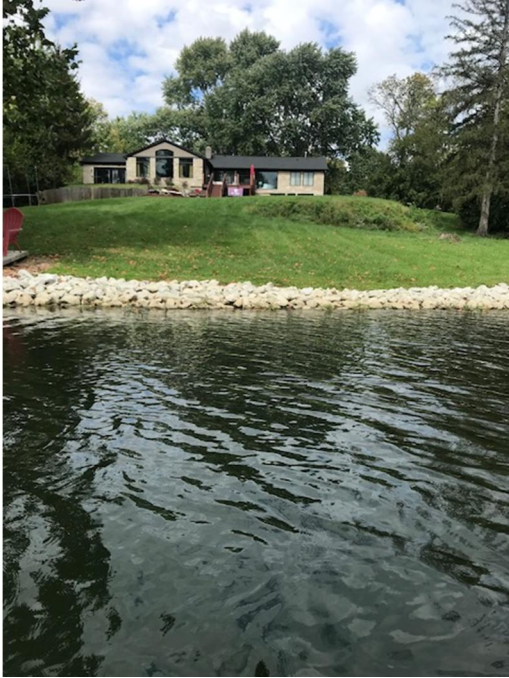
**Figure 4:** Rip rap along shoreline

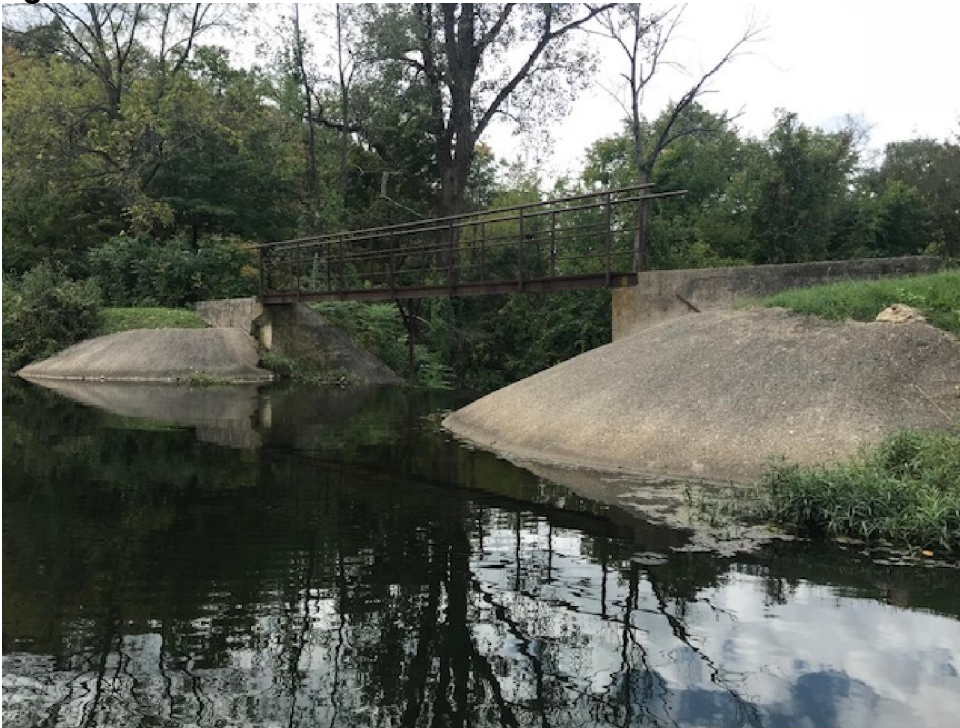
**Figure 5:** Outflow Dam

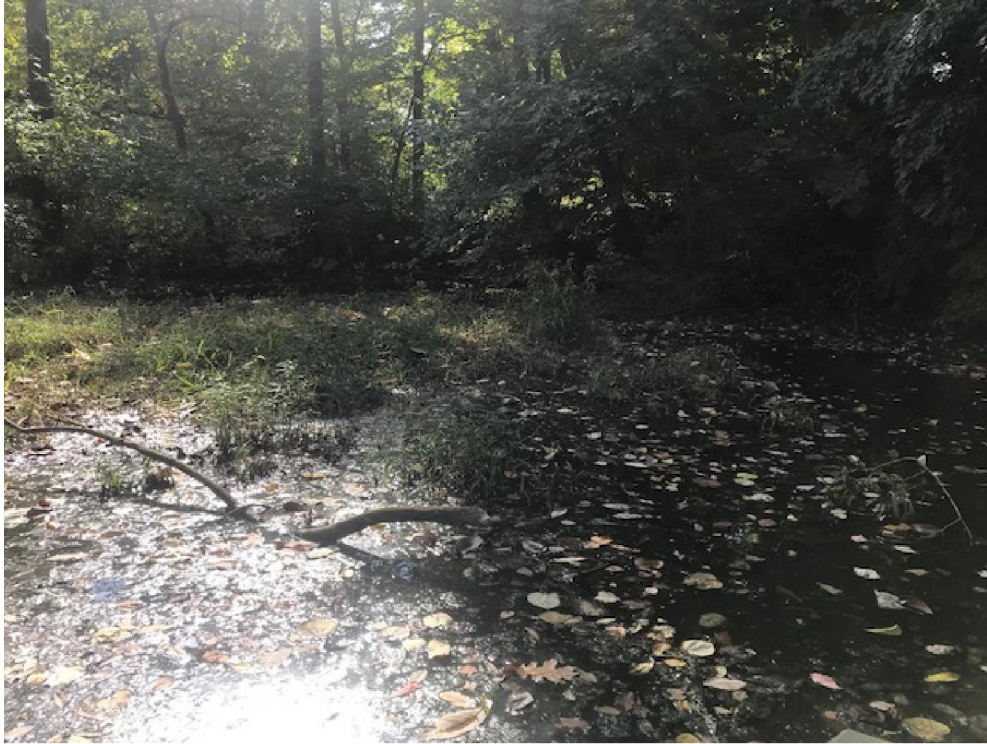
**Figure 6:** Sedimentation at inflow below bridge

nutrients and because the shallower depths caused by sedimentation provide good habitat for nuisance vegetation and algae growth. Portions of the lake have an excess amount of accumulated sediment and organic debris build up. These are areas of concern and the removal of the excess material would be recommended. When and whether or not to dredge a lake is a decision based on the discretion of the lake owners. A lake can function properly to mediate peak storm flows regardless of the depth. However, as it becomes shallower over time, a pond may become choked with algae and aquatic weeds, and may not support an abundant fish population.
