# Virtual Inspection – Start to Finish

Jariah Besing, PE – INDOT

John Lukac, PE, MBA – HWC Engineering

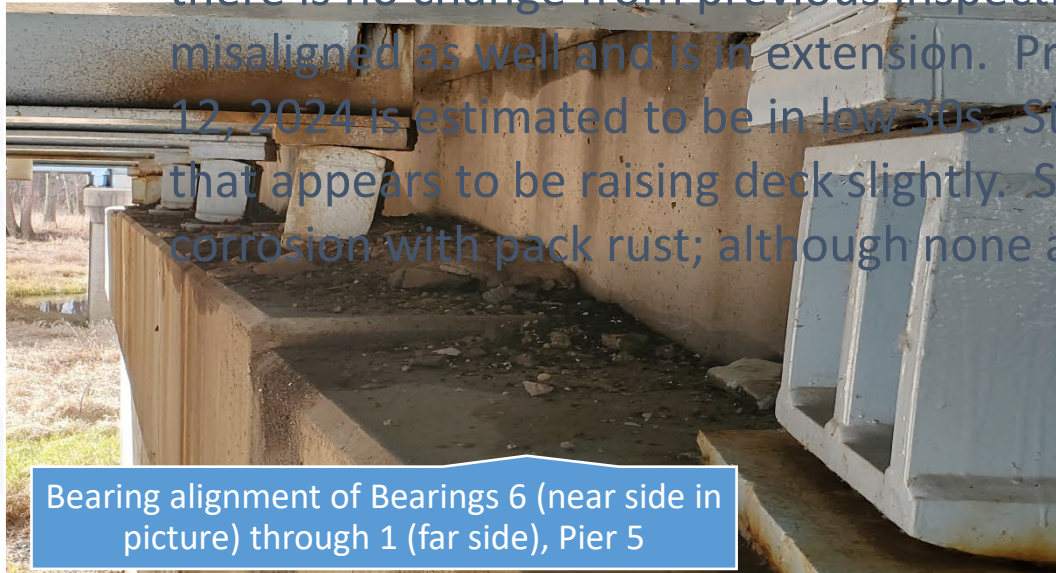
Bearings 5 and 7 over Pier 5 are misaligned; these bearings appear to be frozen as there is no change from previous inspection in Jan. 2022. Bearing 7 over Pier 2 is misaligned as well and is in extension. Previous 24-hour temperature on January 12, 2024 is estimated to be in low 30s. Steel bearings over Pier 2 have pack rust that appears to be raising deck slightly. Steel bearings over Piers 2 and 5 have corrosion with pack rust; although none are loose.

Bearing alignment of Bearings 6 (near side in picture) through 1 (far side), Pier 5

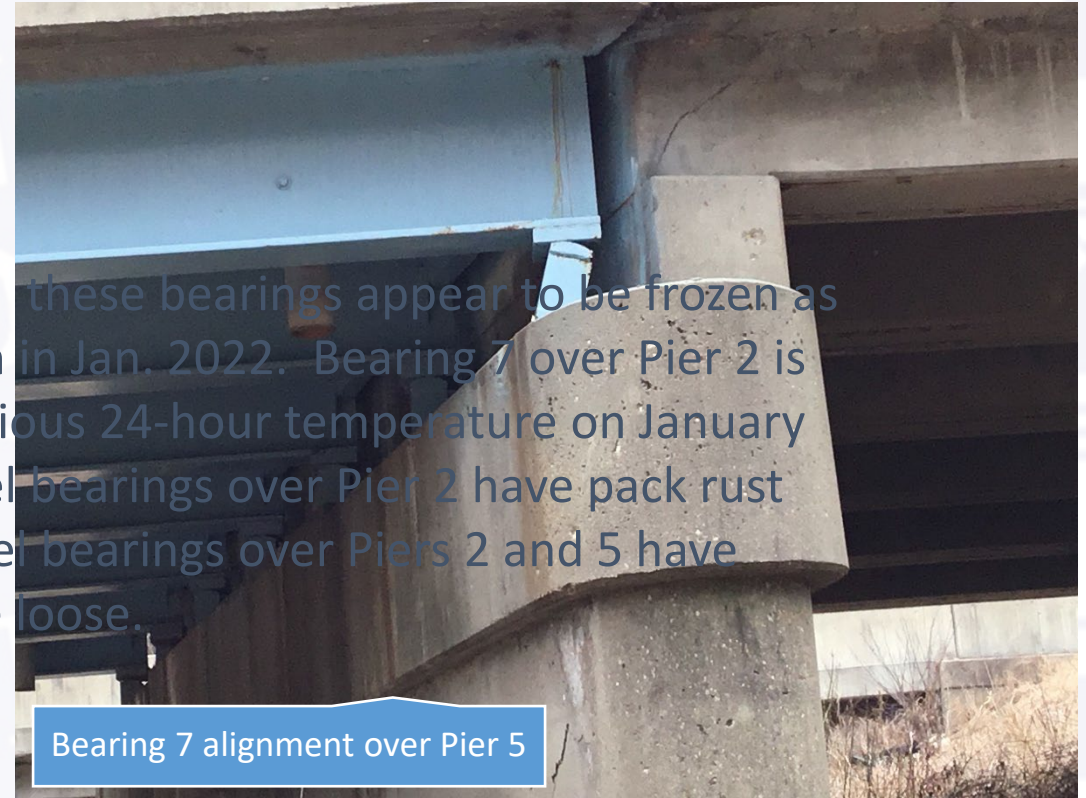
Bearing 7 alignment over Pier 5

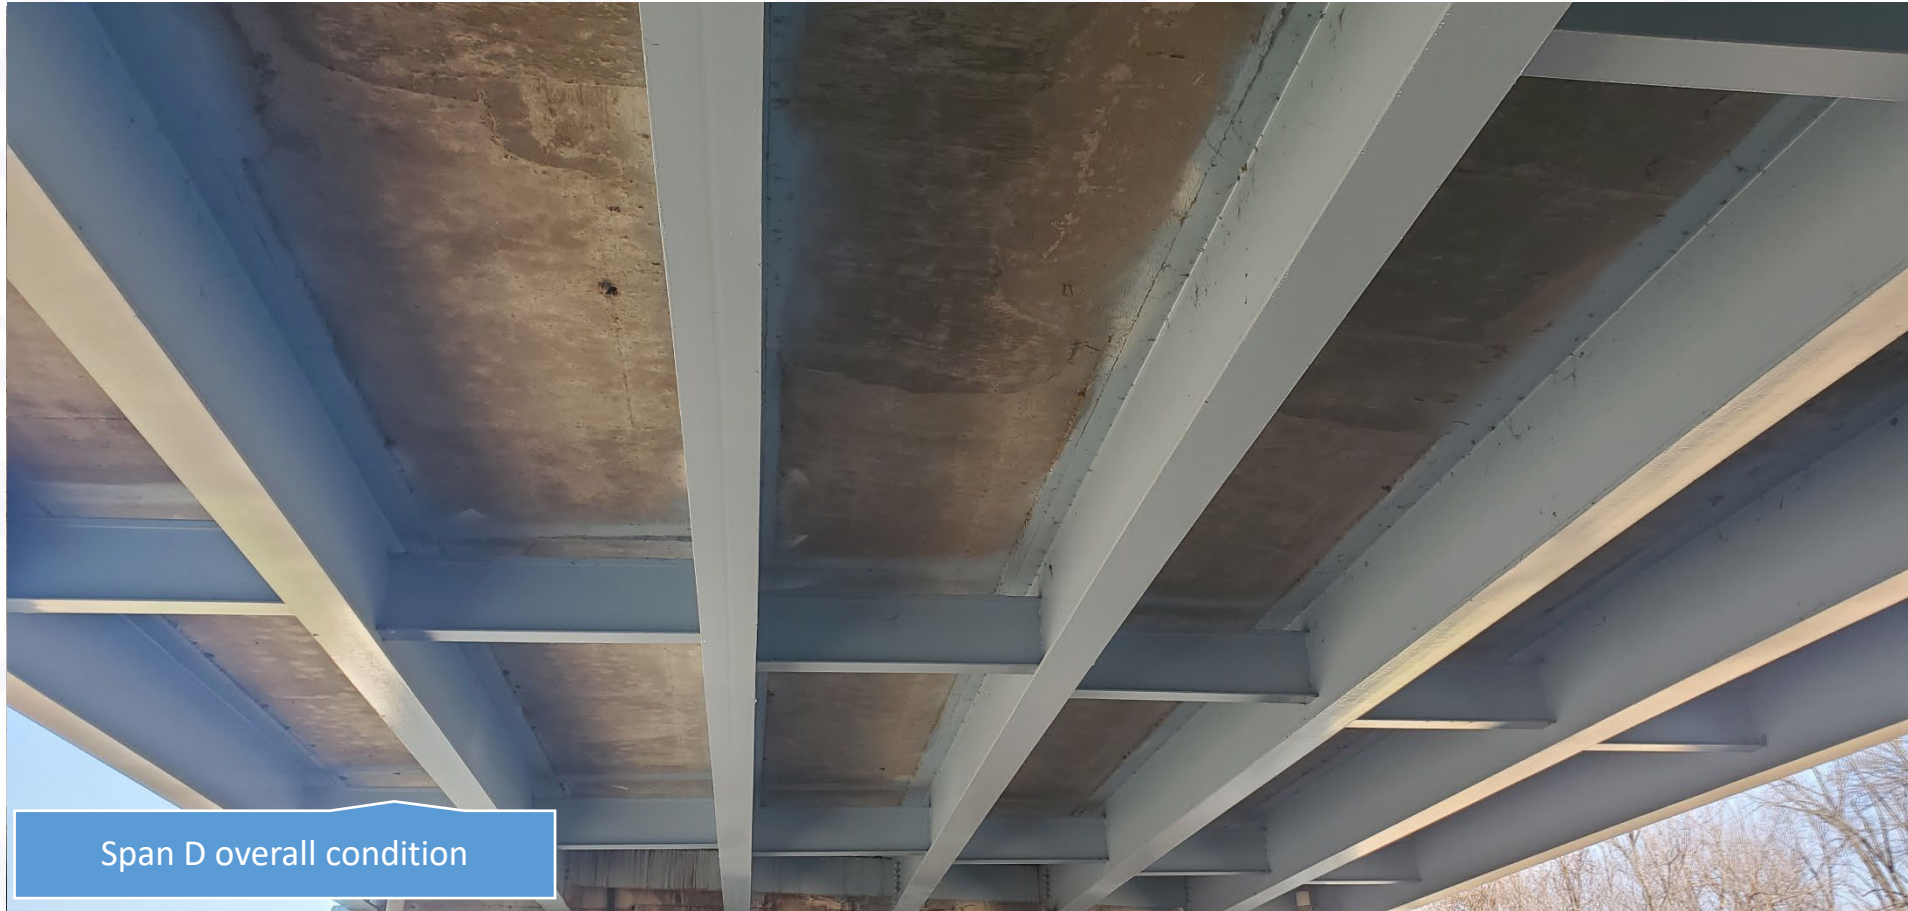
Span D overall condition

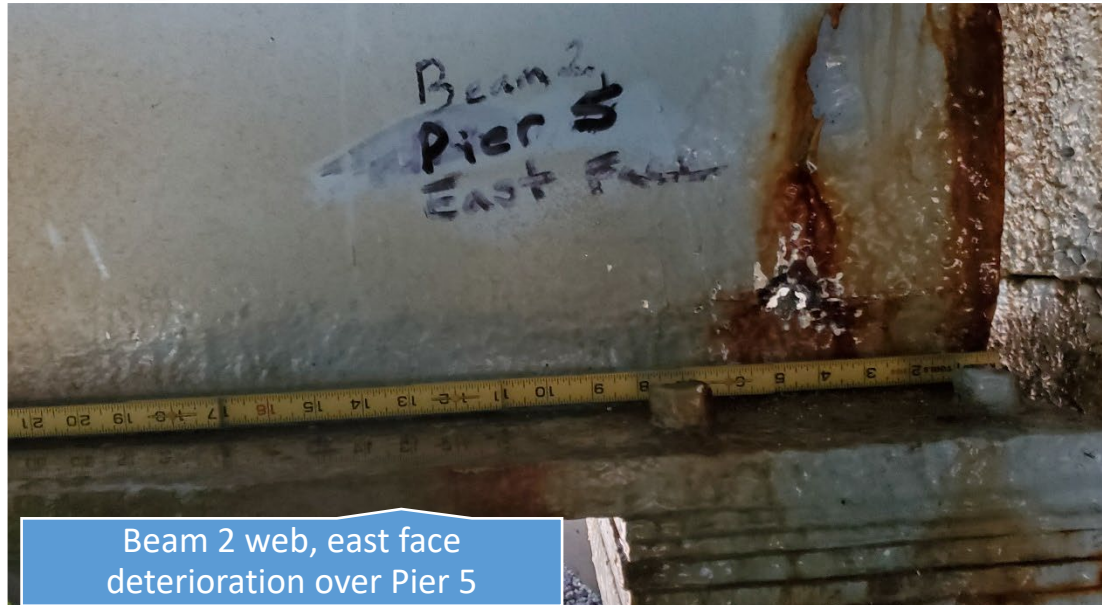
Beam 2 web, east face deterioration over Pier 5

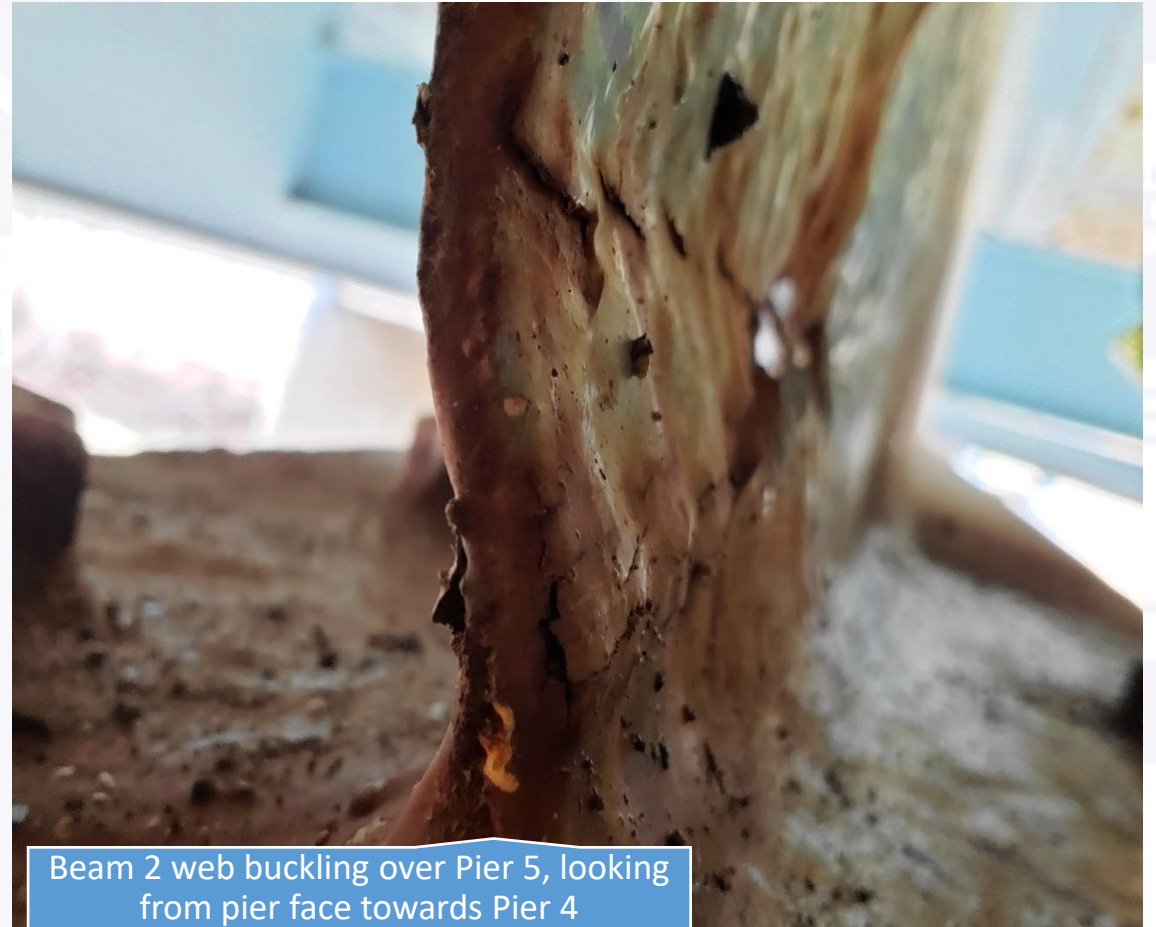
Beam 2 web buckling over Pier 5, looking from pier face towards Pier 4

Beam 2, Pier 5 was found to have web buckling (critical find issued and updated load rating requested; see sketch in attached documents). Steel beam ends and bearings below the Pier 2 and 5 joints exhibited minor section loss from the previous corrosion that generally appears arrested with the newer paint coating (exception is Beam 2, Pier 5 where a 1" hole was found; sketch of this location attached to report. RCGs in approach spans exhibited rust stains from the reinforcing chairs and fine flexural cracks near midspan. Within Span E, RCG 1 exhibited isolated spalling with exposed stirrup reinforcing (~ 3SF; see picture), and RCG 6 exhibited an isolated minor width horizontal crack that has not worsened since the previous routine inspection; this crack appears to be a pending spall similar to the west fascia girder spalling. Very small spalls on the underside of RCG 1, Span A over the south abutment. *Controlling Legal Load Rating Factor decreased from **1.61 to 1.06**.*

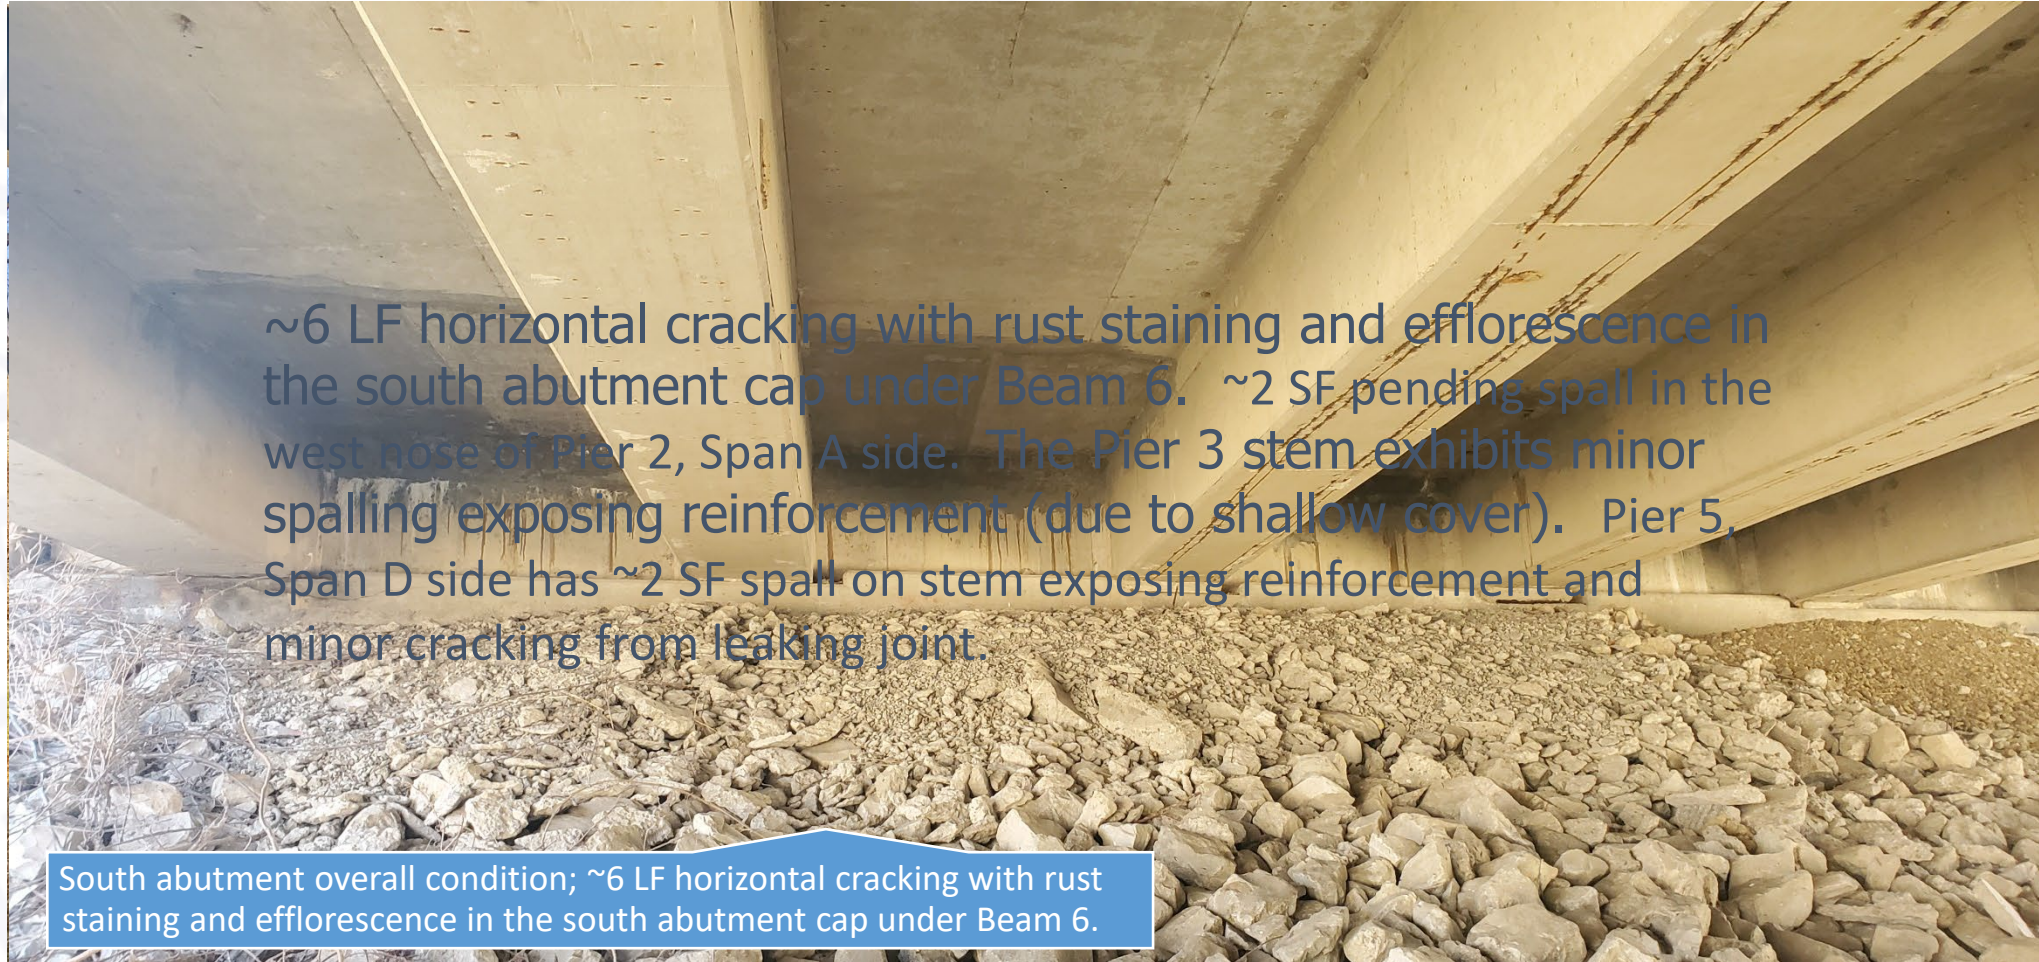
~6 LF horizontal cracking with rust staining and efflorescence in the south abutment cap under Beam 6. ~2 SF pending spall in the west nose of Pier 2, Span A side. The Pier 3 stem exhibits minor spalling exposing reinforcement (due to shallow cover). Pier 5, Span D side has ~2 SF spall on stem exposing reinforcement and minor cracking from leaking joint.

South abutment overall condition; ~6 LF horizontal cracking with rust staining and efflorescence in the south abutment cap under Beam 6.

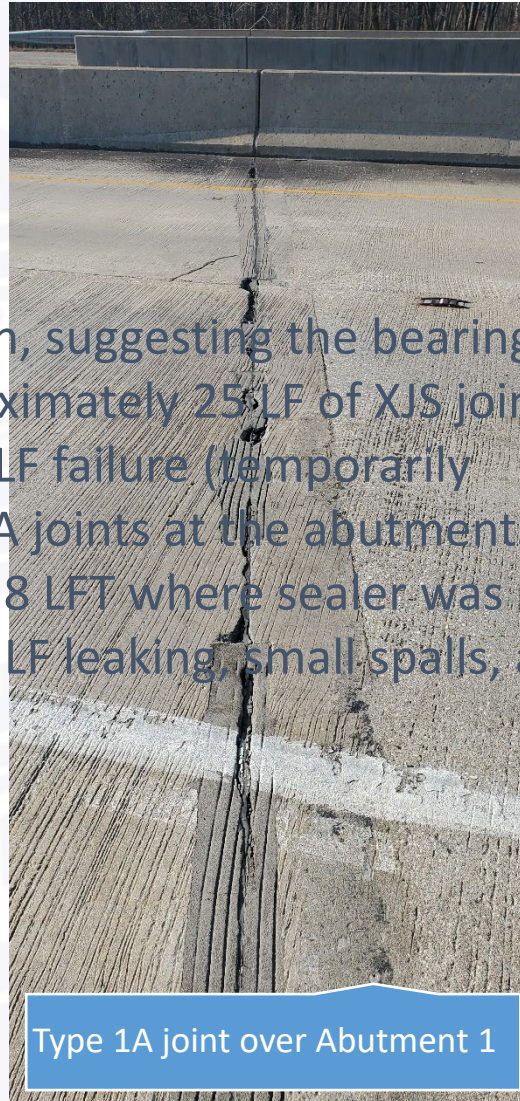
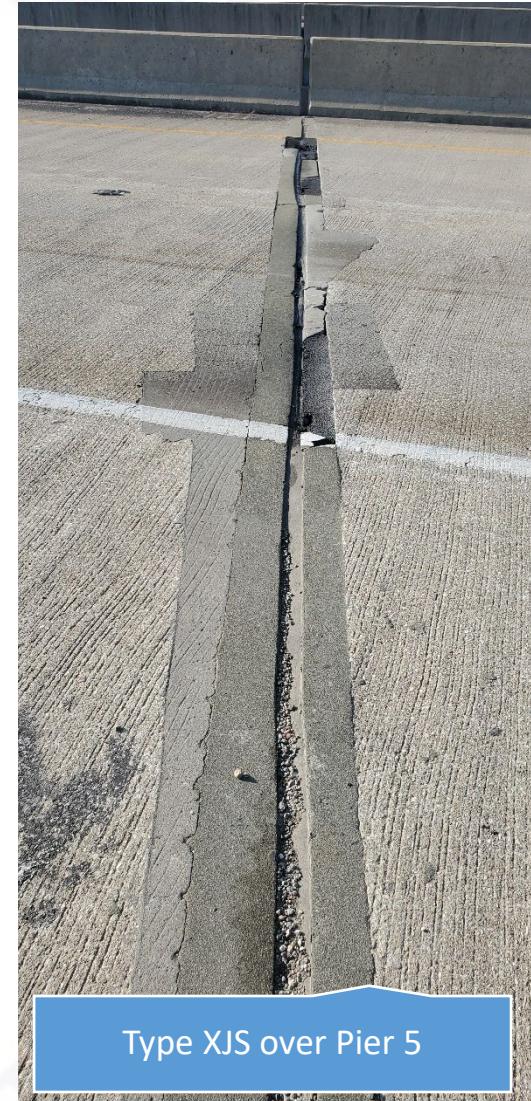
The SS joint over Pier 2 is slightly uneven, suggesting the bearings over Pier 2 have some pack rust. Approximately 25 LF of XJS joint over Pier 5 has been patched with ~ 10 LF failure (temporarily patched on Jan. 12, 2024). Both Type 1A joints at the abutments generally intact; north joint had around 8 LFT where sealer was not fully intact while the south joint has ~ 5 LF leaking, small spalls, and has been largely patched previously.

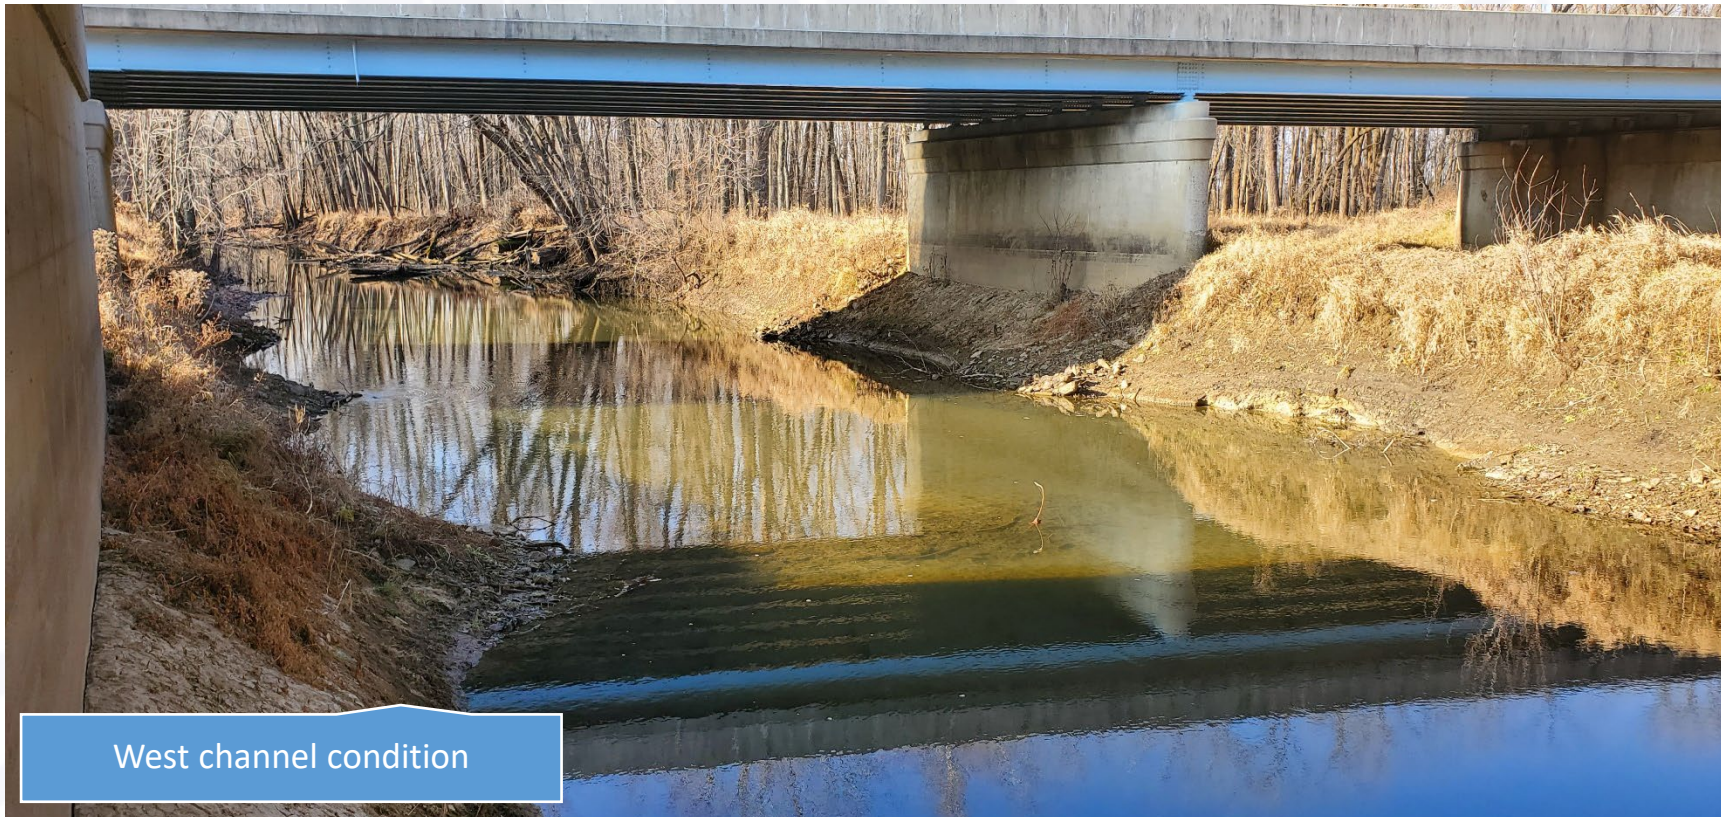
- Channel (61) – B.C.09
  - The channel appears stable. Some minor debris downstream outside ROW.
- Channel Protection – B.C.10

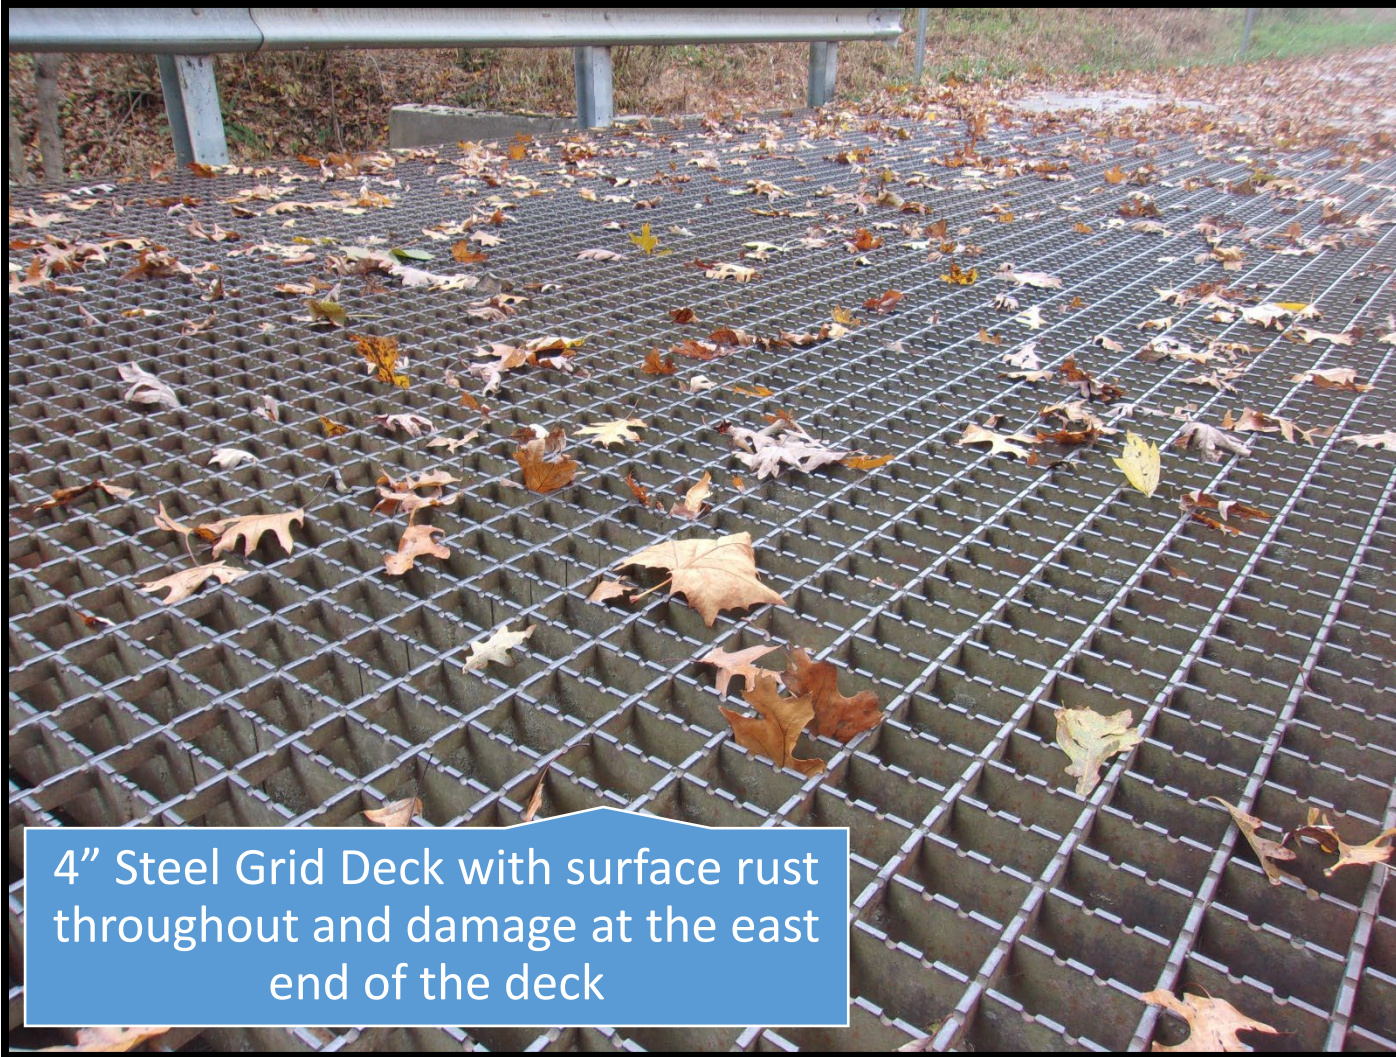
4" Steel Grid Deck with surface rust throughout and damage at the east end of the deck

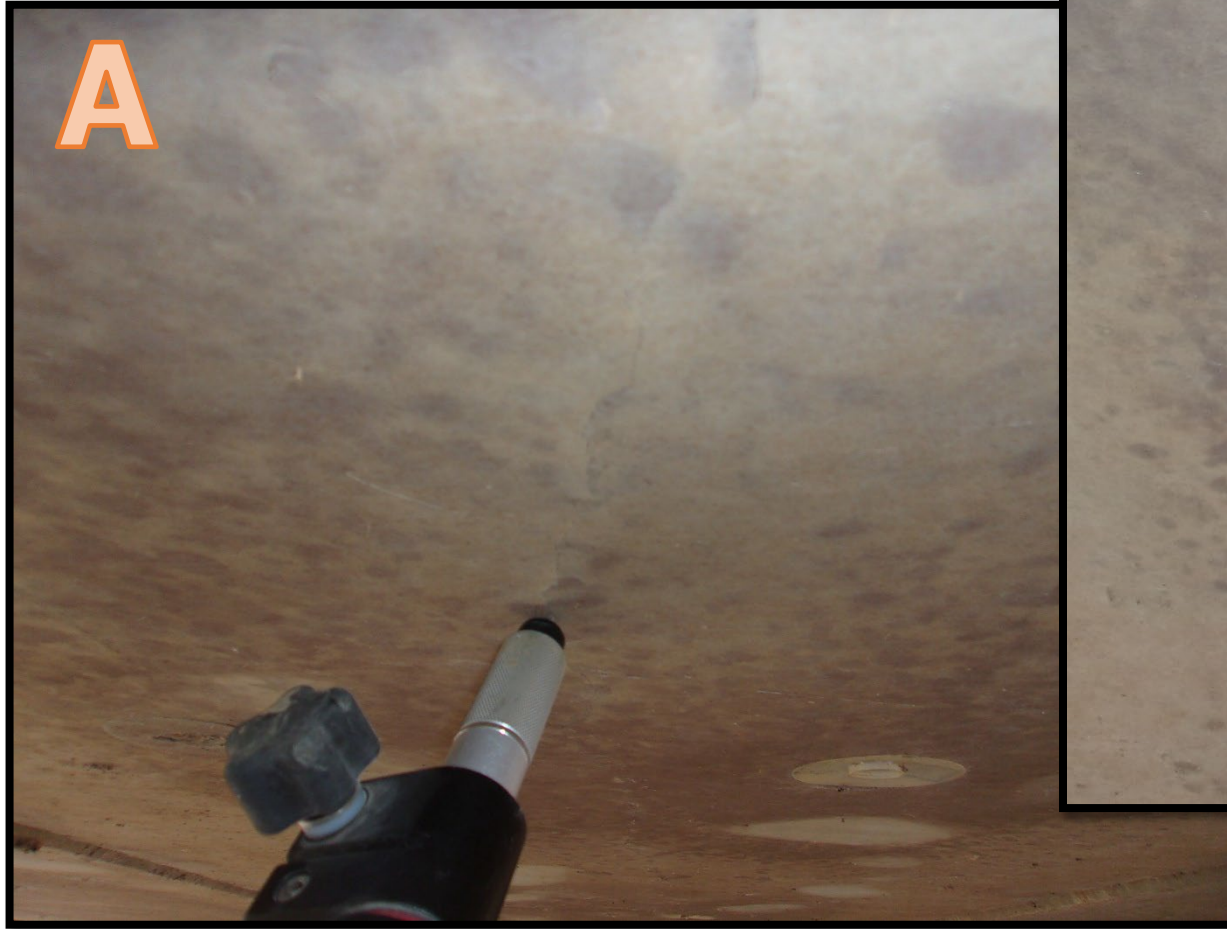
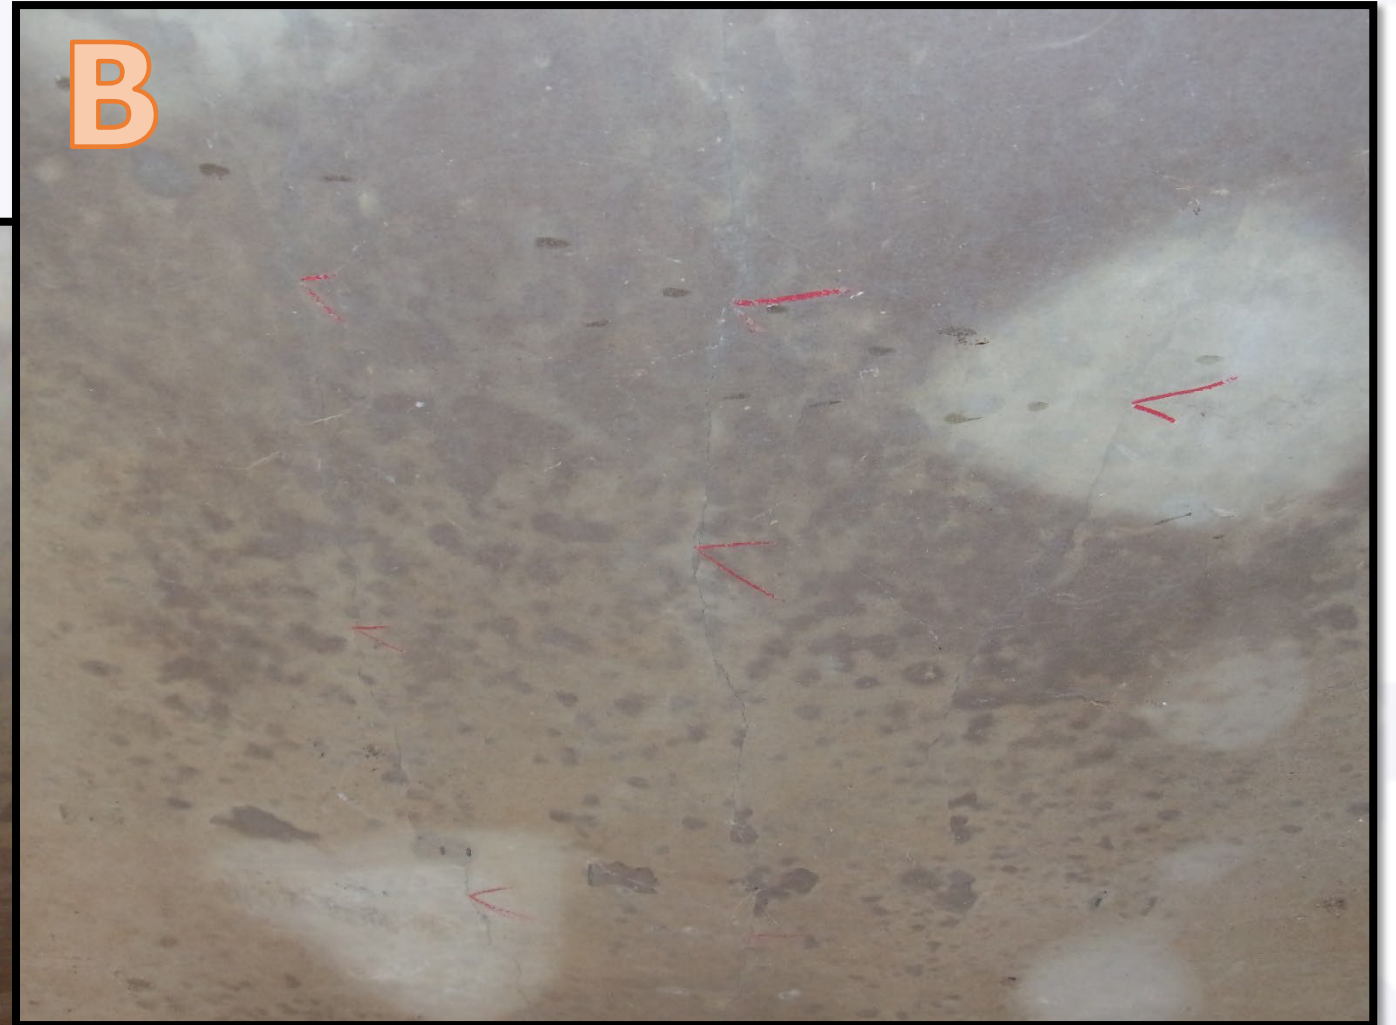
- Superstructure (59) – B.C.02
- Cracks noted on bottom beams

Beam 3 with 4 hairline longitudinal cracks along north 1/2 length of bottom of beam. Two cracks run along full length of beam. Seepage between beams.

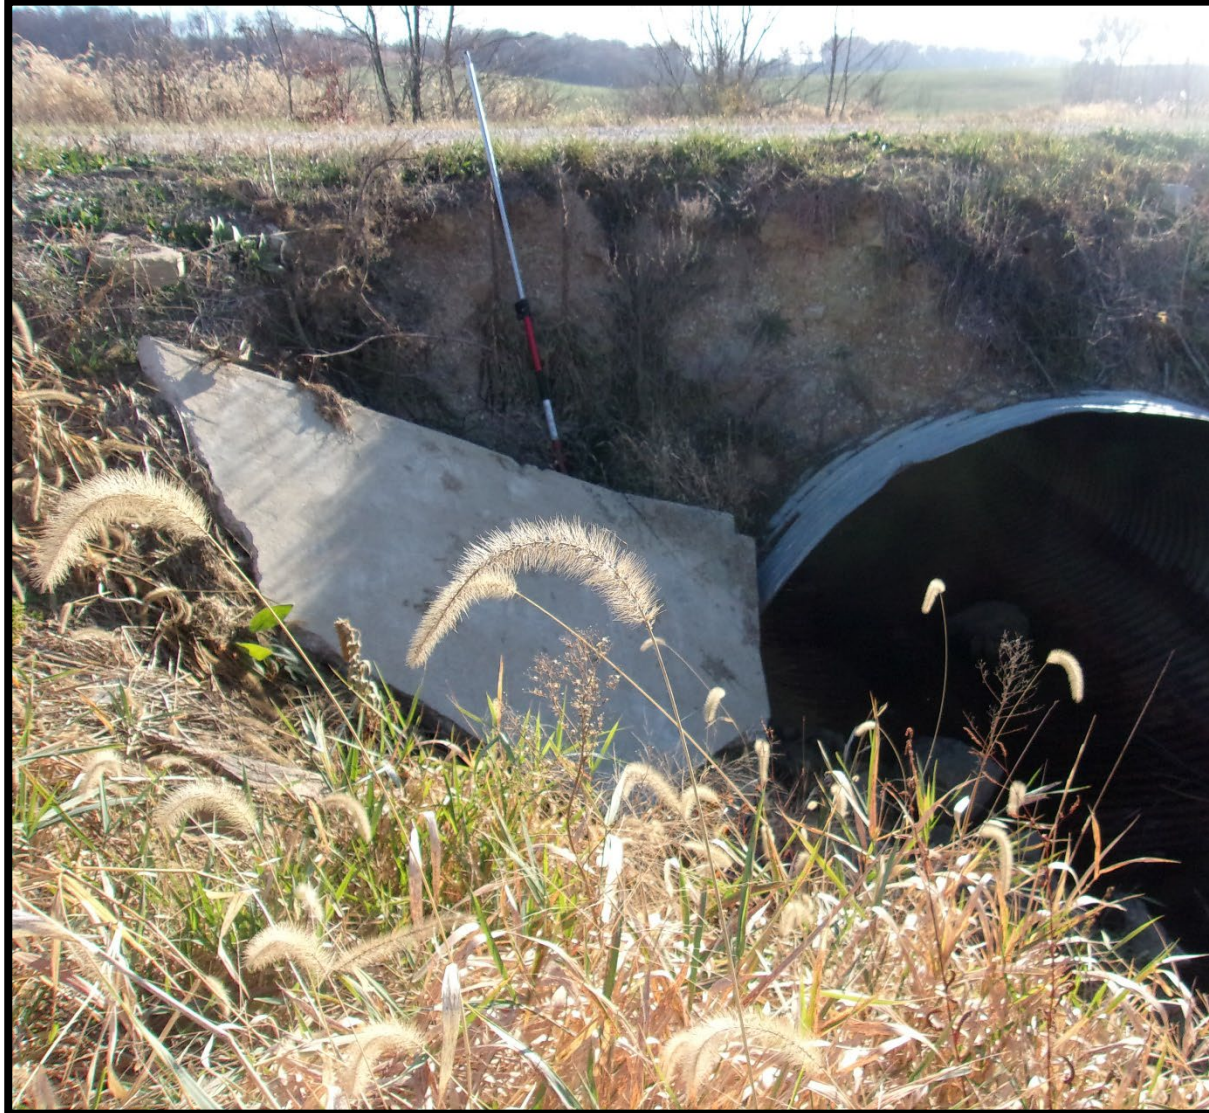
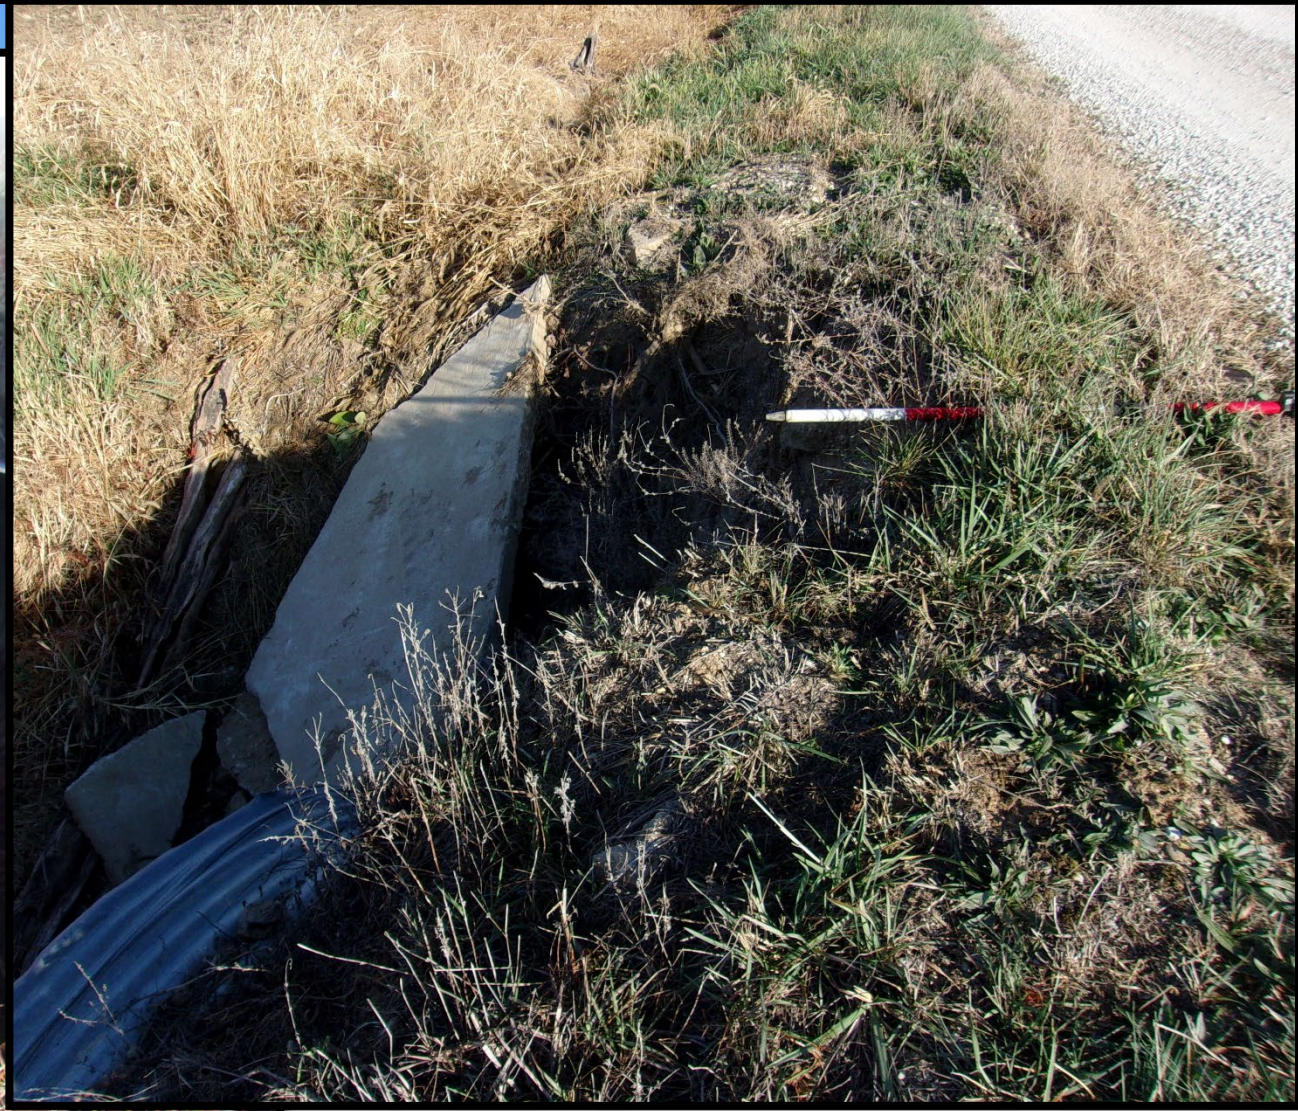
- Condition Description:
- Channel alignment not in line with pipes. 4 ft to 6 ft bank and shoulder erosion on west side of north pipe at inlet. Riprap bank on southwest and southeast corners.
