AML Site 2084, Surprise Pit

A Significant Safety Hazard To Visitors

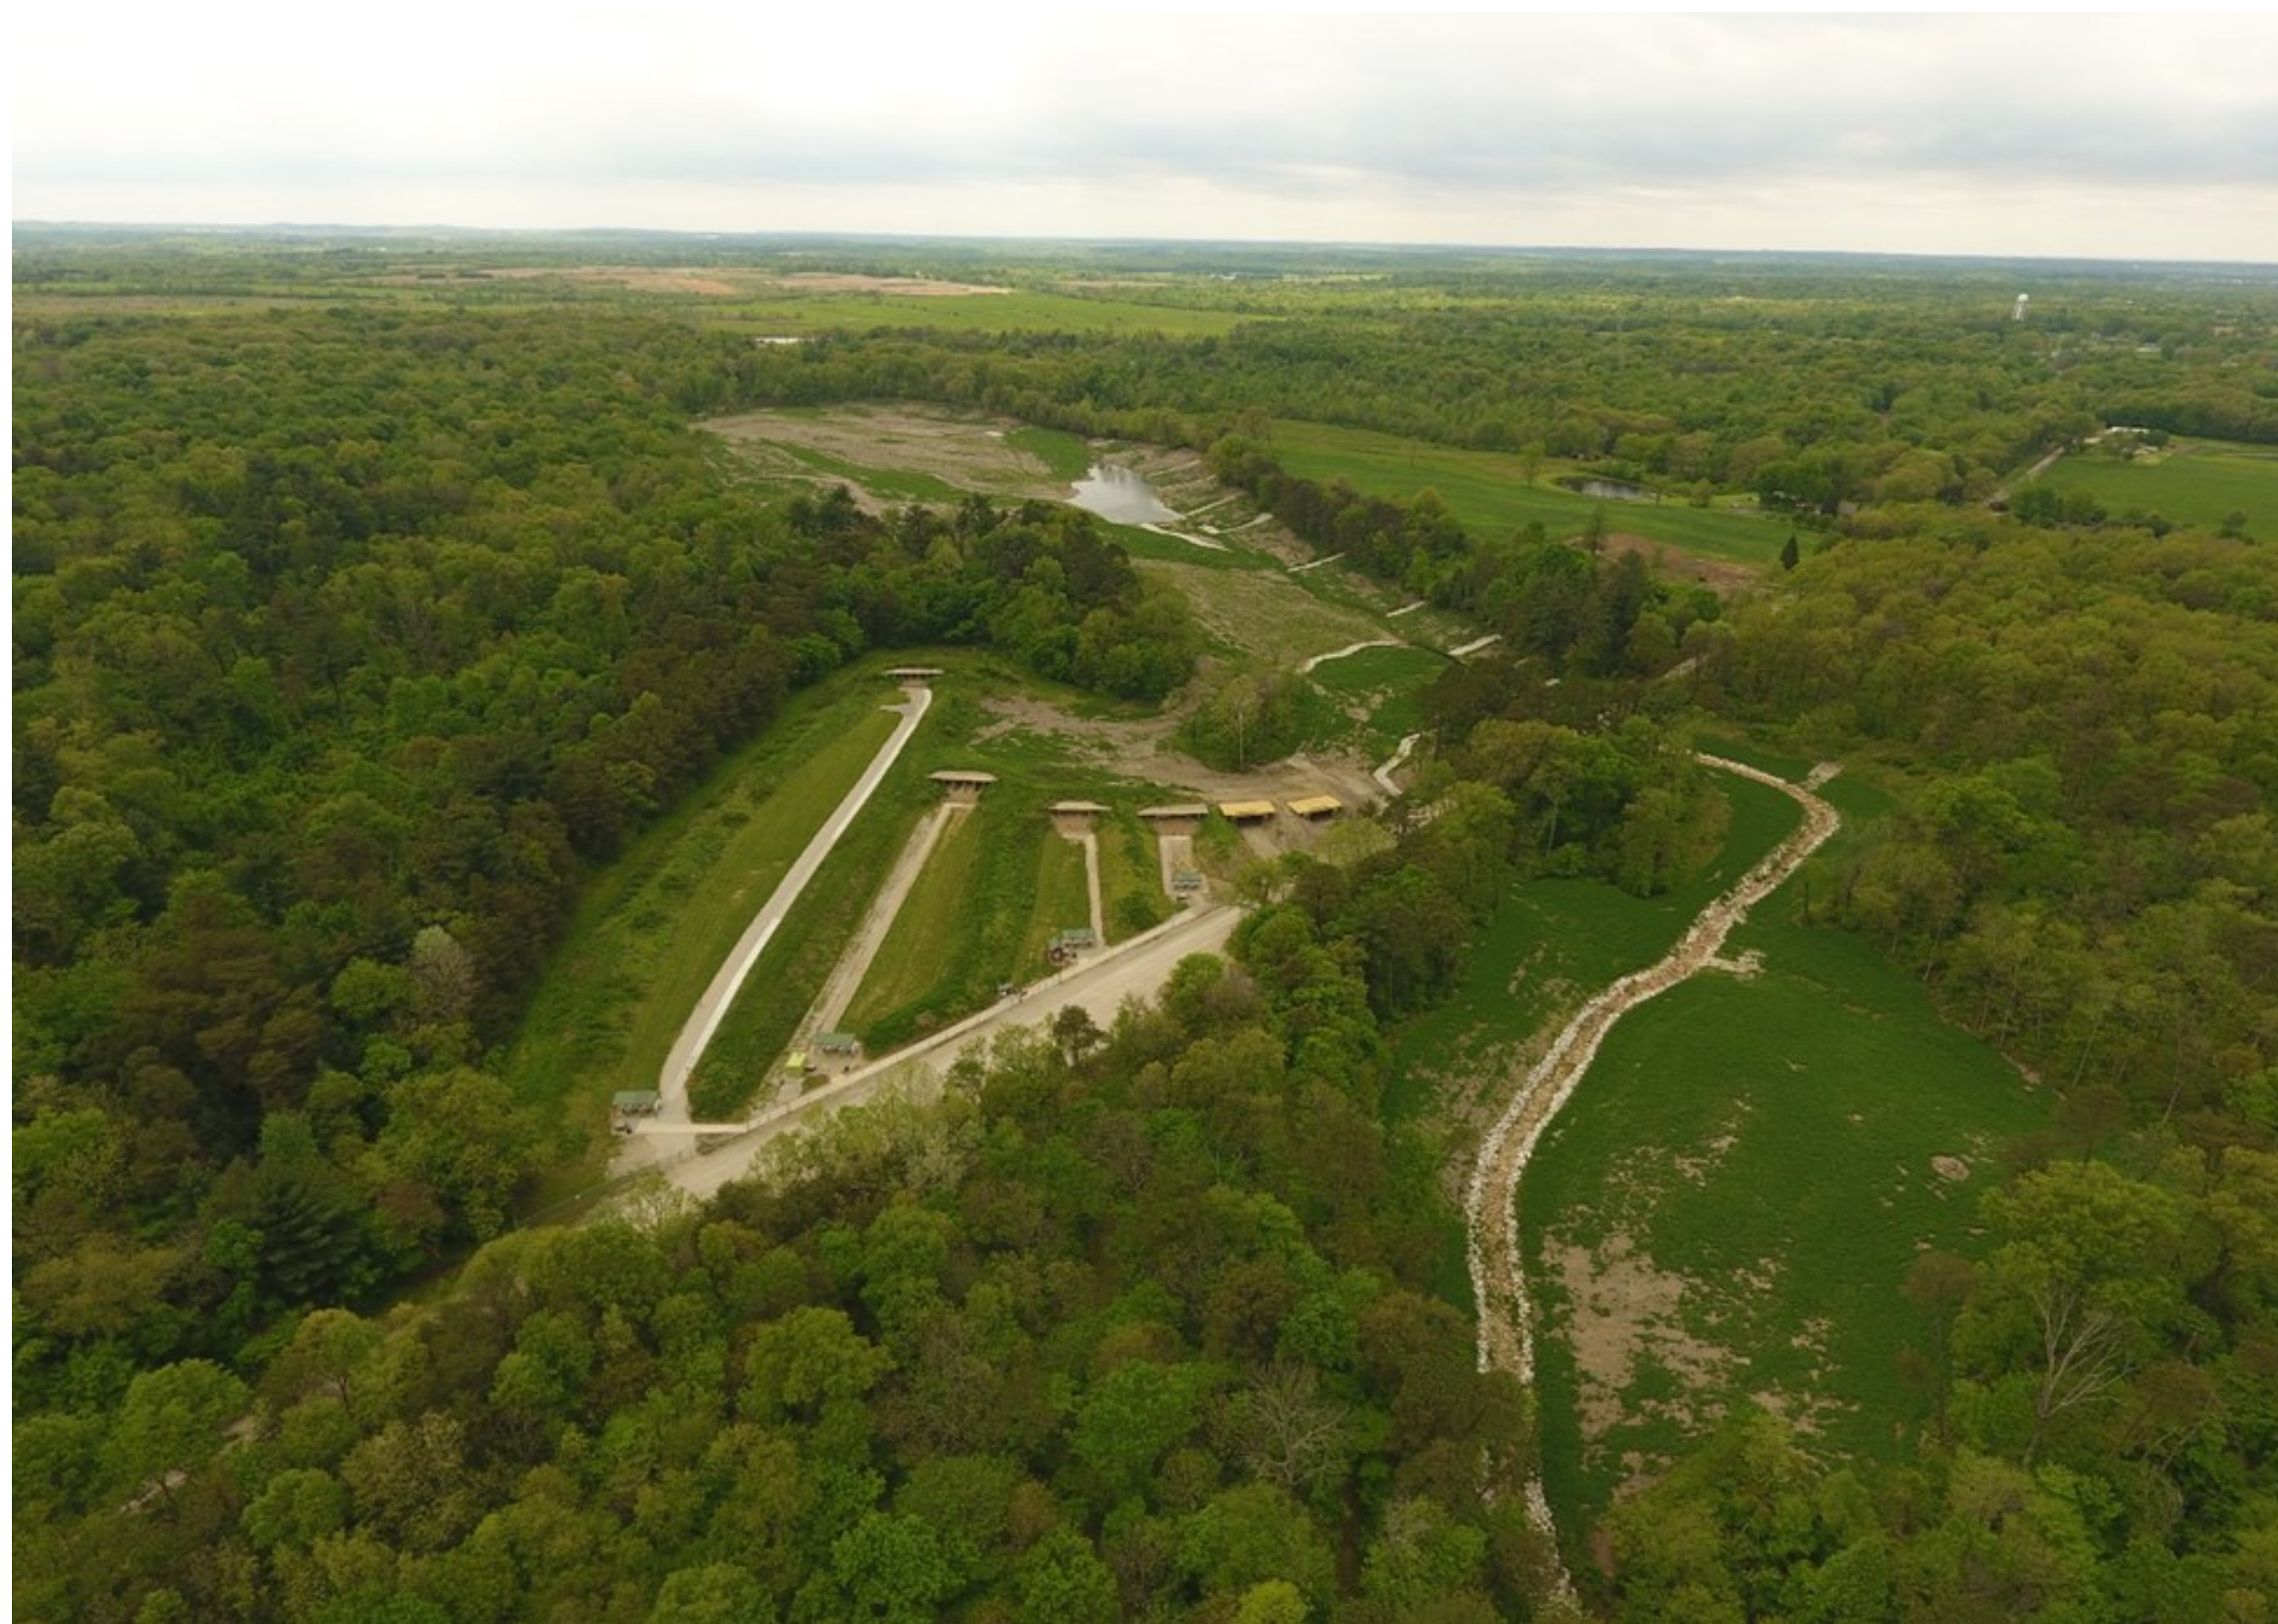
The highwall left by the Ayreshire #8 mine created significant safety hazard for property users and adjacent landowners. The public property is frequented by hunters and fishermen who enjoy the recreational opportunities in the area. The eroding undercut and unstable slopes presented a danger of falling or having rocks and debris falling onto a user of the pit below. In addition to the clear fall hazard, the erosion gulleys formed on the unstable highwall had attracted legacy waste dumping

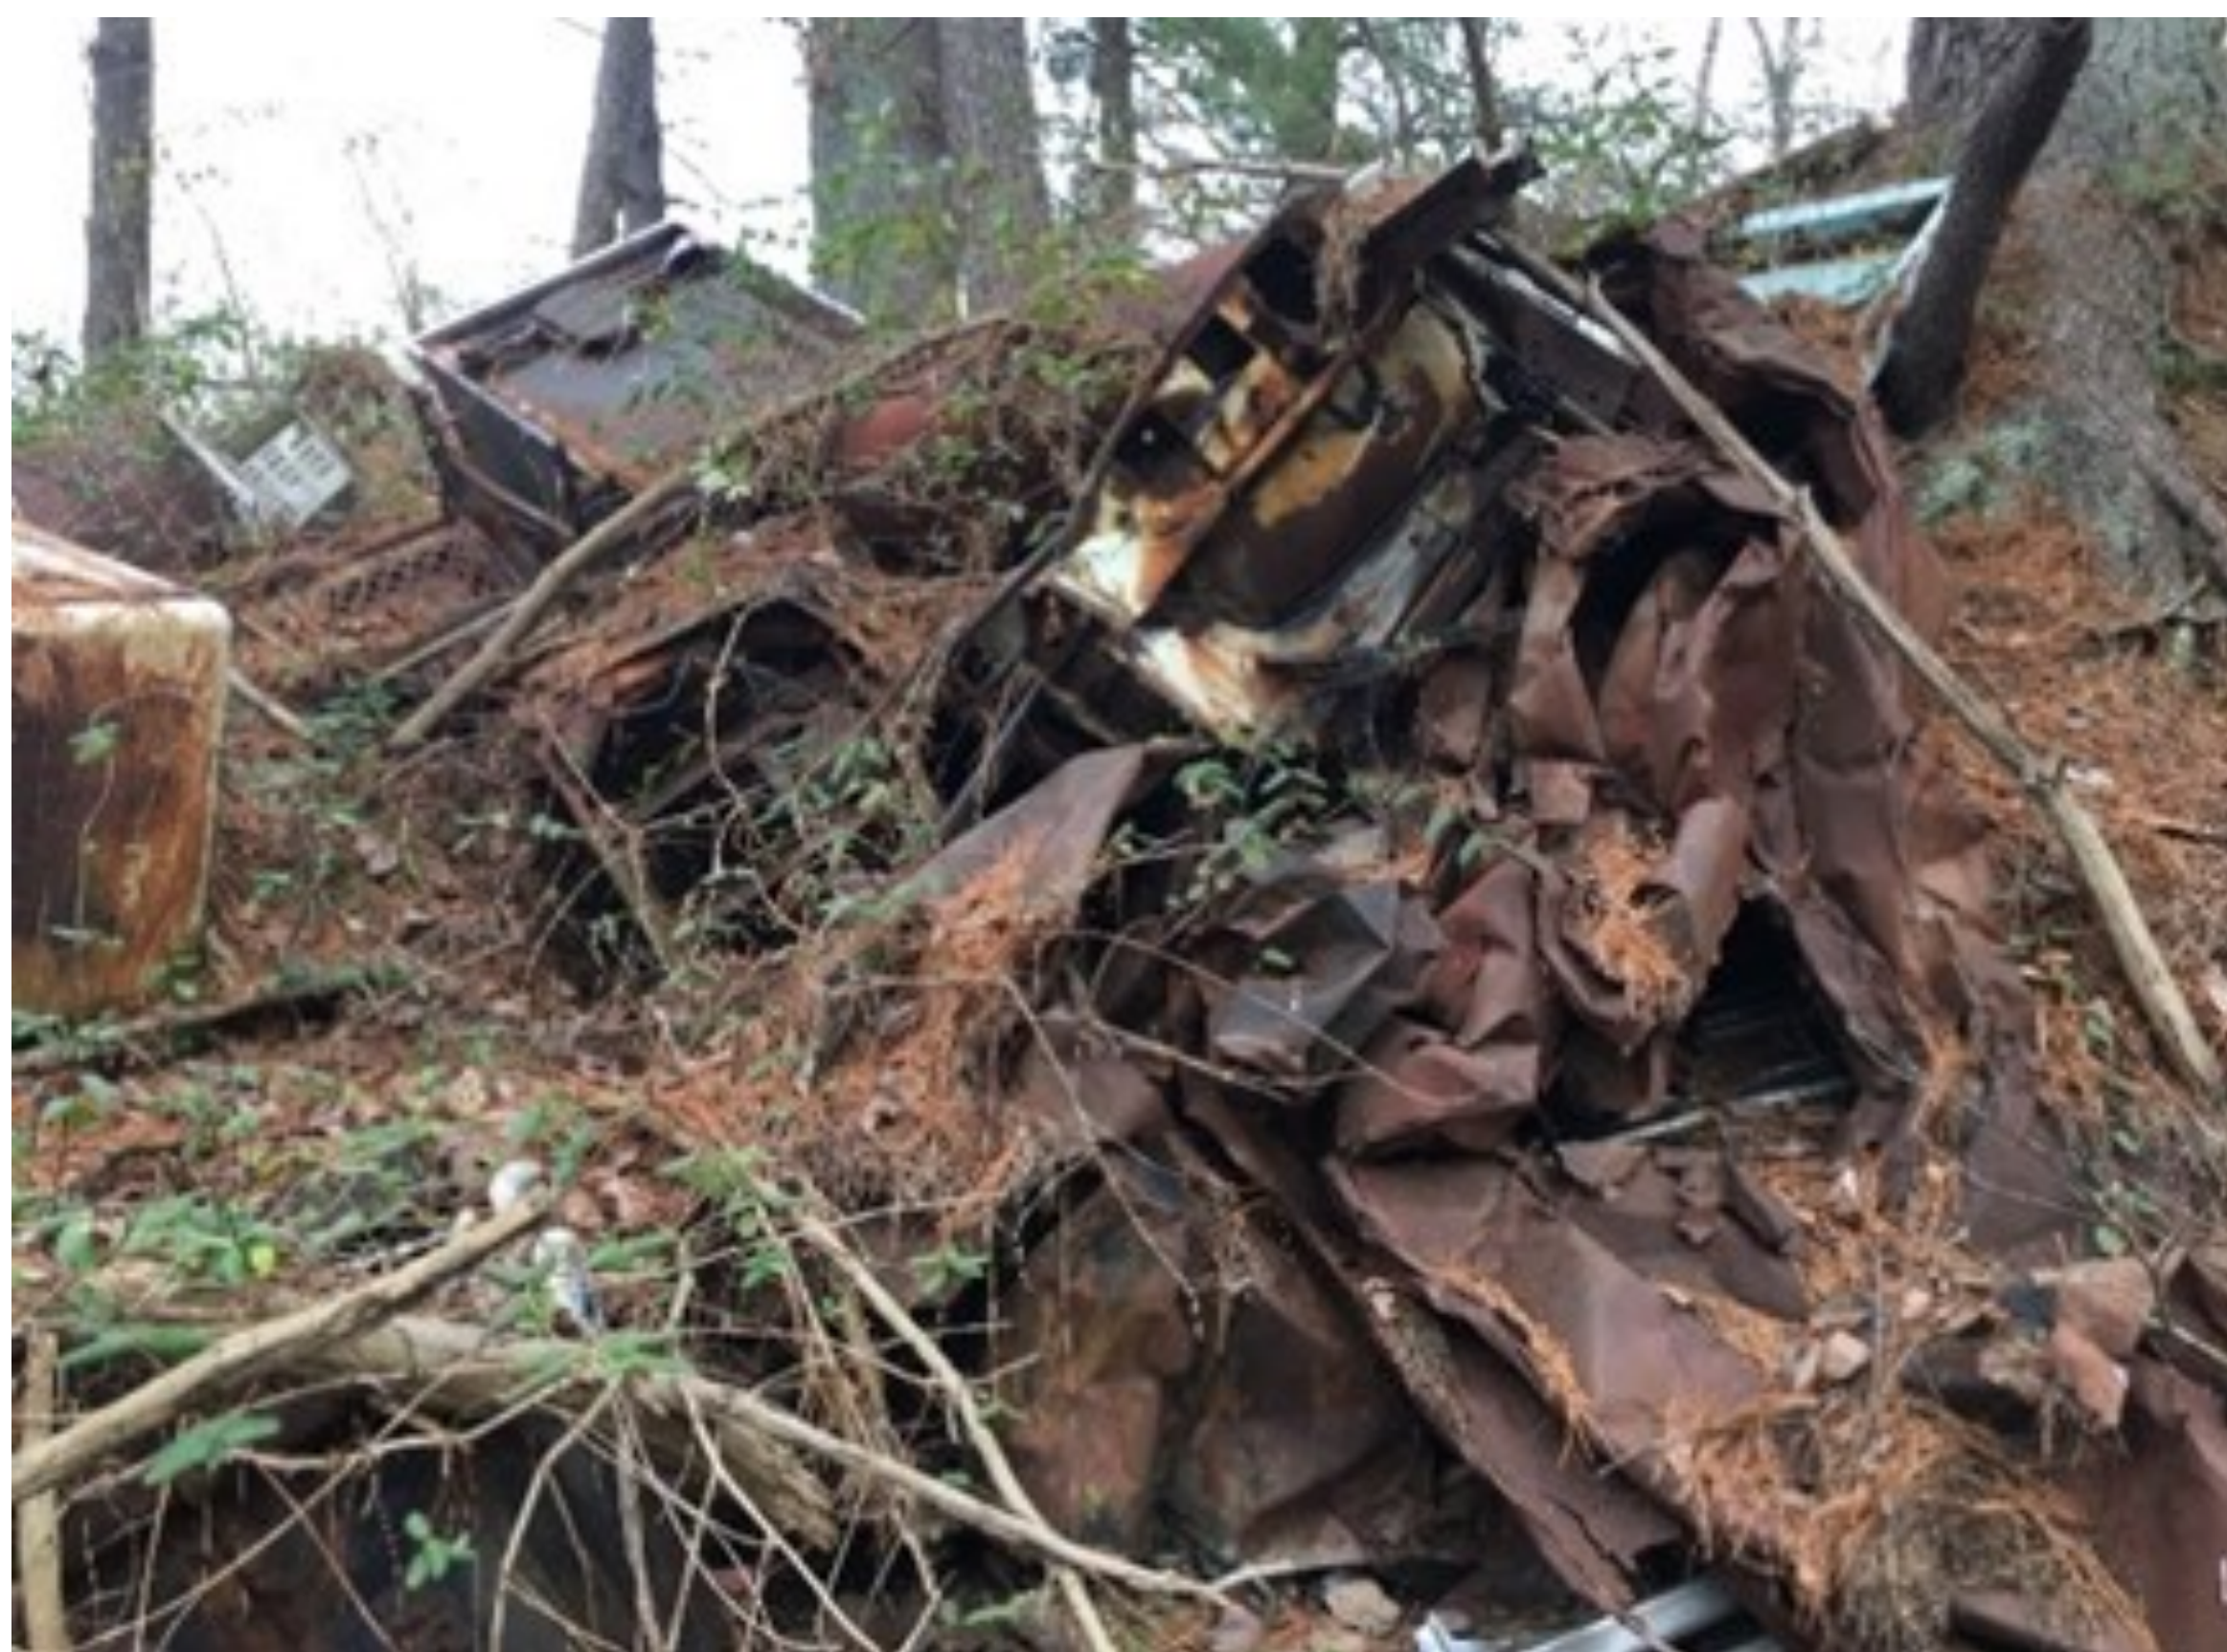
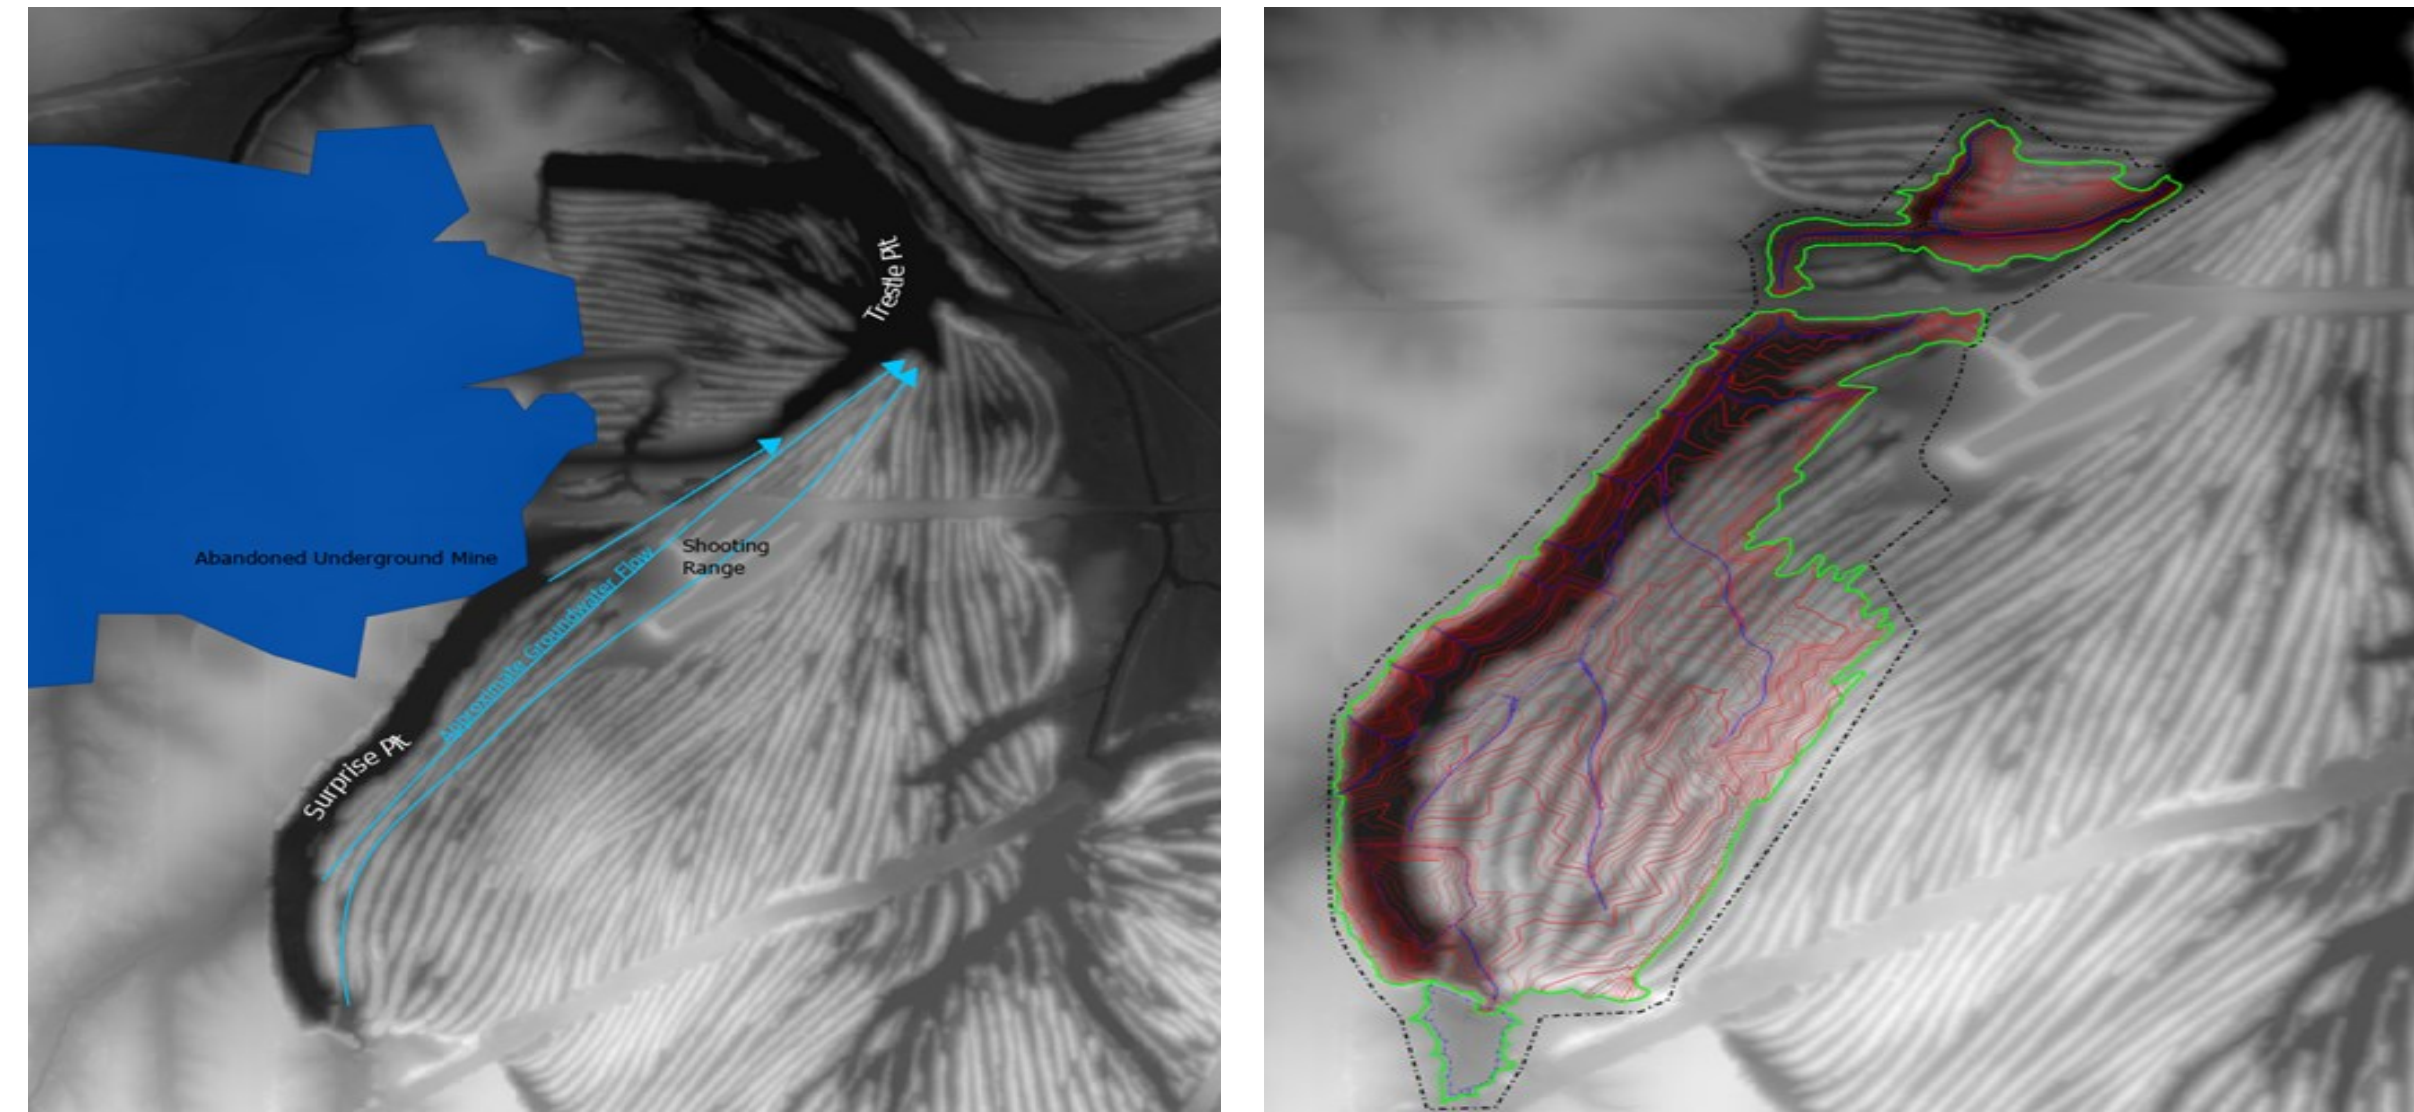
The final design utilized a naturalized drainage pattern that would feed water into 3 heavily compacted ponds built at an elevation much higher than the original pit and situated to minimize exposure to leak zones that would feed AMD seeps across the road. This helped move water across the surface without being impacted by acid producing materials in the spoil.

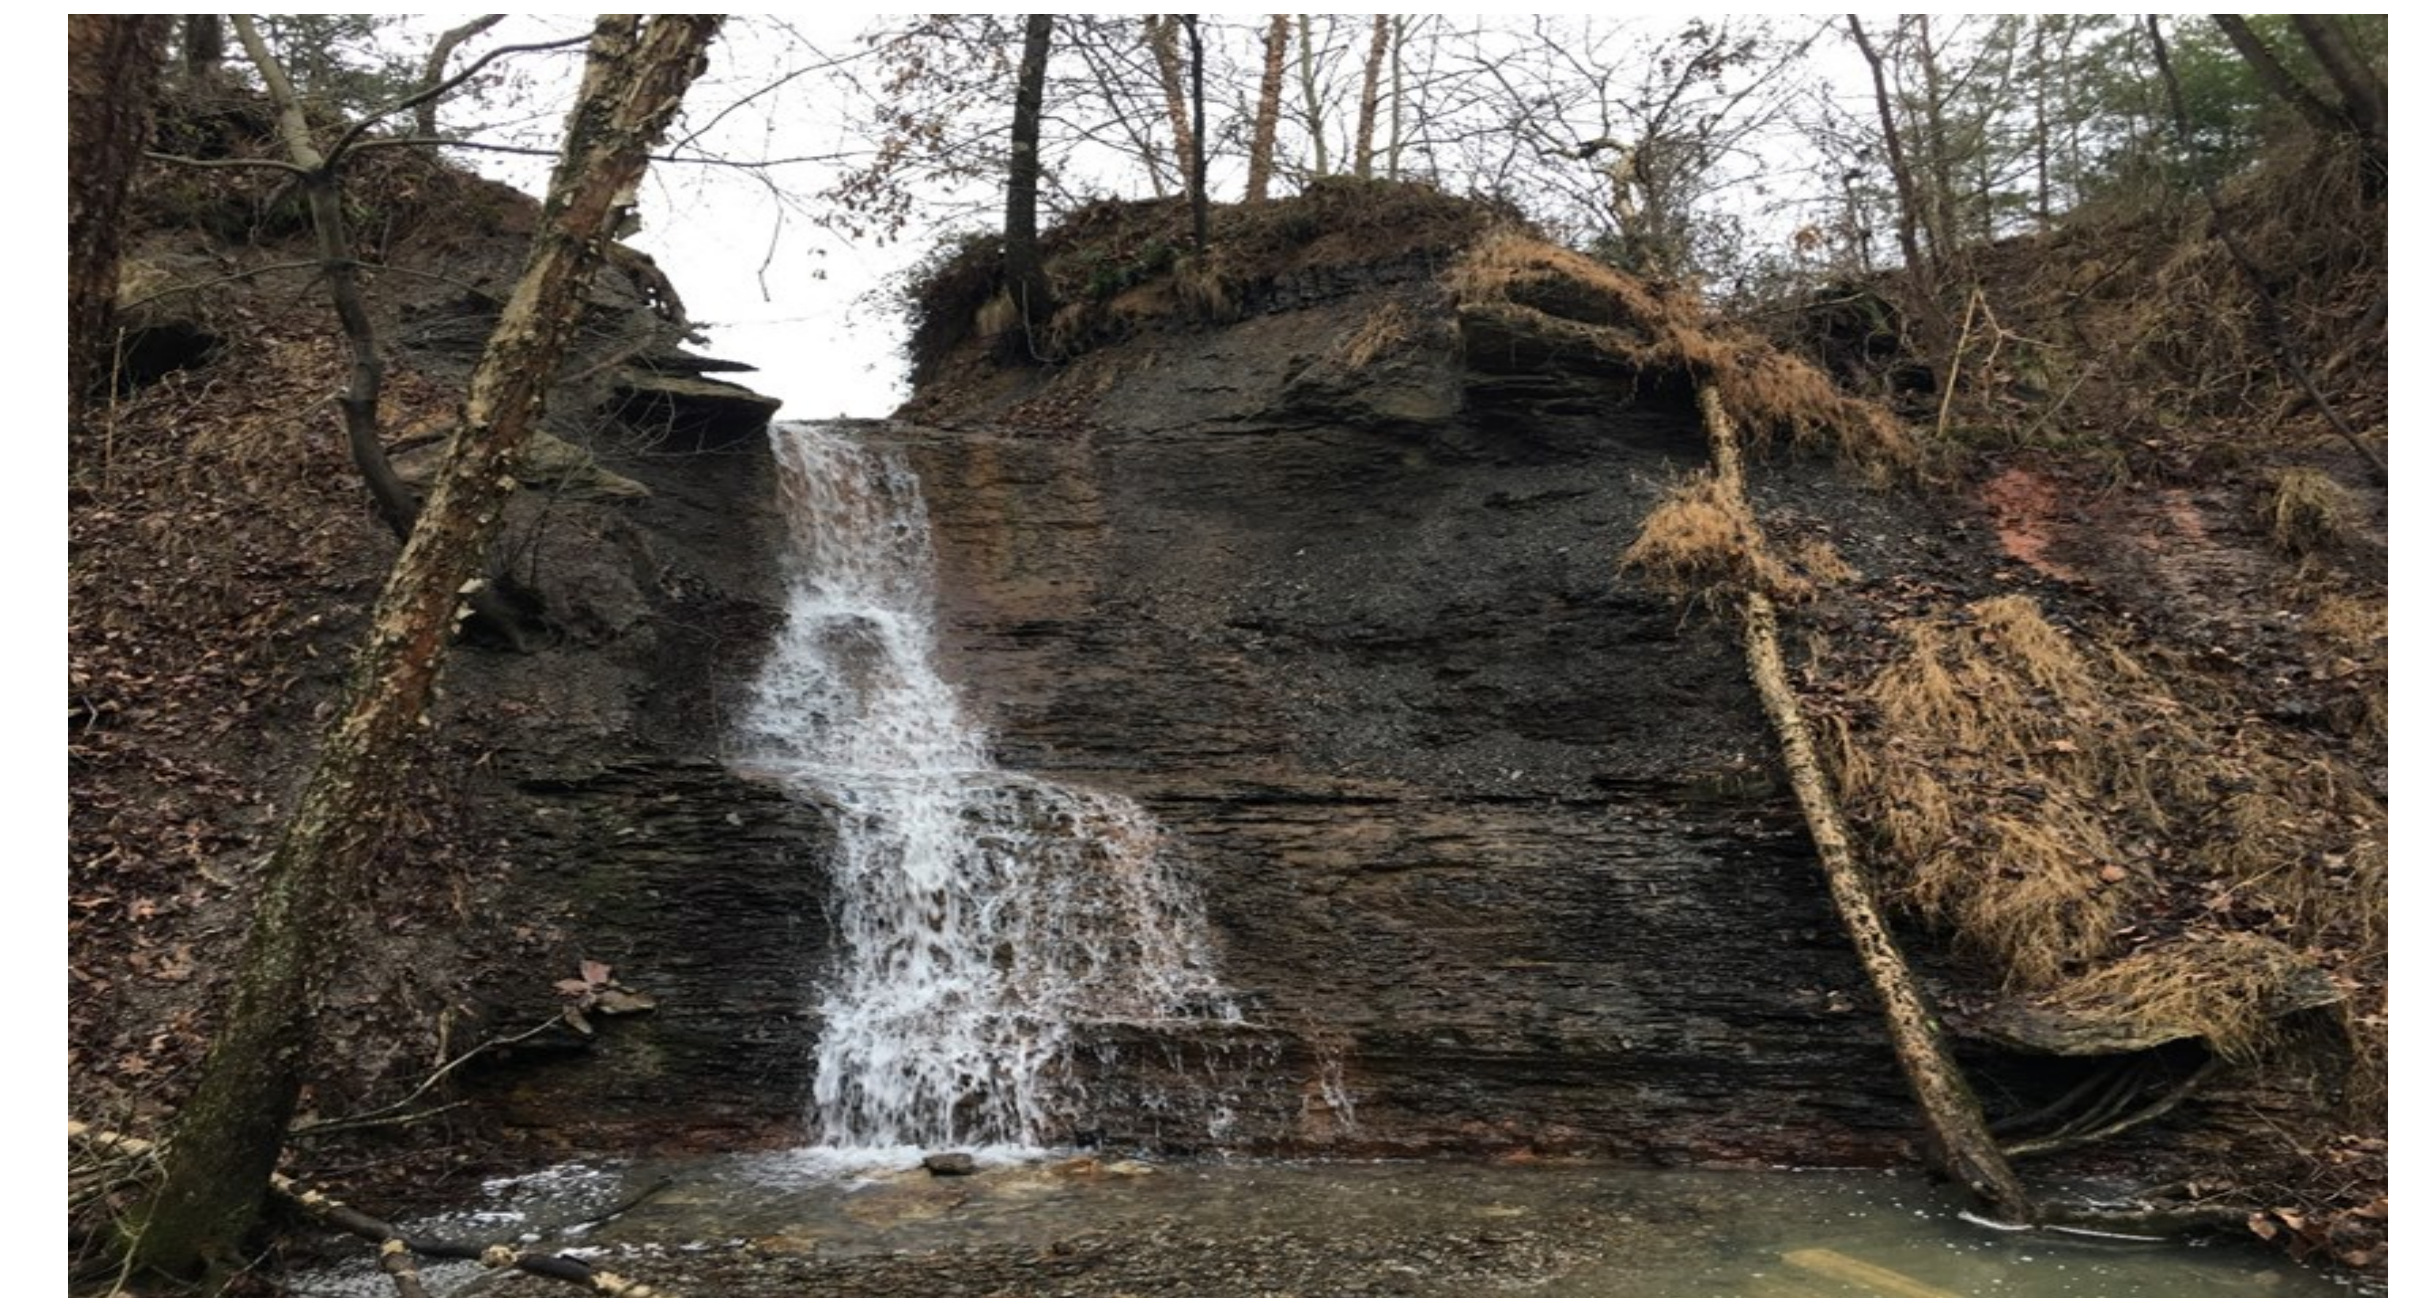
Construction was complicated by drainage patterns on the site. Two large drainages entered the south end of Surprise pit while the entire area had to be dewatered through a culvert to be installed under the county road on the north end. To effectively convey water to the culvert, it would have to be temporarily impounded and then pumped after portions of site were completed. Wet weather kept the 131-acre drainage constantly feeding into the project area.
