**WETLAND DETERMINATION DATA FORM – Midwest Region**

Project/Site: Des. 2002197: SR 159 UNT to Splunge Creek City/County: Vigo County Sampling Date: 8/25/2022  
 Applicant/Owner: INDOT, Crawfordsville District State: IN Sampling Point: 1-OUT  
 Investigator(s): Brock Ervin & Ben Neild, INDOT Crawfordsville DE Section, Township, Range: Section 23, T 10 N, R 8 W  
 Landform (hillslope, terrace, etc.): Forested Flat Local relief (concave, convex, none): None  
 Slope (%): < 2% Lat: 39.296926° Long: -87.259186° Datum: NAD 1983  
 Soil Map Unit Name: AvB2 - Ava silt loam, 2 to 6 percent slopes, eroded NWI classification: No (See Remarks)

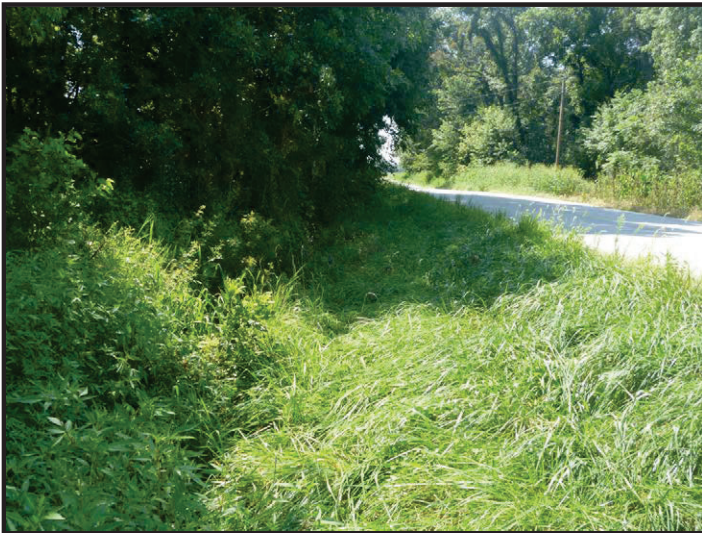
**Photo 73 – Northeast Quadrant, Wetland A:** Facing south along the east side of SR 159 toward the southern limits of Wetland A. A large patch of *Bidens frondosa* (devil’s-pitchfork, FACW) is located to the left.

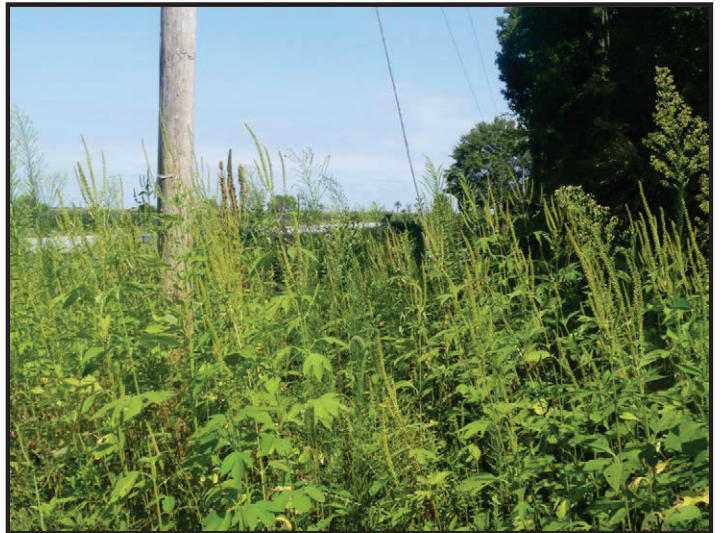
**Photo 74 – Northeast Quadrant, Data Point 3-OUT:** Facing north toward data point 3-OUT and along the woodline where the topography is slightly elevated compared to Wetland A. Great ragweed and horseweed were present.

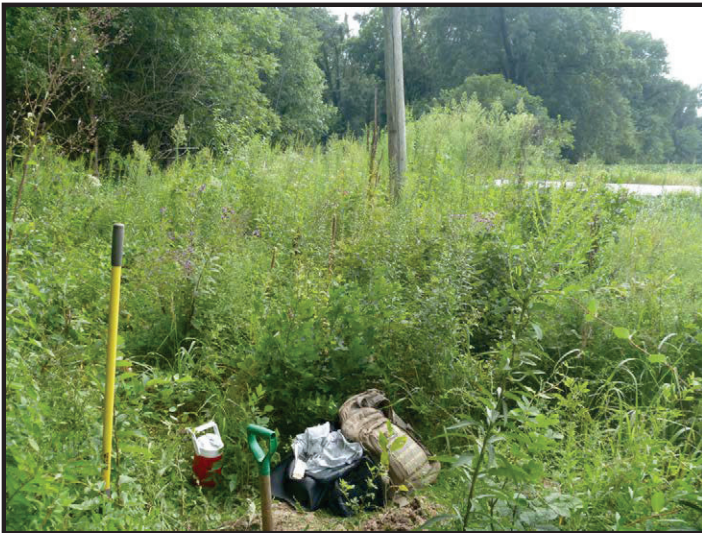
**Photo 75 – Northeast Quadrant, Data Point 3-OUT:** Facing south toward data point 3-OUT. The location passed the Dominance Test for hydrophytic vegetation.

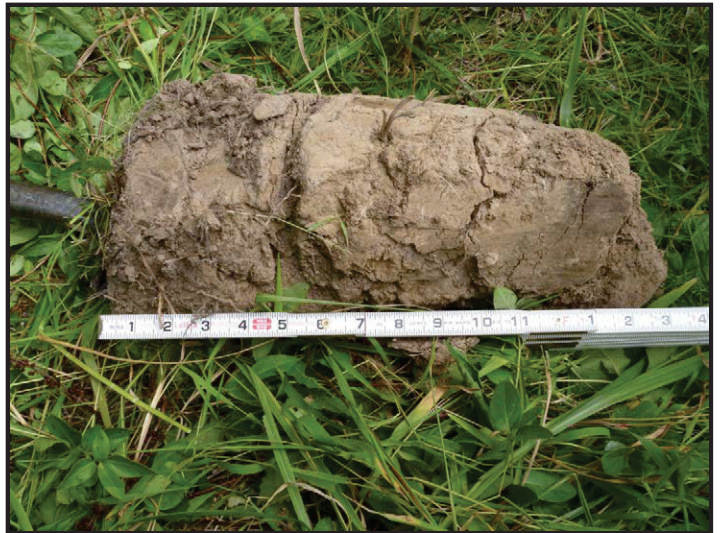
**Photo 76 – Northeast Quadrant, Data Point 3-OUT:** Soil sample from data point 3-OUT exhibited the hydric soil indicator for Depleted Matrix. The sample was very dry and does not show coloration without

<b>Restrictive Layer (if observed):</b>								
Type: _____								
Depth (inches): _____						<b>Hydric Soil Present?</b> Yes <input checked="" type="checkbox"/> No <input type="checkbox"/>		
Remarks:								
Very fine, dry sediment, dusty.

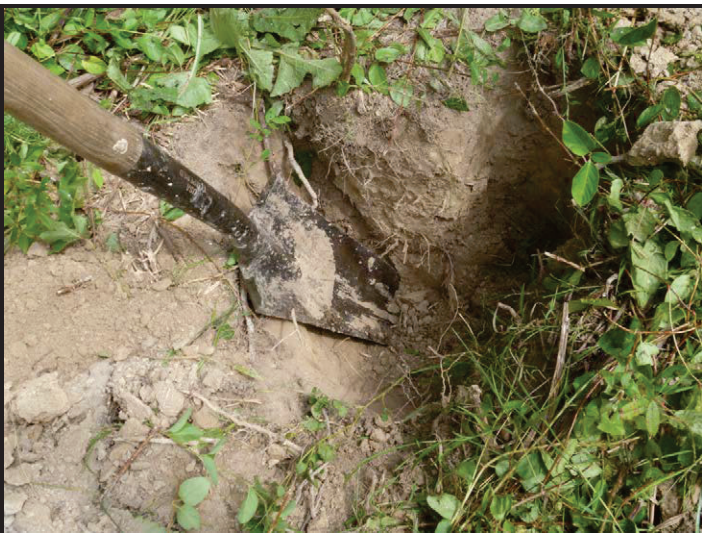
**Photo 77 – Northeast Quadrant, Data Point 3-OUT:** Test pit at data point 3-OUT was dry. While the FAC-Neutral Test was observed, no other hydrology indicators were present.

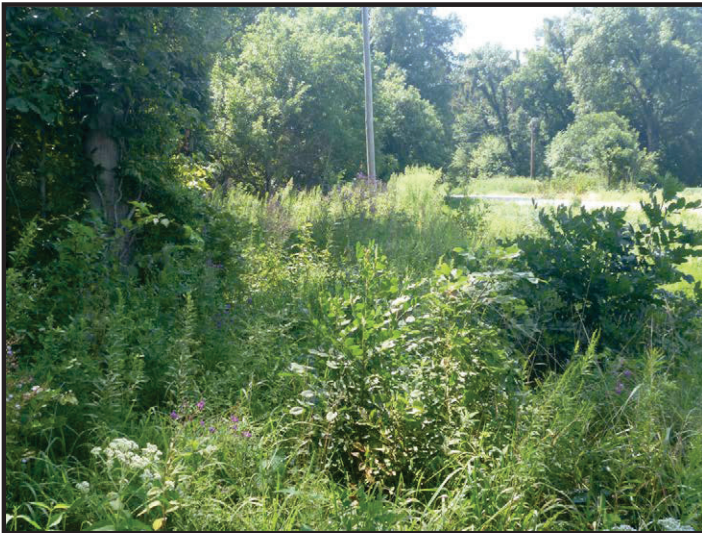
**Photo 79 – Northeast Quadrant, Wetland A:** Facing south along the eastern border of Wetland A. Area contains plants with mixed indicator statuses, but still includes some obligate species (common boneset in bottom left corner).

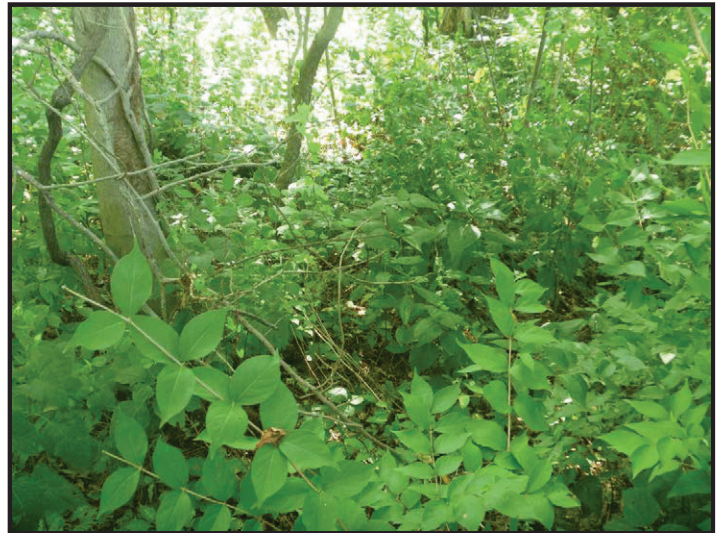
**Photo 80 – Northeast Quadrant:** Facing west from within the forested area in the northwest quadrant of the AOI. No indications of surface water features were observed.

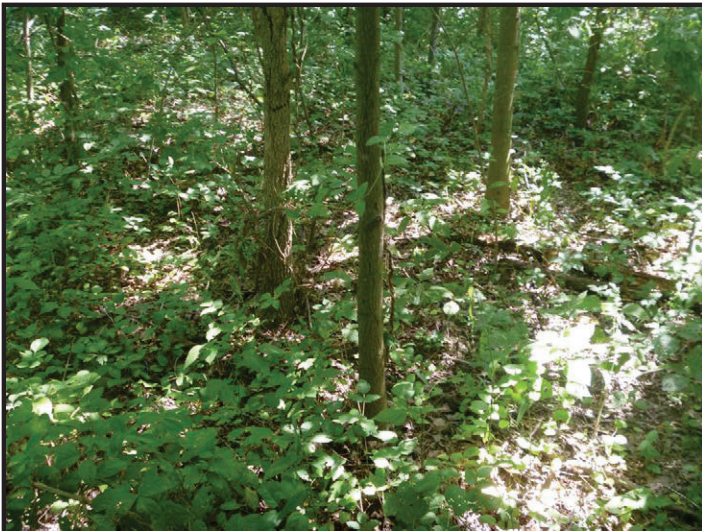
**Photo 81 – Northeast Quadrant:** Facing southwest from within the forested area in the northwest quadrant of the AOI. No indications of surface water features were observed.

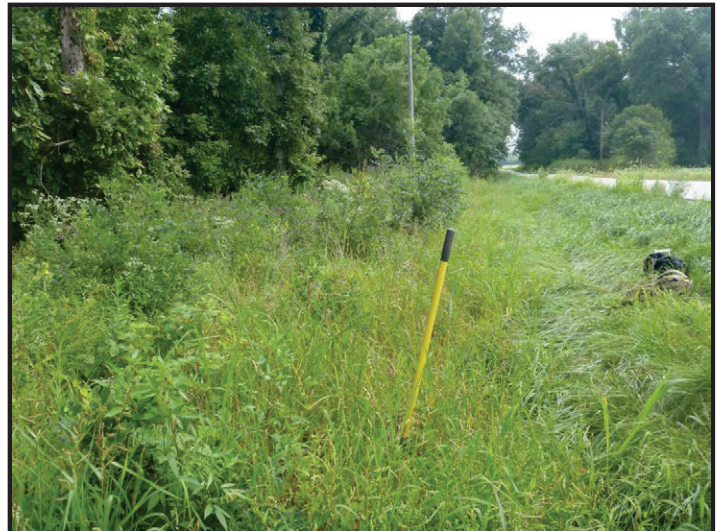
**Photo 82 – Northeast Quadrant, Data Point A-IN:** Facing south toward data point A-IN from within Wetland A and along RSD-3. Large barnyard grass was the only dominant species present, but all other species were FACW or OBL.

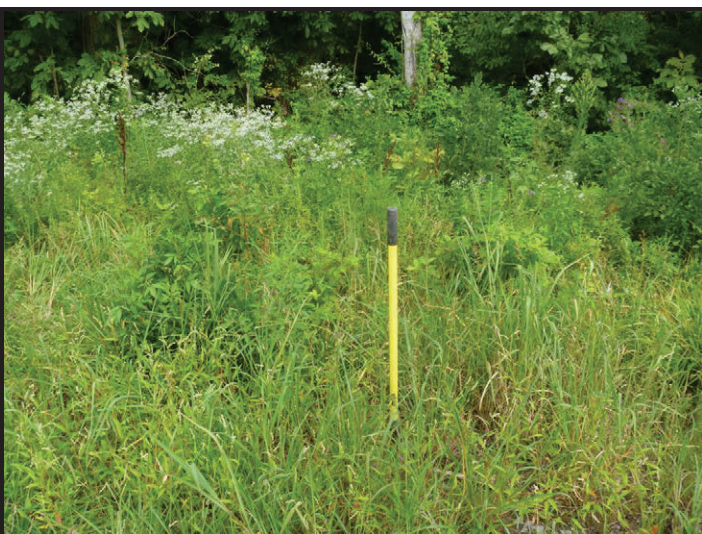
**Photo 83 – Northeast Quadrant, Data Point A-IN:** Facing east toward data point A-IN and across Wetland A. Note the rise in topography further back that helps to delineate the wetland.

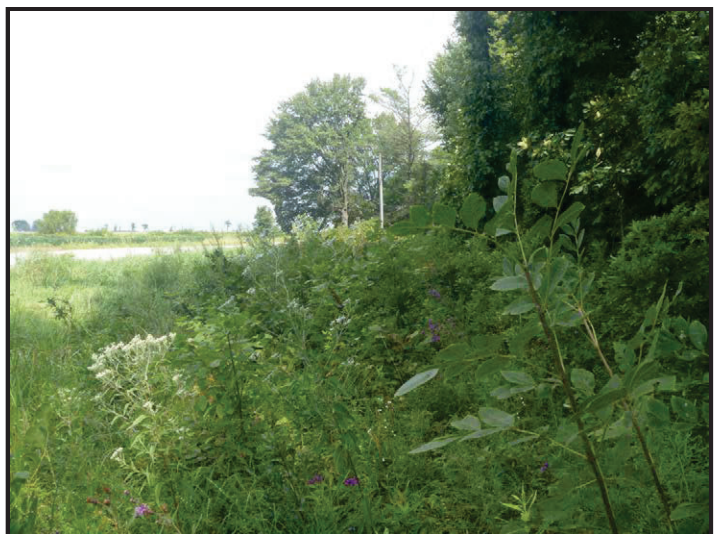
**Photo 84 – Northeast Quadrant, Wetland A:** Facing north along the eastern limits of Wetland A. Note the higher topography along the woodline of the right-of-way.

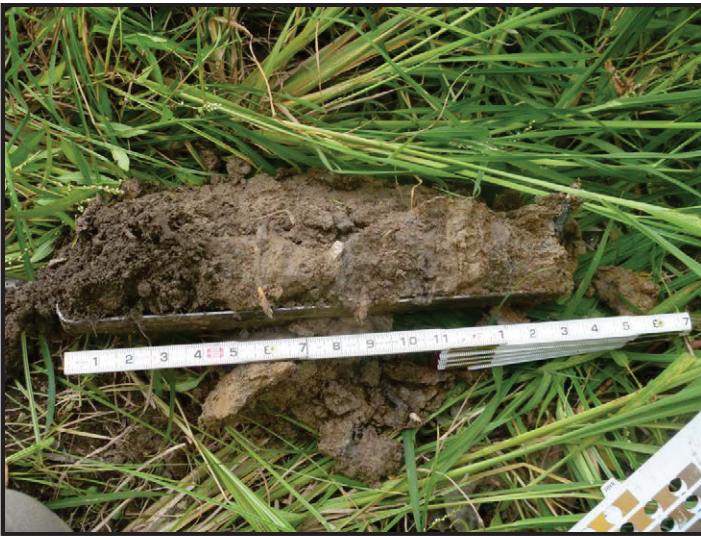
**Photo 85 – Northeast Quadrant, Data Point A-IN:** The soil sample at data point A-IN exhibited two indicators of hydric soils, including Depleted Below Dark Surface and Depleted Matrix.

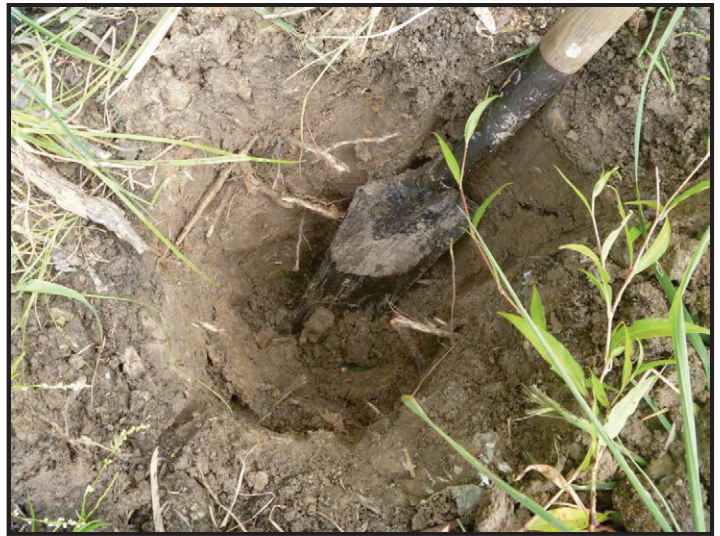
**Photo 86 – Northeast Quadrant, Data Point A-IN:** Test pit at data point A-IN contained moist soils and became nearly saturated at the bottom. Geomorphic Position and FAC-Neutral Test indicators were present.

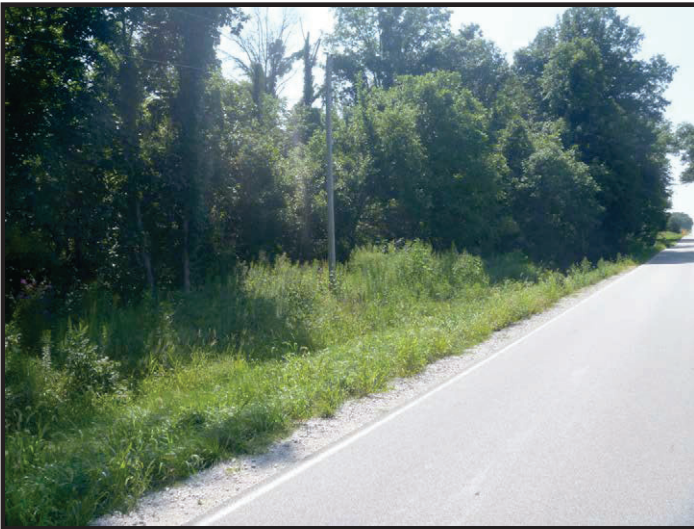
**Photo 87 – Northeast Quadrant, Wetland A and RSD-3:** Facing southeast toward Wetland A and RSD-3 from SR 159. RSD-3 did not exhibit an OHWM or defined bed and bank.

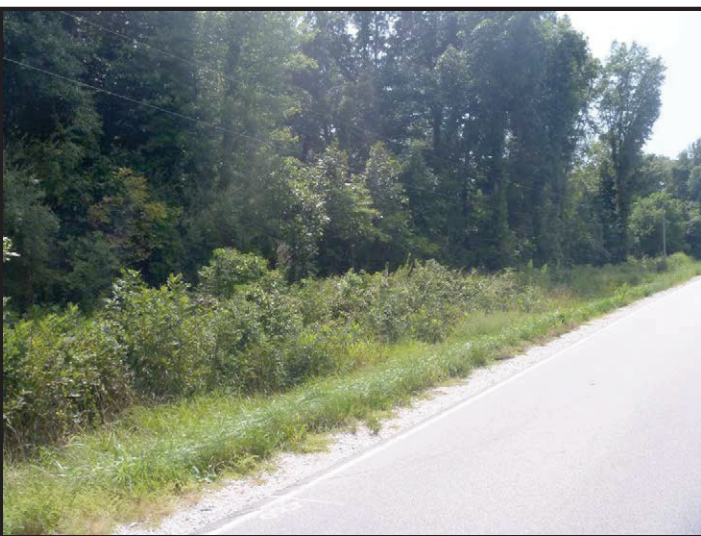
**Photo 89 – Northeast Quadrant, Wetland A and RSD-3:** Facing southeast toward Wetland A and RSD-3 from SR 159. Photo shows the change in topography of where Wetland A expands beyond the roadside ditch (right).

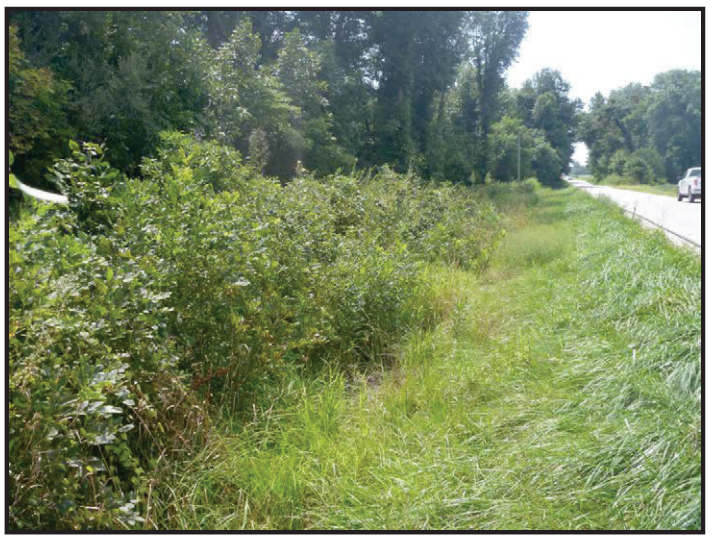
**Photo 90 – Northeast Quadrant, Wetland A and RSD-3:** Facing south along Wetland A and RSD-3 from the northern terminus of the AOI. The northern segment of Wetland A is confined to RSD-3.

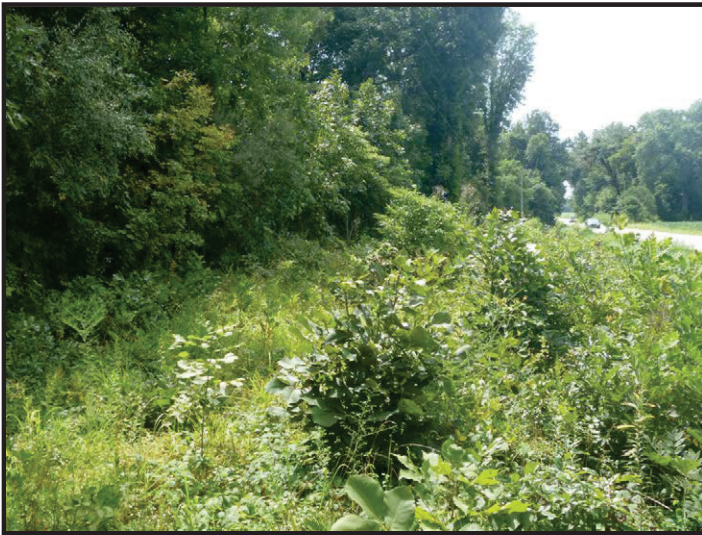
**Photo 91 – Northeast Quadrant:** Facing south along the vegetated right-of-way between RSD-3 and the treeline. The area is elevated, confining Wetland A to the roadside ditch.

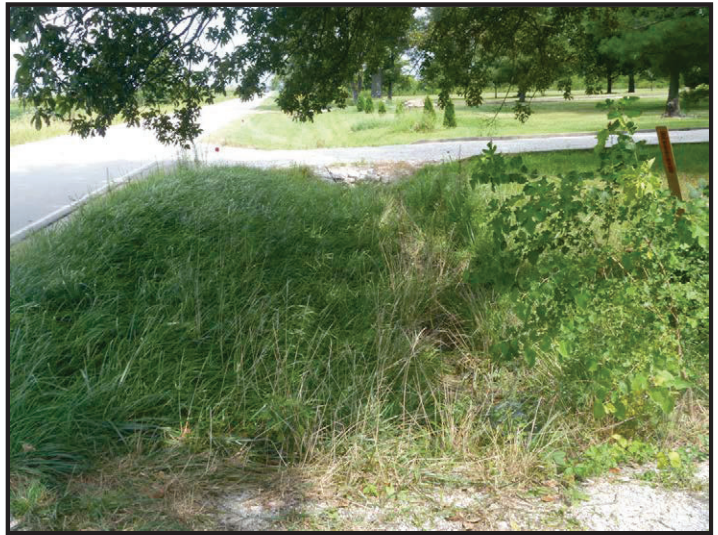
**Photo 92 – Northeast Quadrant, RSD-3:** Facing north along RSD-3, beyond the northern limits of the AOI. RSD-3 did not exhibit an OHWM or defined bed and bank.

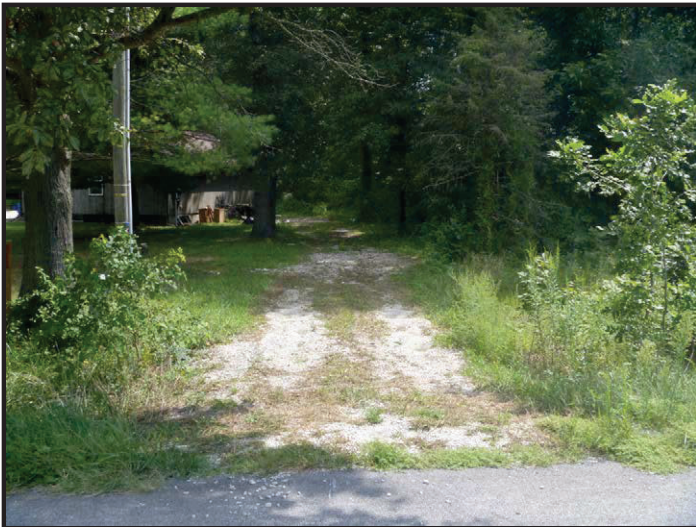
**Photo 93 – Northeast Quadrant:** Facing east toward a gravel access drive over RSD-3 at the northern terminus of the AOI. Wetland A starts immediately south of the drive.

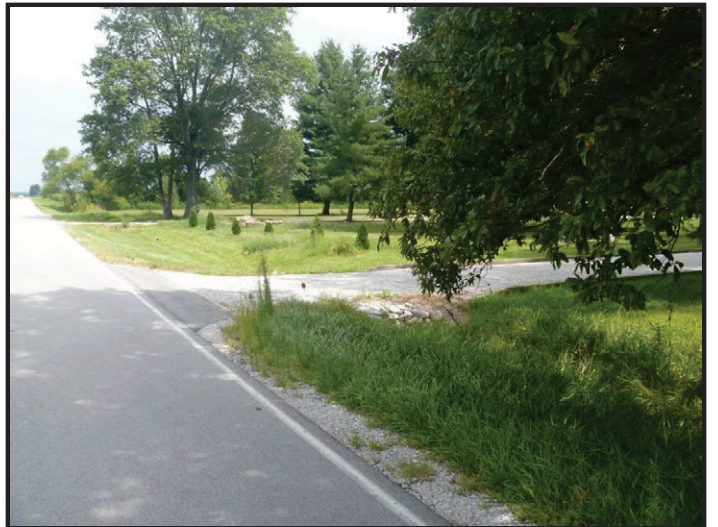
**Photo 94 – Northeast Quadrant, Beyond AOI:** Facing northeast beyond the northern limits of the AOI toward a rural residential property.

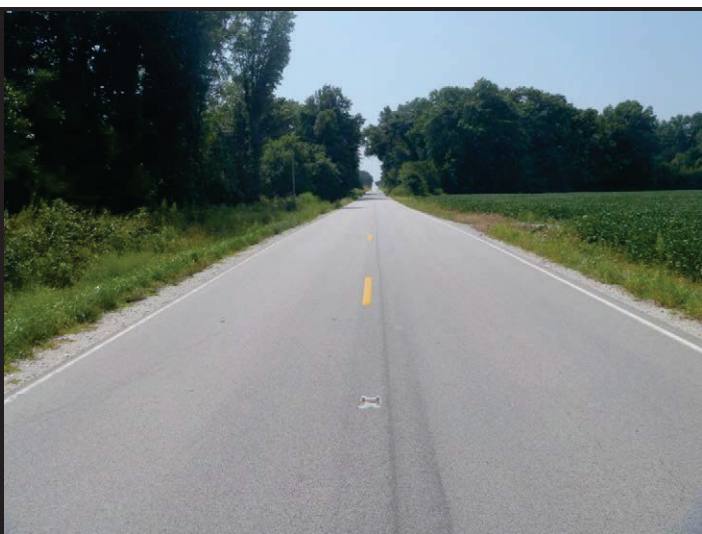
**Photo 95 – North Project Setting, Toward AOI:** Facing south along SR 159 from the northern limits of the AOI. Topography north of the subject culvert is flat. Land use is forested and agricultural.

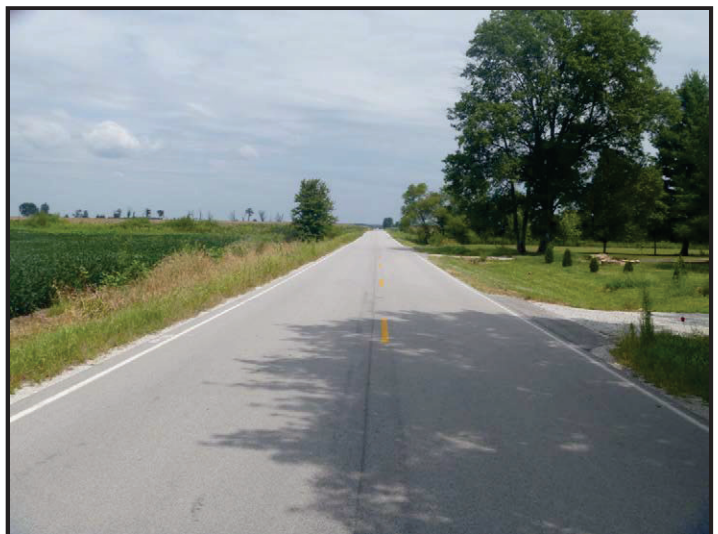
**Photo 96 – North Project Setting, Beyond AOI:** Facing north beyond the northern limits of the AOI. Topography is flat. Land use is agricultural and rural residential.
