Lead Des 1800082
Appendix F
Water Resources

Waters Report
US 31
Roadway Reconstruction Project
Johnson County, Indiana
Des. No. 1800082 et al.

Report Completed on: September 21, 2021

Prepared By:
Christian Radcliff
SJCA Inc.
9102 N Meridian Street, Suite 200
Indianapolis, IN 46260

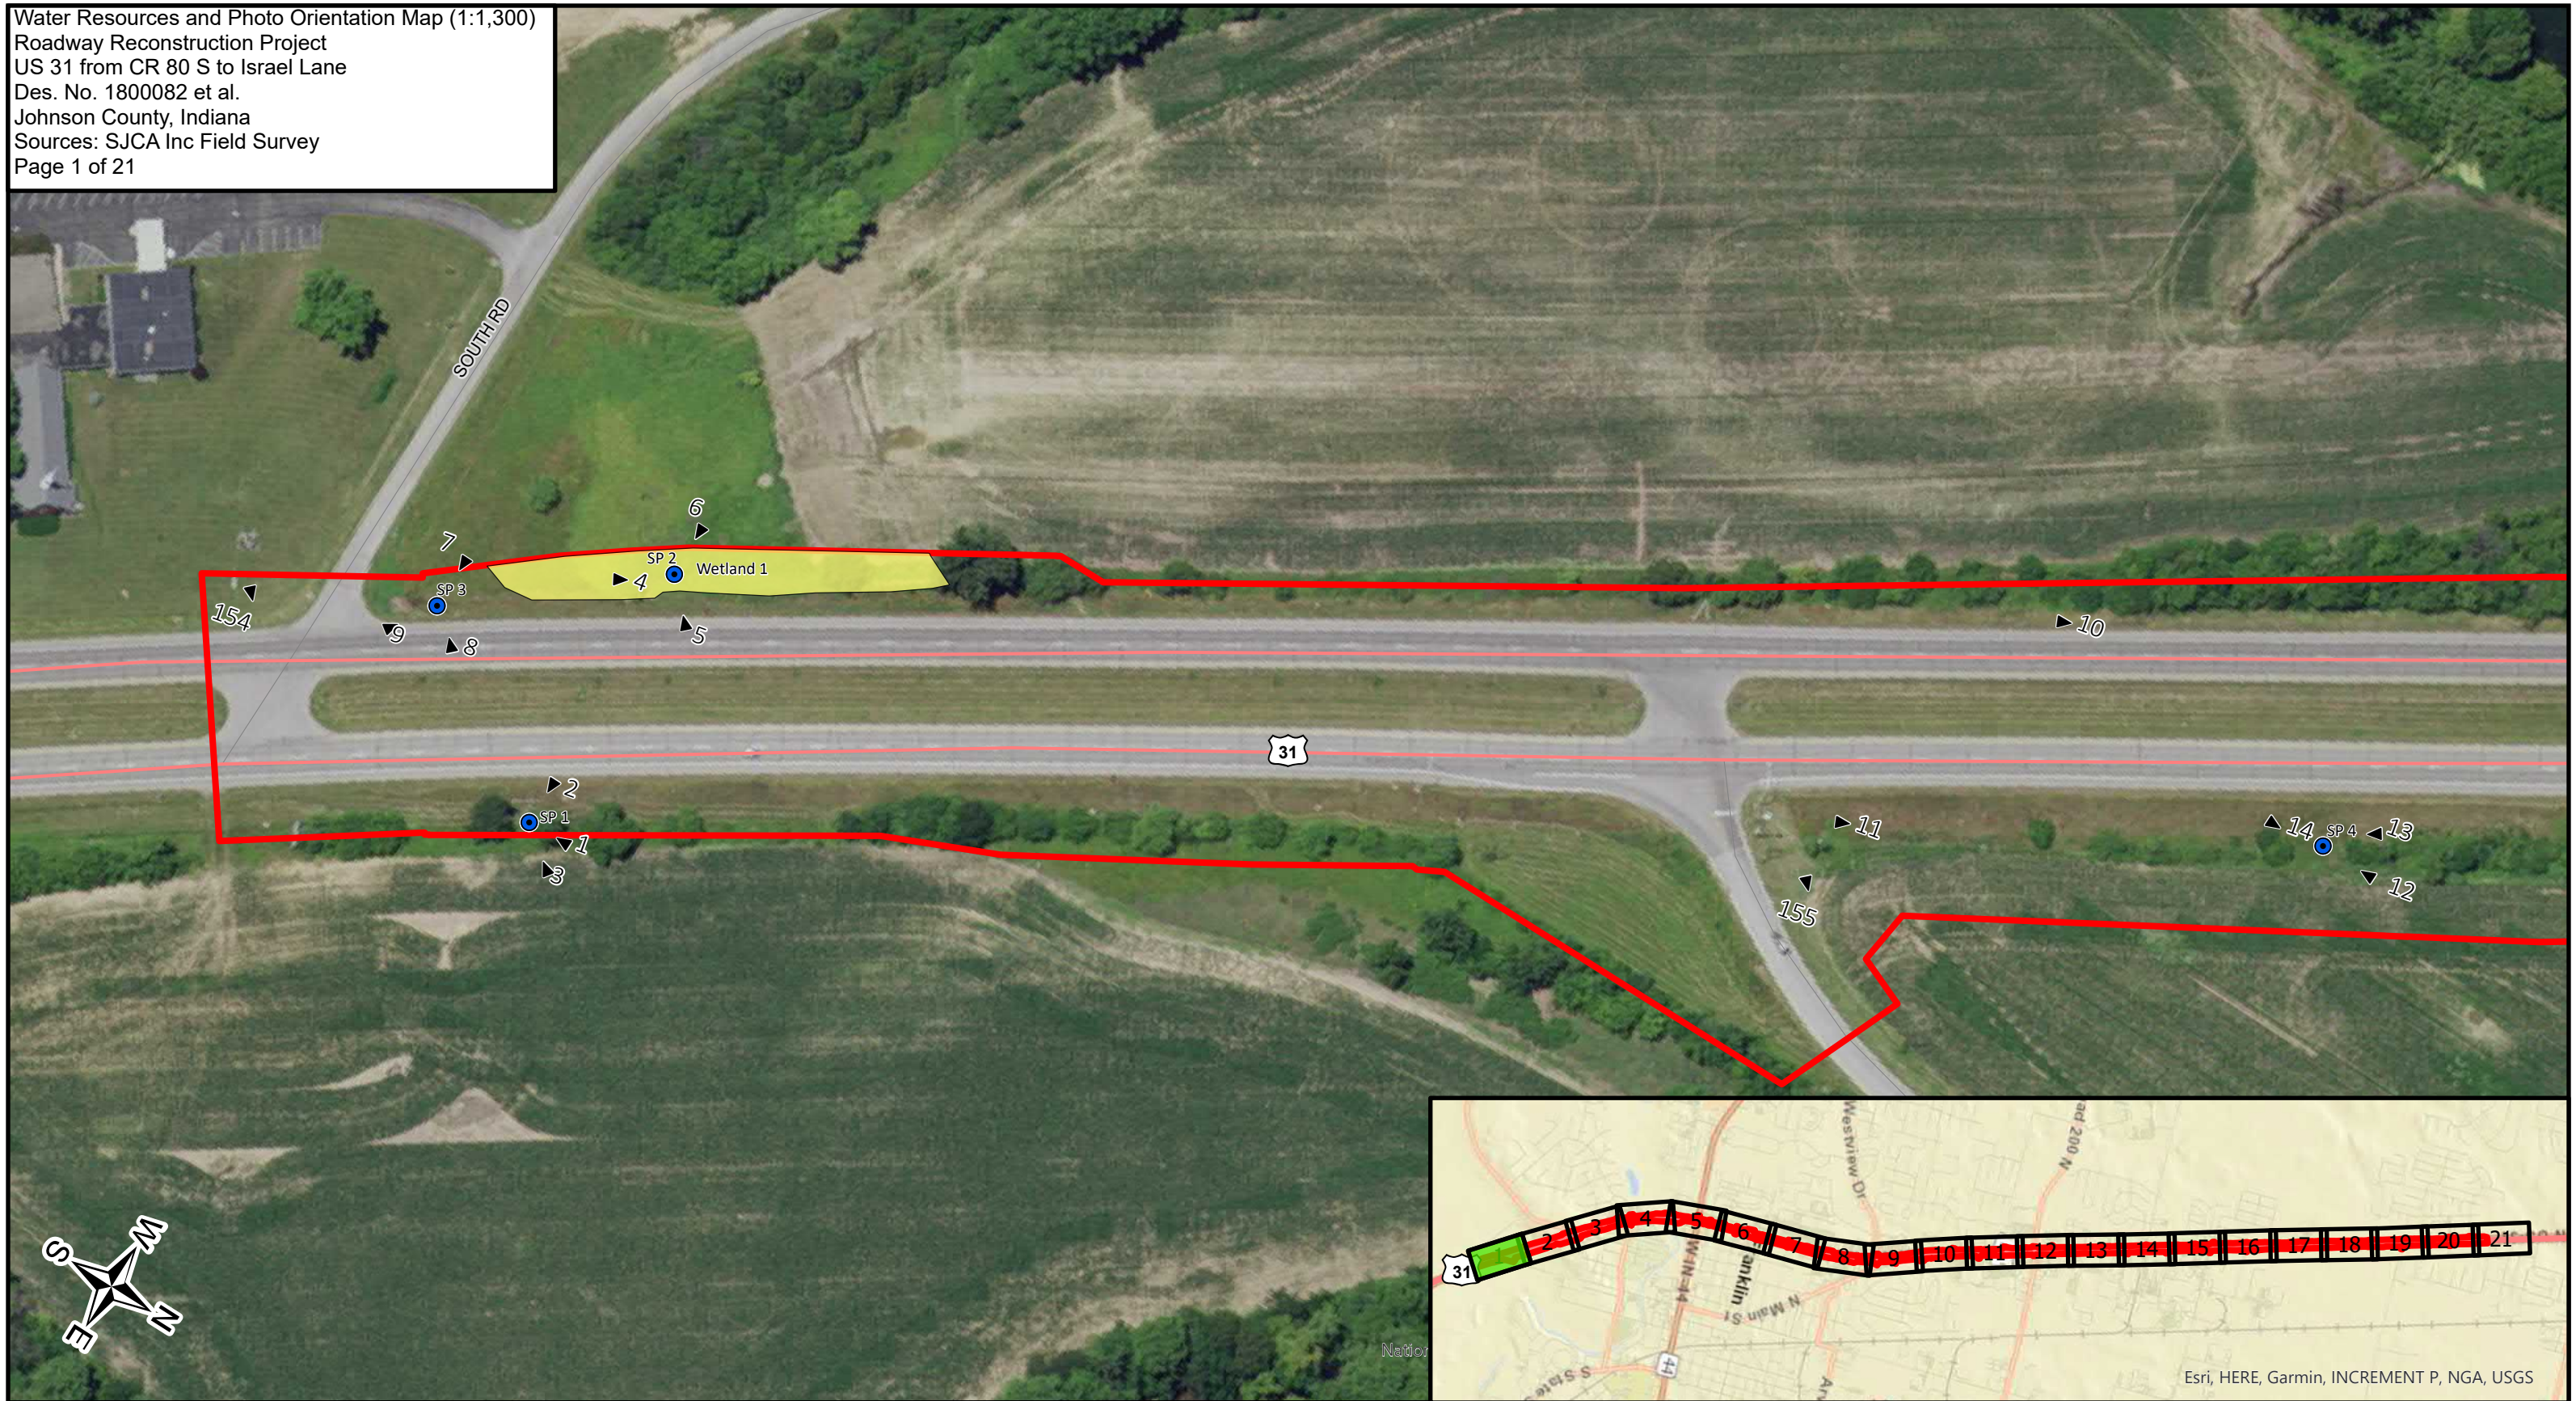
- Investigated Area
- Emergent
- Scrub-Shrub
- Forested
- Stream
- RSD
- Photo Location
- Sample Point
- OHWM
