Des. No. 2002000
SR 18 at East Crossing of
Greenwood Ditch
Bridge Project
6.84 Miles East of US 52
Benton County

INDOT, Crawfordsville District, with funding from FHWA, has programmed Des. No. 2002000 to address the deteriorating condition of the superstructure and substructure of the bridge at the east crossing of SR 18 over Greenwood Ditch in Benton County.

Bridge Inspection Report

018-04-01689 B
SR 18
over
GREENWOOD DITCH

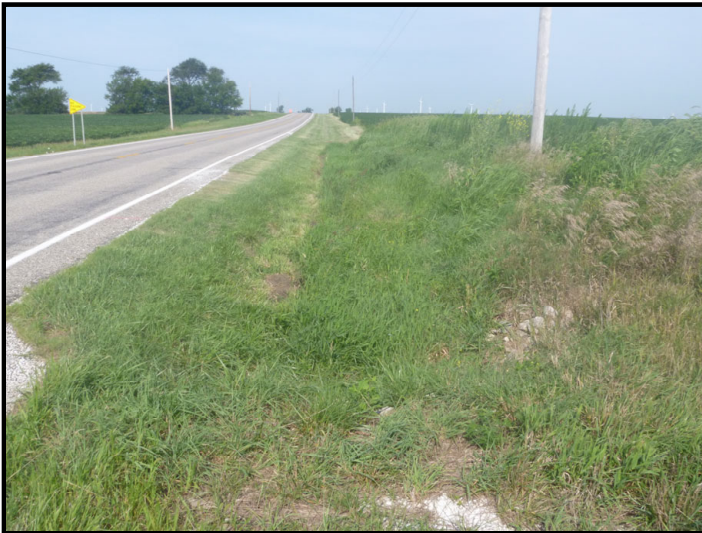
Photo 1 – RSD-1: Facing west along the north side of SR 18 beyond the review area and along the man-made roadside ditch (RSD-1).

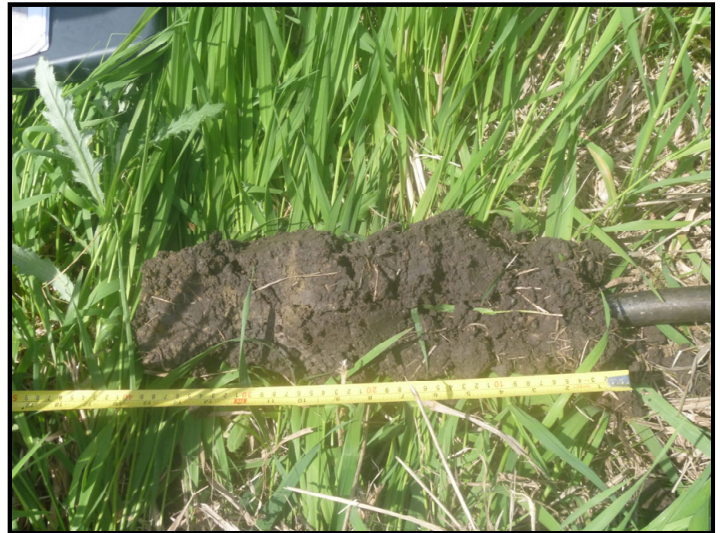
Photo 2 – Data Point A: Facing down toward soil sample from wetland determination point A-OUT. Soils did not exhibit hydric soil indicators.

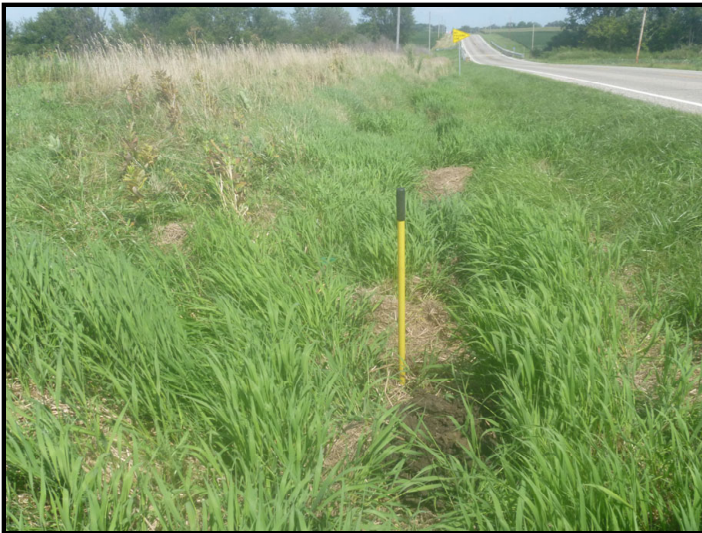
Photo 3 – Data Point A & RSD-1: Facing east along RSD-1 toward data point A-OUT. This segment of the ditch exhibited hydrophytic vegetation due to dominance of reed canary grass.

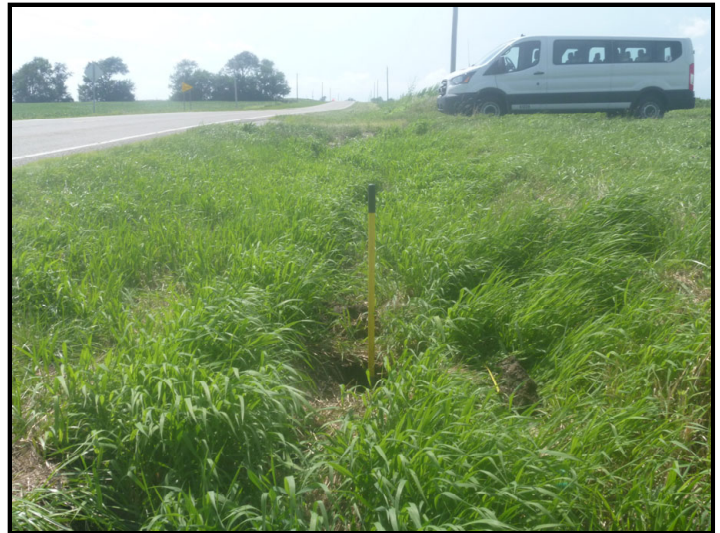
Photo 4 – Data Point A & RSD-1: Facing west along RSD-1 toward data point A-OUT. A-OUT exhibited wetland hydrology due to geomorphic position and the FAC-neutral test, but no water or saturation were present.

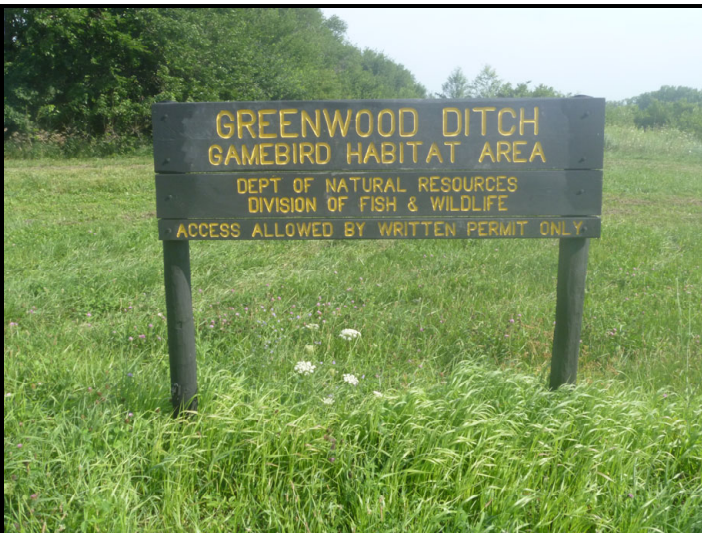
Photo 5 – Northwest Quadrant: Facing north toward the sign at the entrance of the Greenwood Ditch Gamebird Habitat Area, owned by IDNR, which is located in the northwest quadrant of the project area.

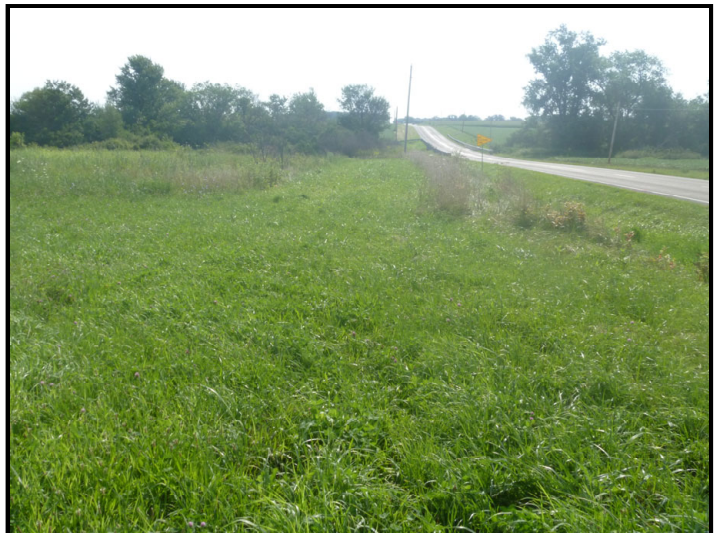
Photo 6 – Northwest Quadrant: Facing east along IDNR access path and SR 18 road frontage of Greenwood Ditch Gamebird Habitat Area. No indications of wetlands observed.

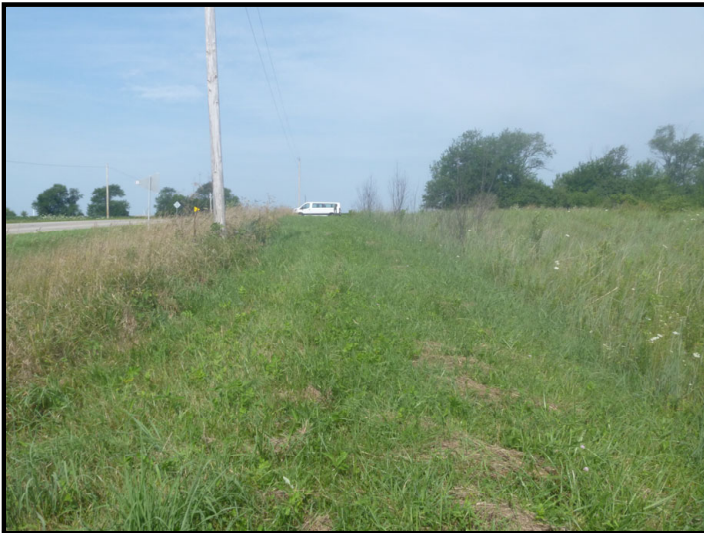
Photo 7 – Northwest Quadrant: Facing west along IDNR access path and SR 18 road frontage of Greenwood Ditch Gamebird Habitat Area. No indications of wetlands observed.

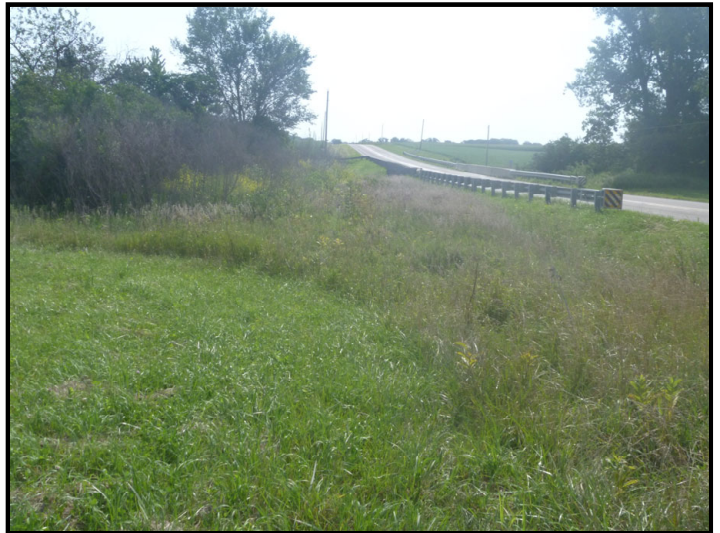
Photo 8 – Northwest Quadrant: Facing east along IDNR access path and SR 18 road frontage of Greenwood Ditch Gamebird Habitat Area. No indications of wetlands observed.

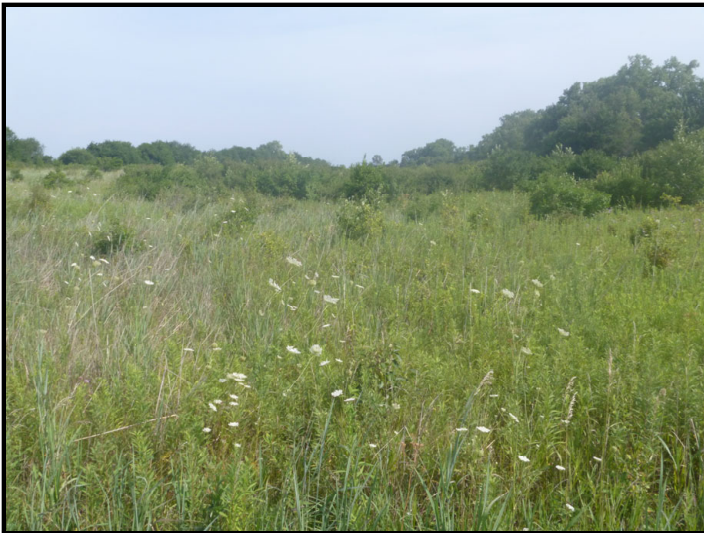
Photo 9 – Northwest Quadrant: Facing north toward gamebird habitat area containing Indian grass and other upland species. No indications of wetlands observed.

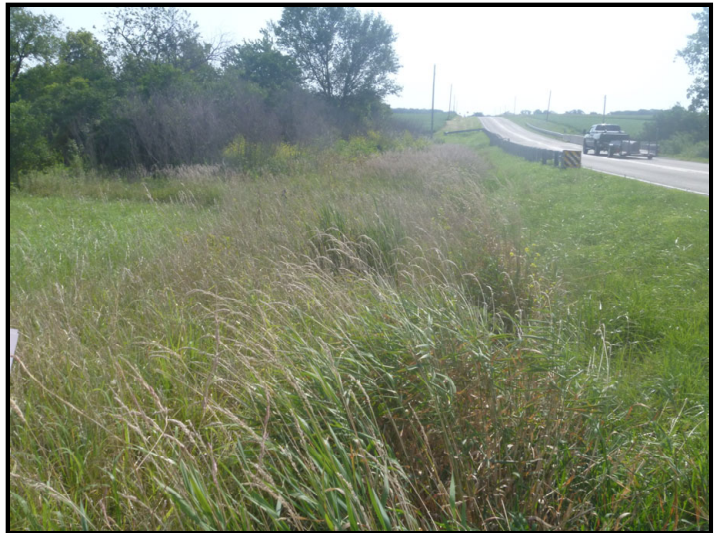
Photo 10 – RSD-1: Facing east along the vegetated RSD-1. During the growing season, RSD-1 did not exhibit a consistent OHWM.

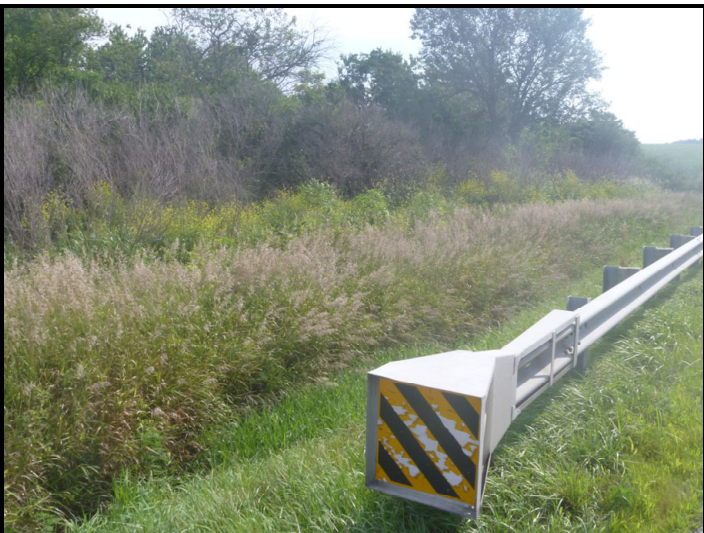
Photo 11 – RSD-1: Facing northeast toward RSD-1 and northwest quadrant of crossing. RSD-1 was heavily vegetated and did not exhibit a consistent OHWM.

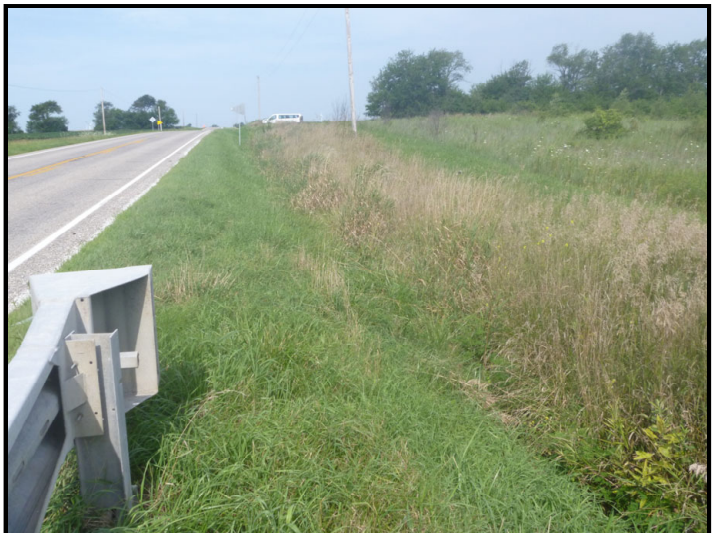
Photo 12 – RSD-1: Facing east along RSD-1 from near the SR 18 bridge over Greenwood Ditch.

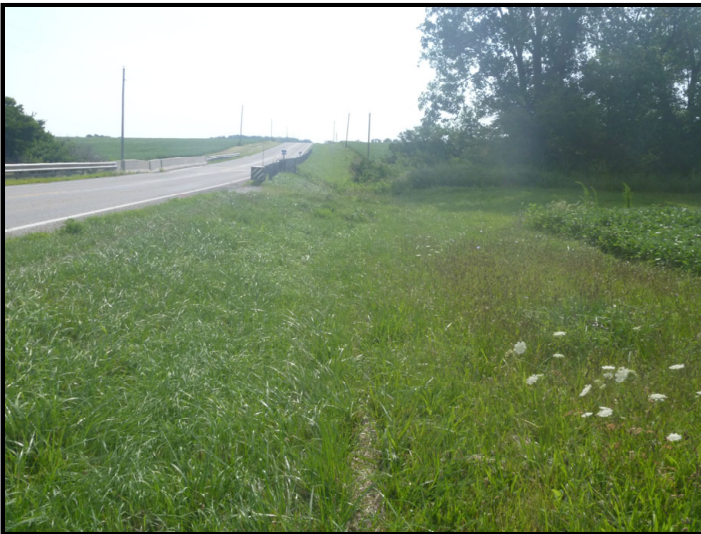
Photo 13 – Southwest Quadrant: Facing east along grassy right-of-way in the southwest quadrant of the project area. SR 18 bridge and Greenwood Ditch in background.

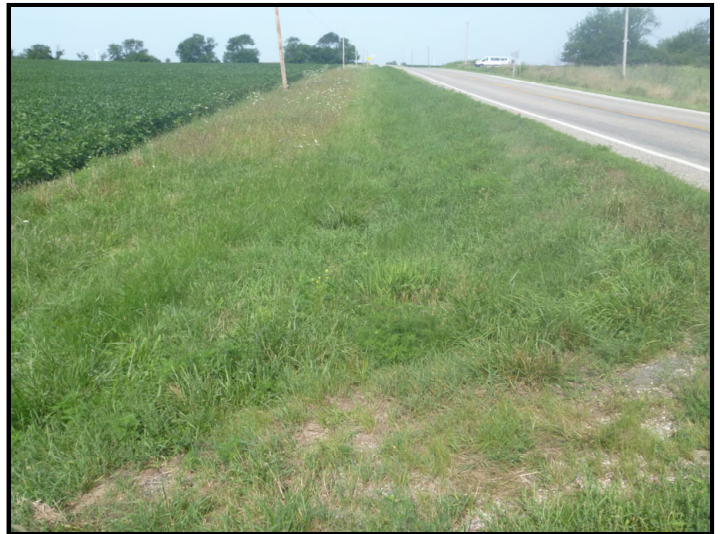
Photo 14 – Southwest Quadrant: Facing west along grassy right-of-way in southwest quadrant of the project area from field access drive.

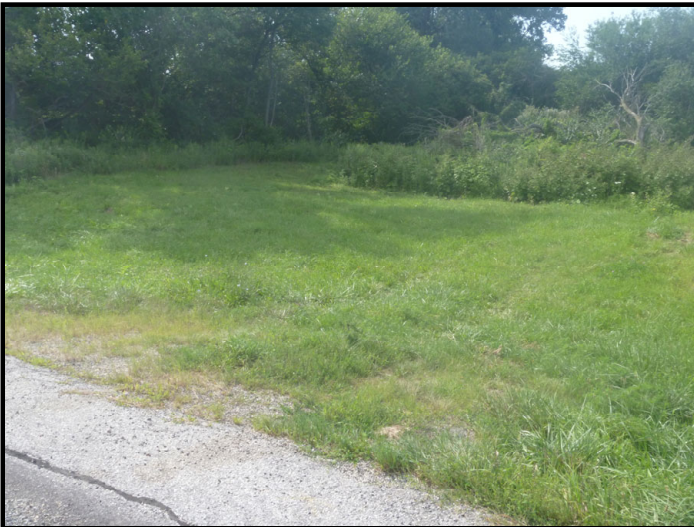
Photo 15 – Southwest Quadrant: Facing southeast toward the southwest quadrant of the project area from a field access drive. Pile of log debris in background is presumably from past tree clearing along riparian.

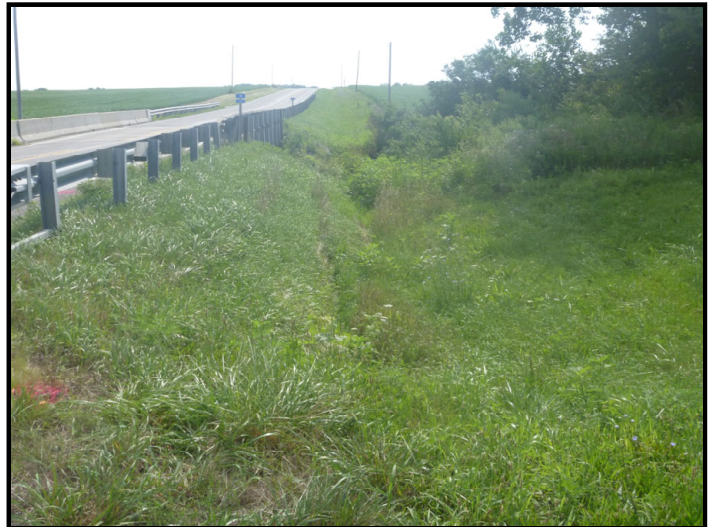
Photo 16 – Southwest Quadrant: Facing east along short vegetated roadside ditch in southwest quadrant near bank of Greenwood Ditch.

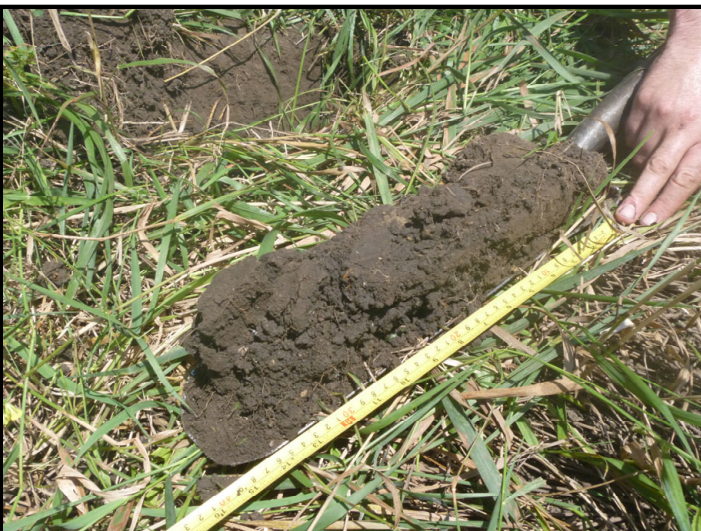
Photo 17 – Data Point B: Facing down toward soil sample from wetland determination point B-OUT. Soils did not exhibit hydric soil indicators.

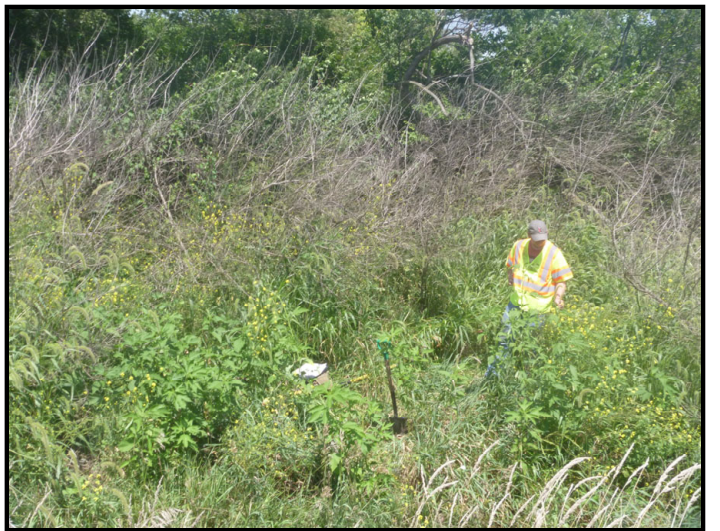
Photo 18 – Data Point B: Facing north toward area of data point B-OUT. Amur honeysuckle and Japanese bristle grass were the primary dominant species, with abundant field mustard and great ragweed adjacent. Hydrophytic vegetation indicators were not present.

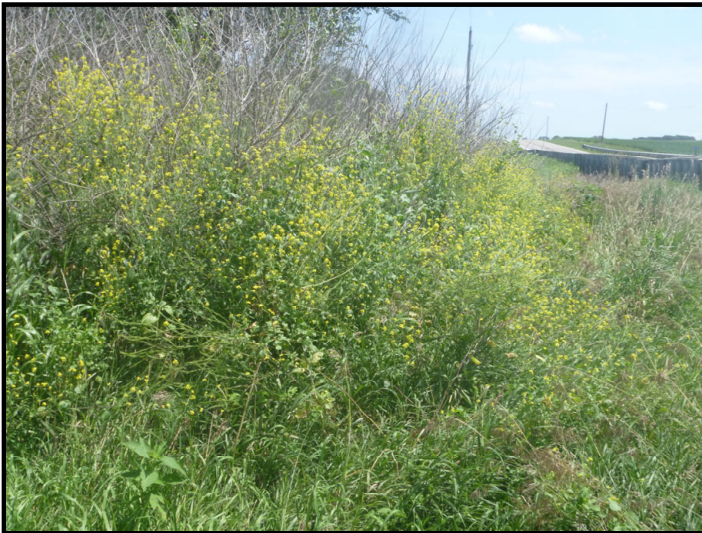
Photo 19 – Data Point B: Facing east toward area of data point B-OUT. Wetland hydrology indicators, surface water, and saturation were not present.

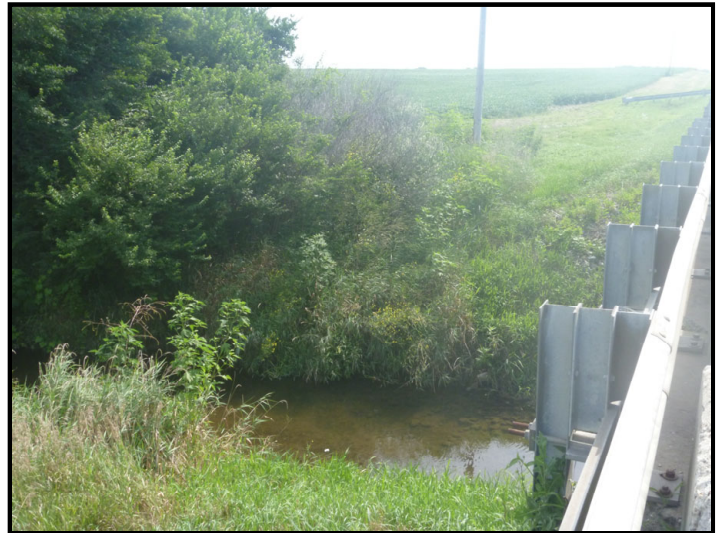
Photo 20 – Northeast Quadrant of Crossing: Facing northeast toward the northeast bank of Greenwood Ditch at the SR 18 bridge.

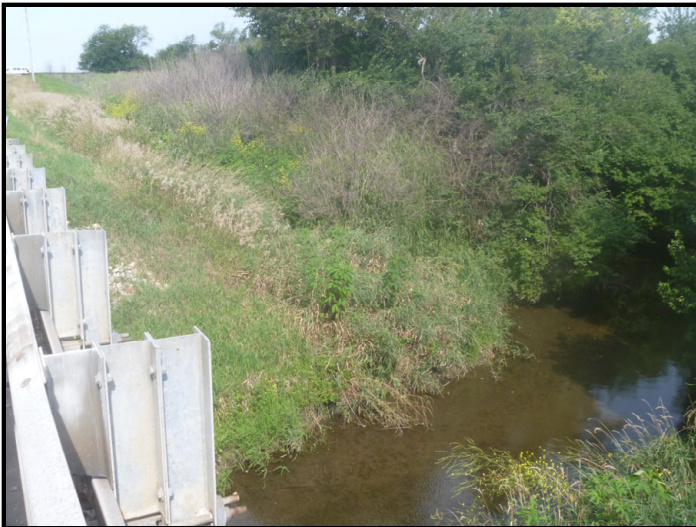
Photo 21 – Northwest Quadrant of Crossing: Facing northwest toward the northwest bank of Greenwood Ditch at the SR 18 bridge. Location of data point B-OUT in background along tree line.

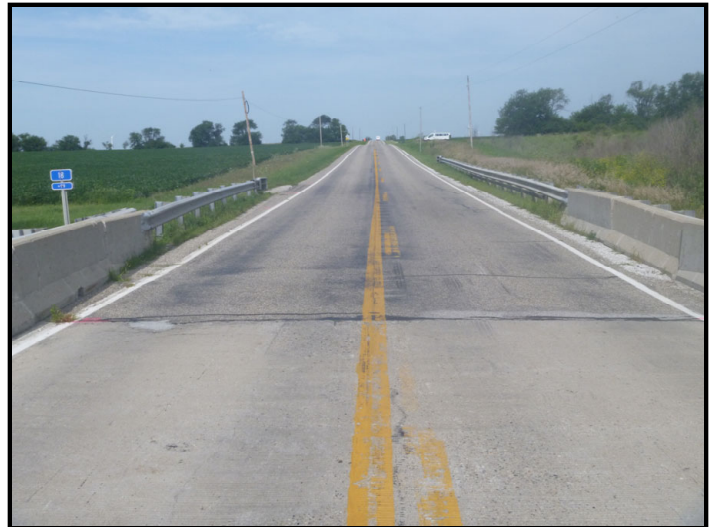
Photo 22 – SR 18 Crossing: Facing west along SR 18 from the top of the bridge over Greenwood Ditch. Topography is generally flat to rolling. Creek and bridge sit in a shallow depression of the landscape.

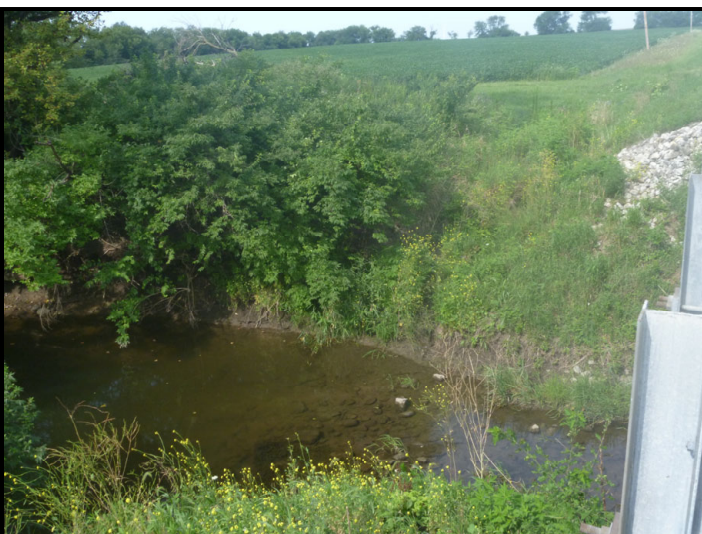
Photo 23 – Southwest Quadrant of Crossing: Facing southeast toward the southeast bank of Greenwood Ditch at the SR 18 bridge.

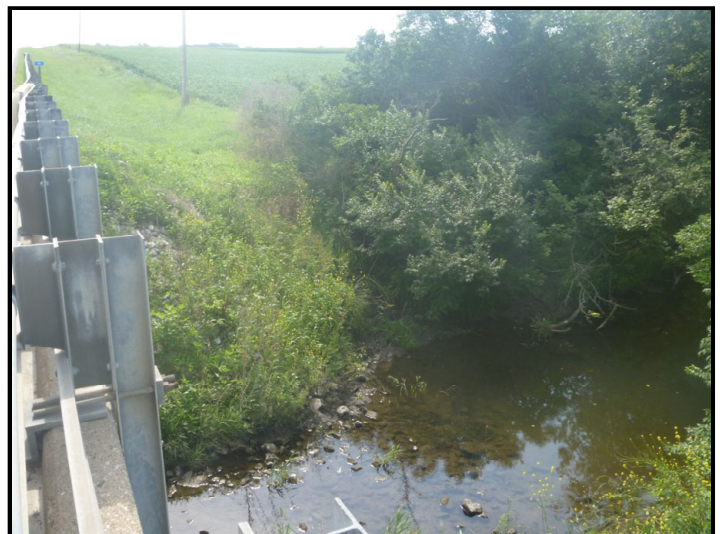
Photo 24 – Southeast Quadrant at Crossing: Facing southwest toward the southwest bank of Greenwood Ditch at the SR 18 bridge. Location of data point A-OUT in background along tree line.

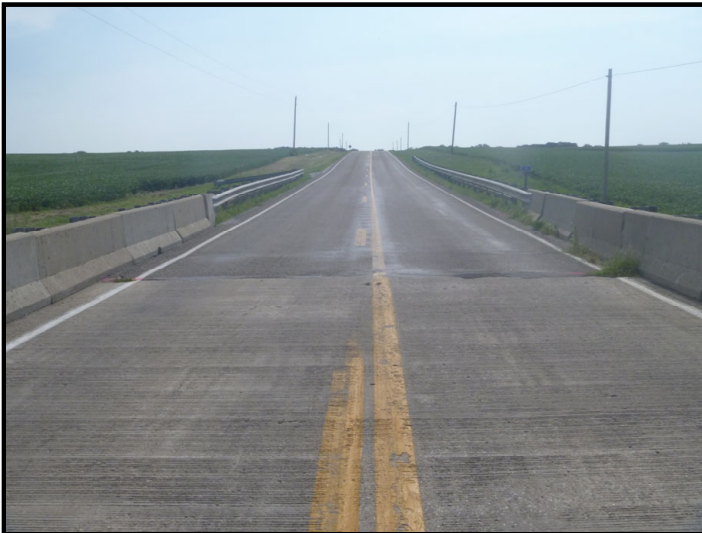
Photo 25 – SR 18 at Crossing: Facing east along SR 18 from the top of the bridge over Greenwood Ditch. Topography is generally flat to rolling. Creek and bridge sit in a shallow depression of the landscape.

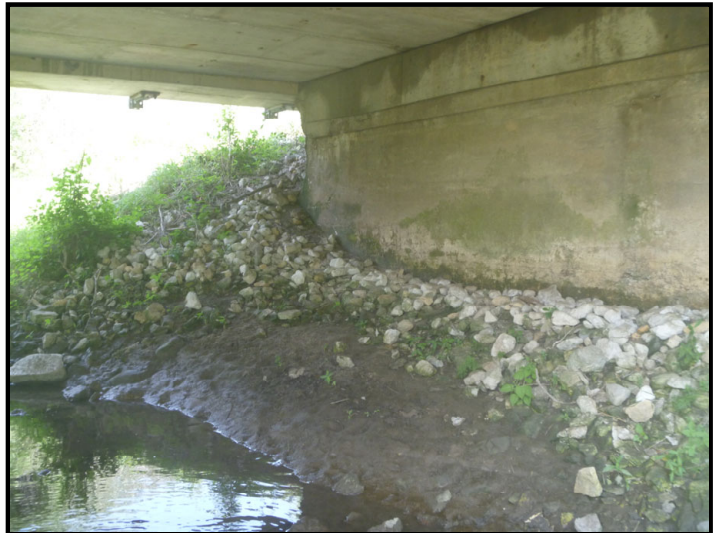
Photo 26 – Greenwood Ditch: Facing northeast toward the riprapped embankment along the east abutment of the SR 18 bridge at Greenwood Ditch.

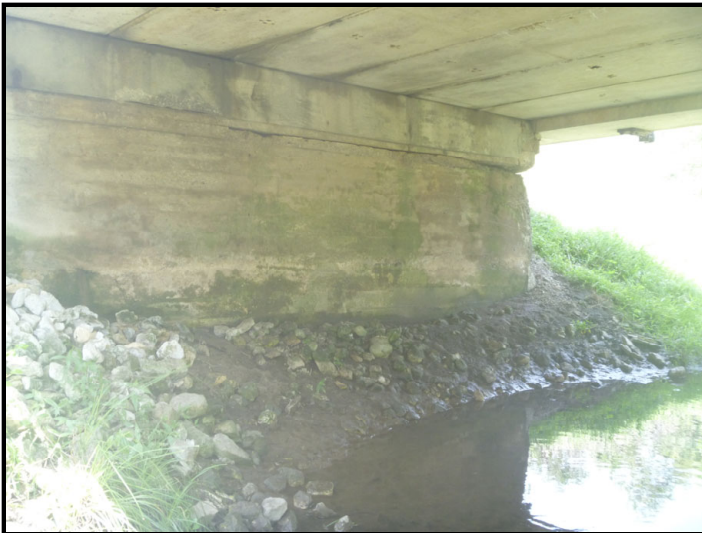
Photo 27 – Greenwood Ditch: Facing northwest toward the riprapped embankment along the west abutment of the SR 18 bridge at Greenwood Ditch.

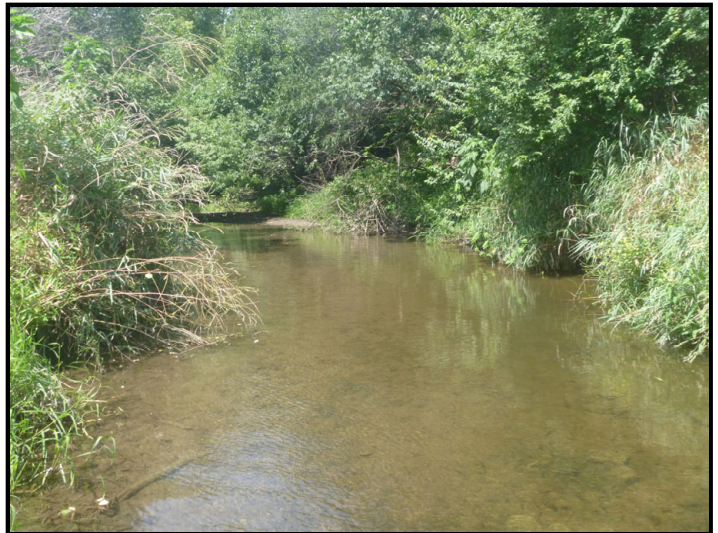
Photo 28 – Greenwood Ditch: Facing upstream to the north along Greenwood ditch from the north side of the SR 18 bridge.

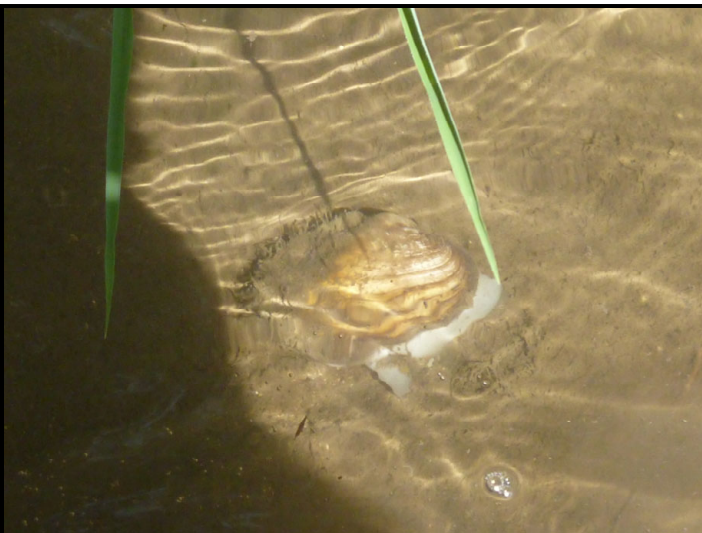
Photo 29 – Greenwood Ditch: Living mussel on bed of creek.

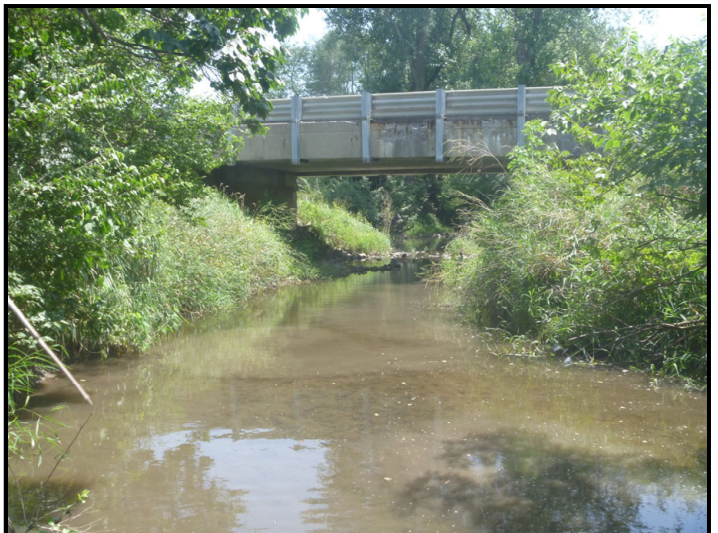
Photo 30 – Greenwood Ditch: Facing downstream to the south along Greenwood Ditch toward the SR 18 bridge, INDOT Structure No. 018-04-01689 B. The existing bridge has a single 34-foot span, with a total length of 54 feet.

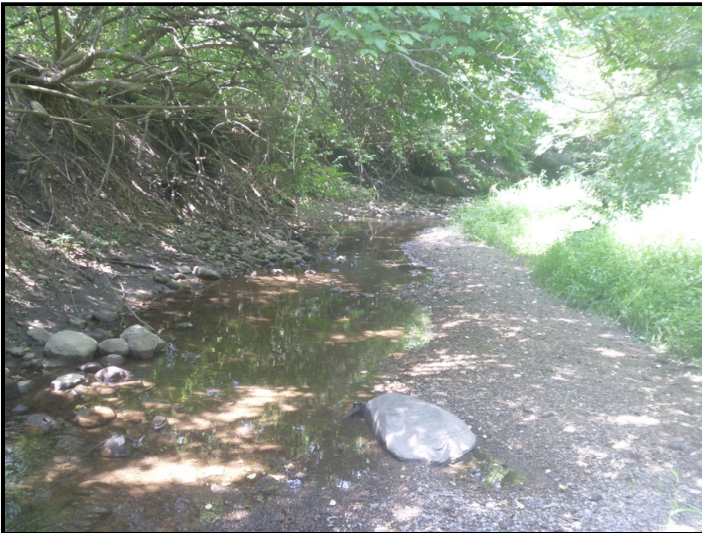
Photo 31 – Greenwood Ditch: Facing upstream to the northwest along Greenwood ditch from approximately 75 north of the bridge. Bank-full depth along this segment was approximately 10 feet deep.

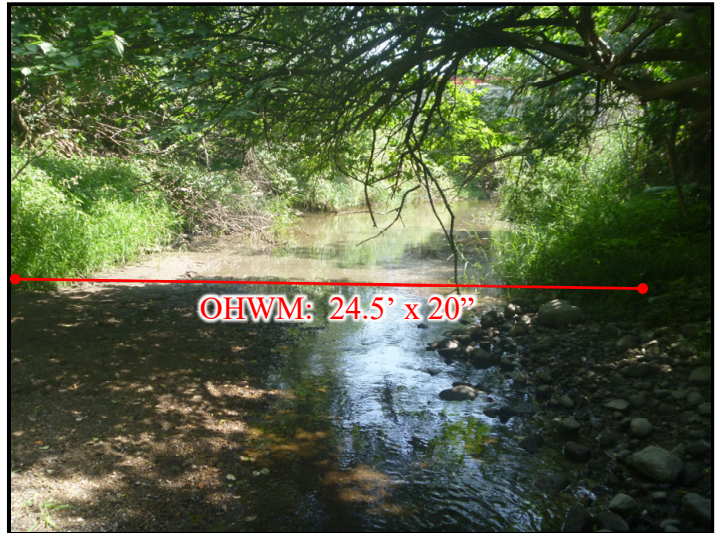
Photo 32 – Greenwood Ditch: Facing downstream to the southeast along Greenwood Ditch from approximately 75 feet north of the bridge. At this location, the creek exhibited an OHWM of 24.5 feet wide by 20 inches deep.

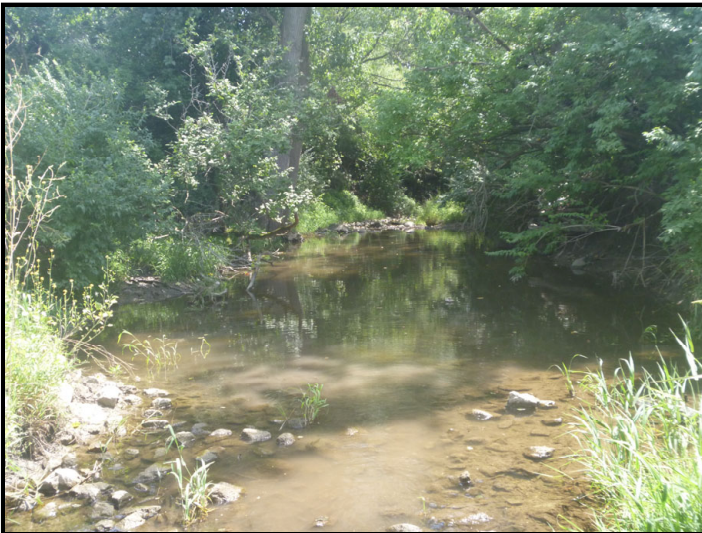
Photo 33 – Greenwood Ditch: Facing downstream to the south along Greenwood Ditch from the south side of the SR 18 bridge.

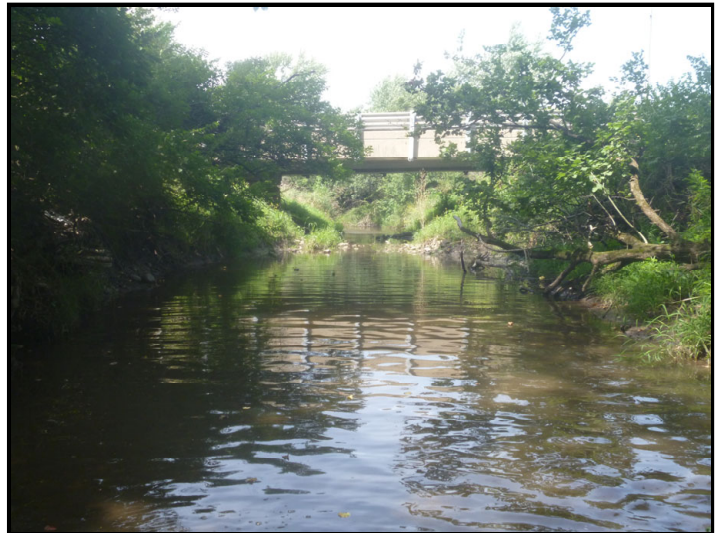
Photo 34 – Greenwood Ditch: Facing upstream to the north along Greenwood Ditch toward the SR 18 bridge.

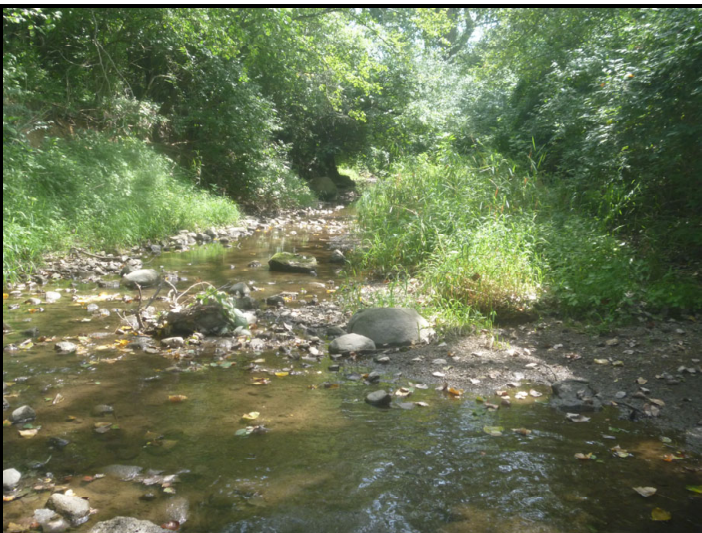
Photo 35 – Greenwood Ditch: Facing downstream to the southeast along Greenwood ditch from south of the bridge. Bank-full depth at this location was variable at 7 to 10 feet.

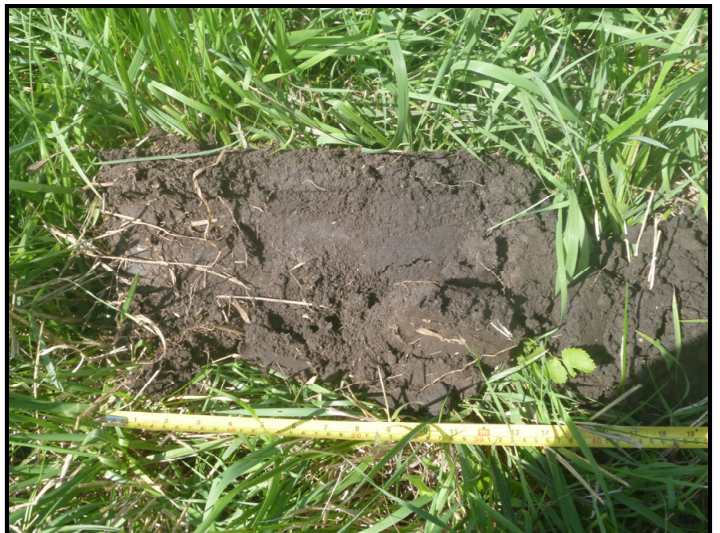
Photo 36 – Data Point C: Facing down toward soil sample from wetland determination point C-OUT. Soils did not exhibit hydric soil indicators.

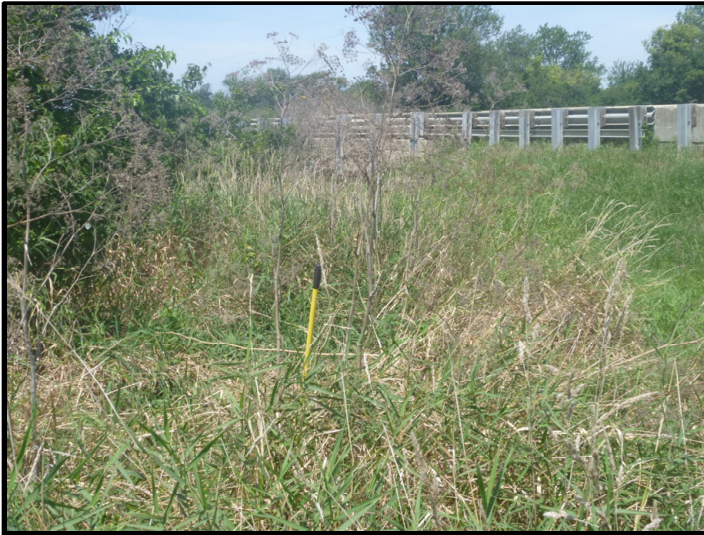
Photo 37 – Data Point C: Facing northwest toward data point C-OUT. Primary dominant vegetation was amur honeysuckle and reed canary grass. Hydrophytic vegetation indicators were not present.

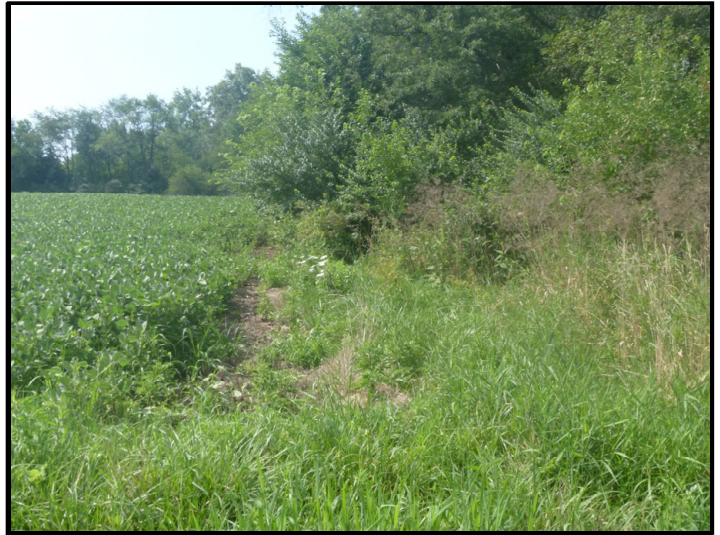
Photo 38 – Data Point C: Facing south from near data point C-OUT. Wetland hydrology indicators, surface water, and saturation were not present.

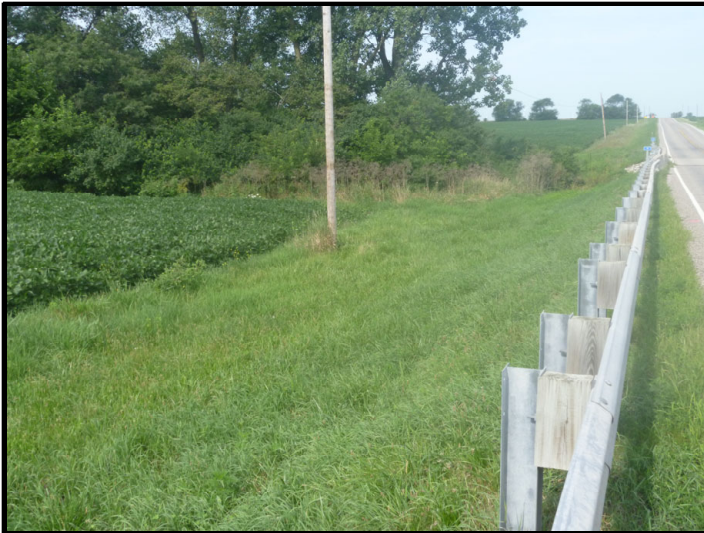
Photo 39 – Southeast Quadrant: Facing southwest toward southeast quadrant of bridge. Location of data point C-OUT is in background along tree line.

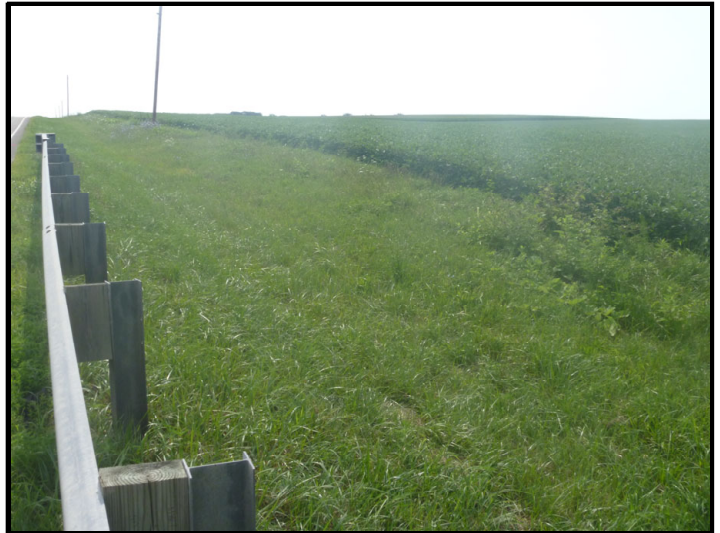
Photo 40 – Southeast Quadrant: Facing southeast from the southeast quadrant of the project location. Roadside ditch is a vegetated, poorly defined swale.

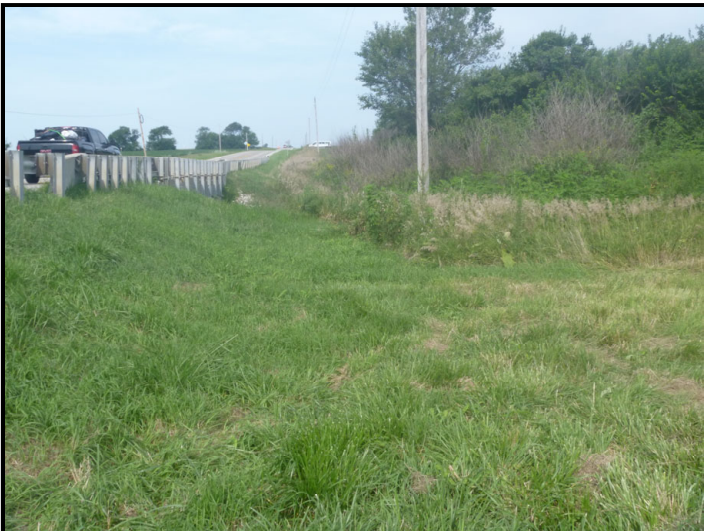
Photo 41 – Northeast Quadrant: Facing west toward the northeast quadrant of the SR 18 bridge. Vegetation consists of numerous generally upland species, including amur honeysuckle, red mulberry, great ragweed, Canadian thistle, tall goldenrod, and Japanese bristle grass.

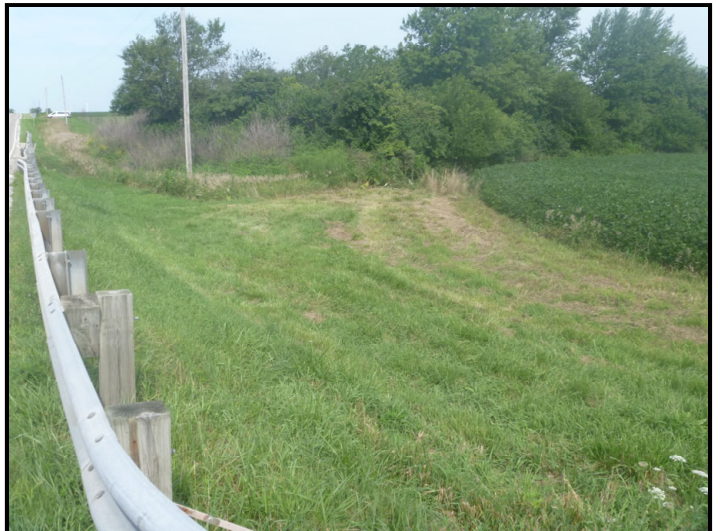
Photo 42 – Northeast Quadrant: Facing northwest toward the northeast quadrant of the SR 18 bridge from a field access drive.

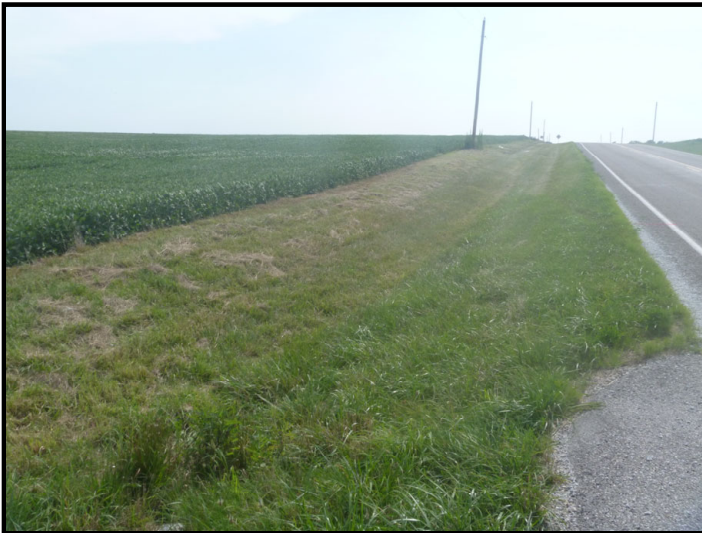
Photo 43 – Northeast Quadrant: Facing northeast along the north side of SR 18 in the northeast quadrant of the project area. The roadside ditch is a grassy swale.

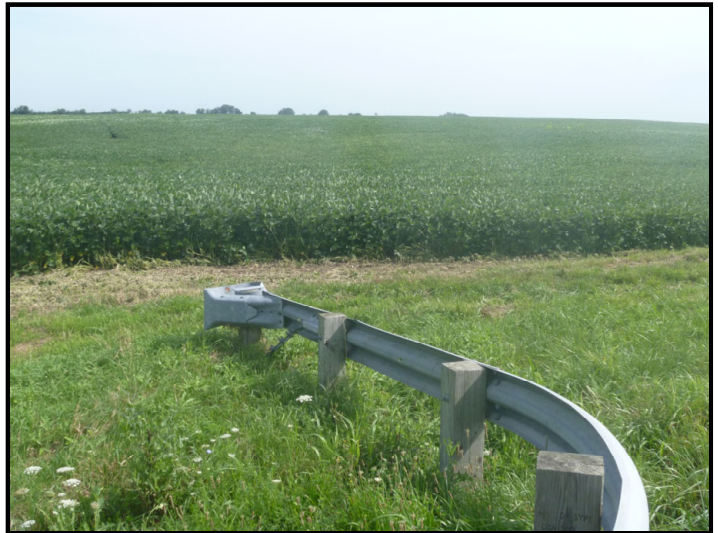
Photo 44 – Northeast Quadrant: Facing northeast toward farmland in the northeast quadrant from a field access location. Topography and GIS mapping shows a surface water feature in the field, but none is present.

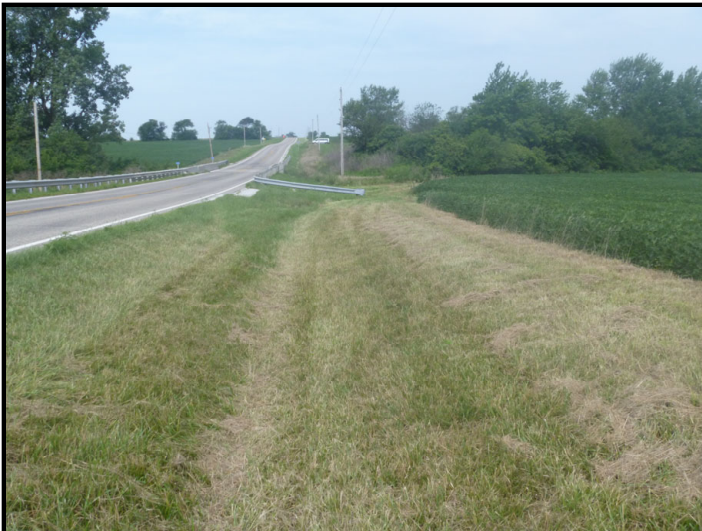
Photo 45 – Northeast Quadrant: Facing west along the north side of SR 18 in the northeast quadrant. The roadside ditch is a grassy swale.

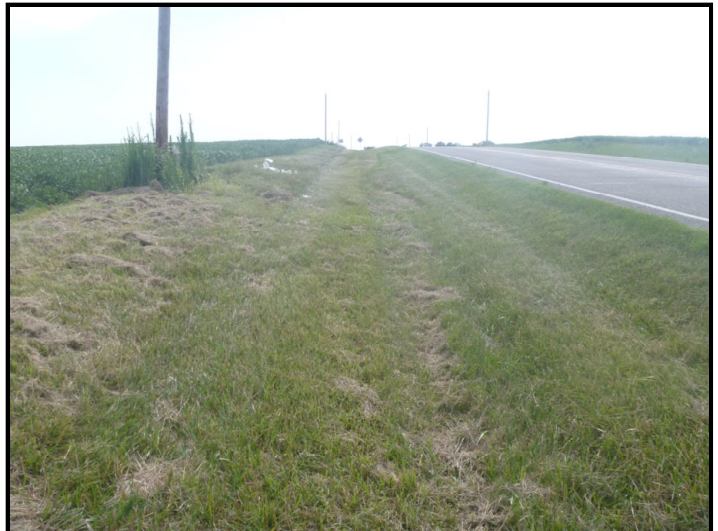
Photo 46 – Northeast Quadrant: Facing east along the north side of SR 18 in the northeast quadrant of the project area. The roadside ditch is a grassy swale.

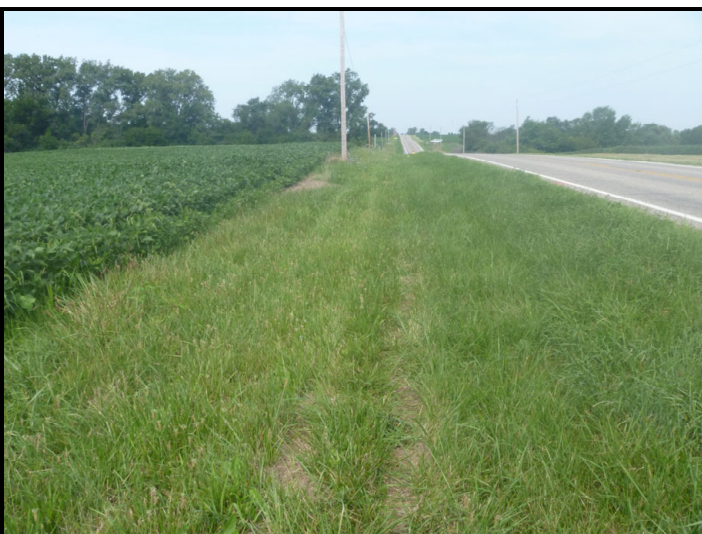
Photo 47 – Southeast Quadrant: Facing west along the south side of SR 18 near the west end of the review area. The roadside ditch is a grassy swale.

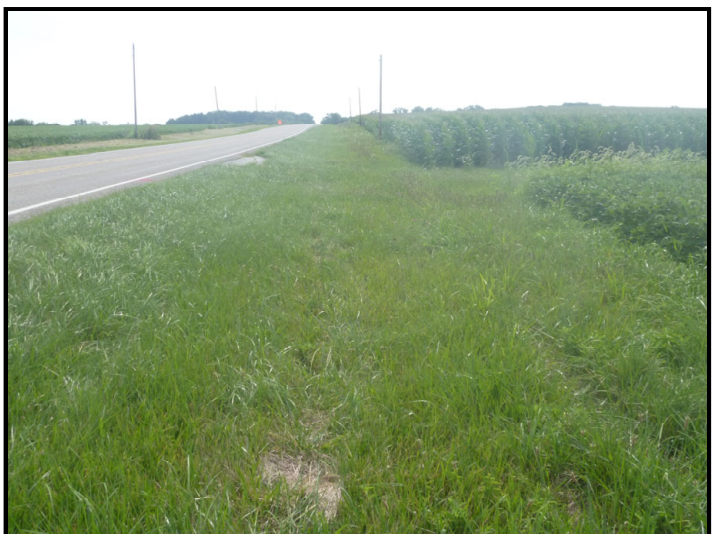
Photo 48 – Southeast Quadrant: Facing east along the south side of SR 18 beyond the review area. The roadside ditch is a grassy swale.

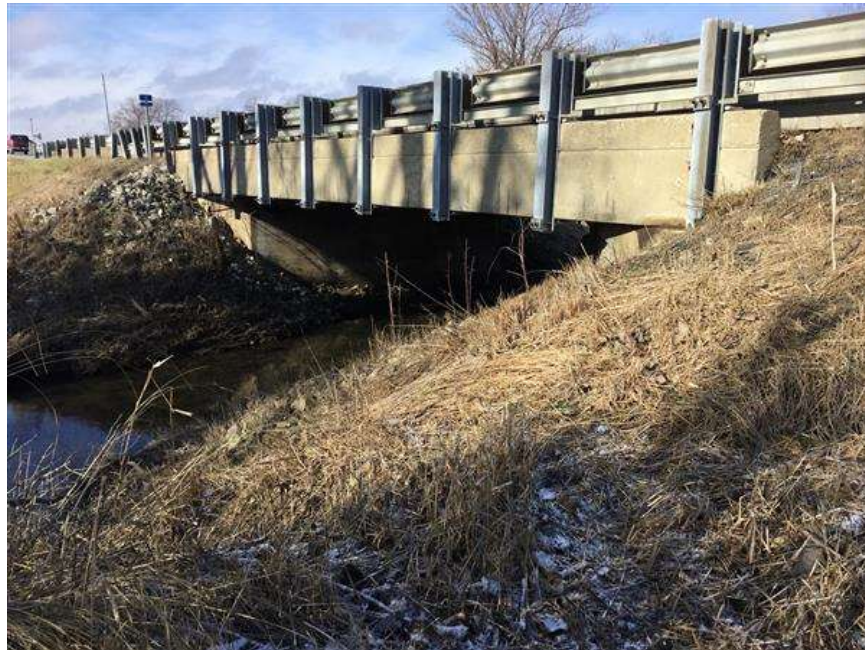
1/04/2022 Bridge is in overall fair condition.

(58) DECK: 6 - Satisfactory Condition (minor deterioration)
 Comments:
 There are longitudinal cracks located above the locations where the box beams meet along with diagonal cracking and a minor pocking. The deck underside cannot be seen, box beams cover underside. (Both curbs have spall; the north being the worst, having rebar exposed.)

The outer north and south beam line along each side of the bridge has guardrail connected to the bottom in several locations. Each connection is bolted and there is a spall in the box beams around some of these connections. The north fascia box beam has longitudinal cracking with efflorescence and has spalling with rebar exposed on the north face.

There are large spalls on both bents along with cracking and some efflorescence. All four corners of the abutments have spall, and the fascia beams are continuous over these corners
