# Virtual Inspection – Start to Finish

Jariah Besing, PE – INDOT

John Lukac, PE, MBA – HWC Engineering

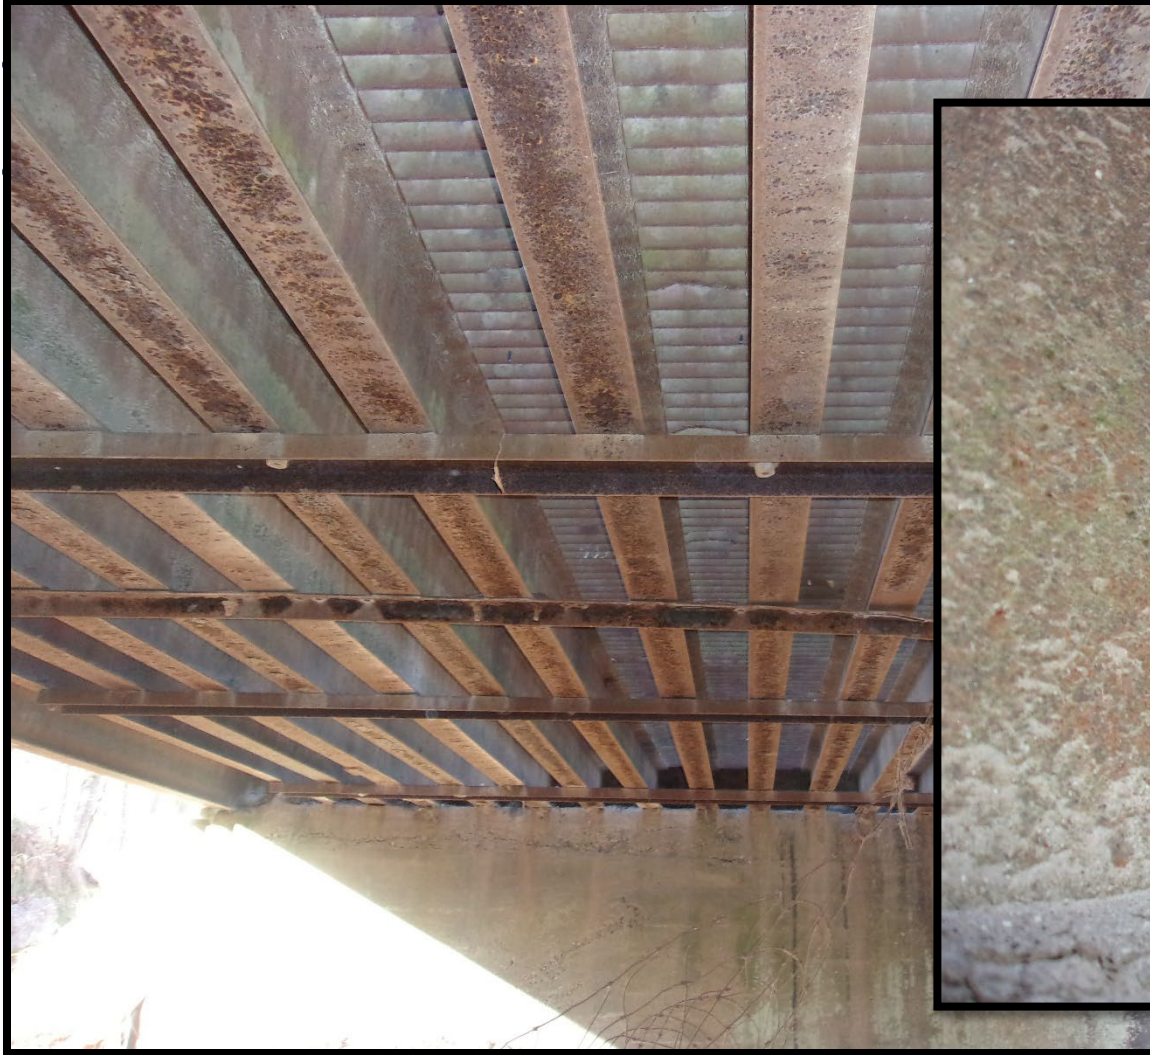
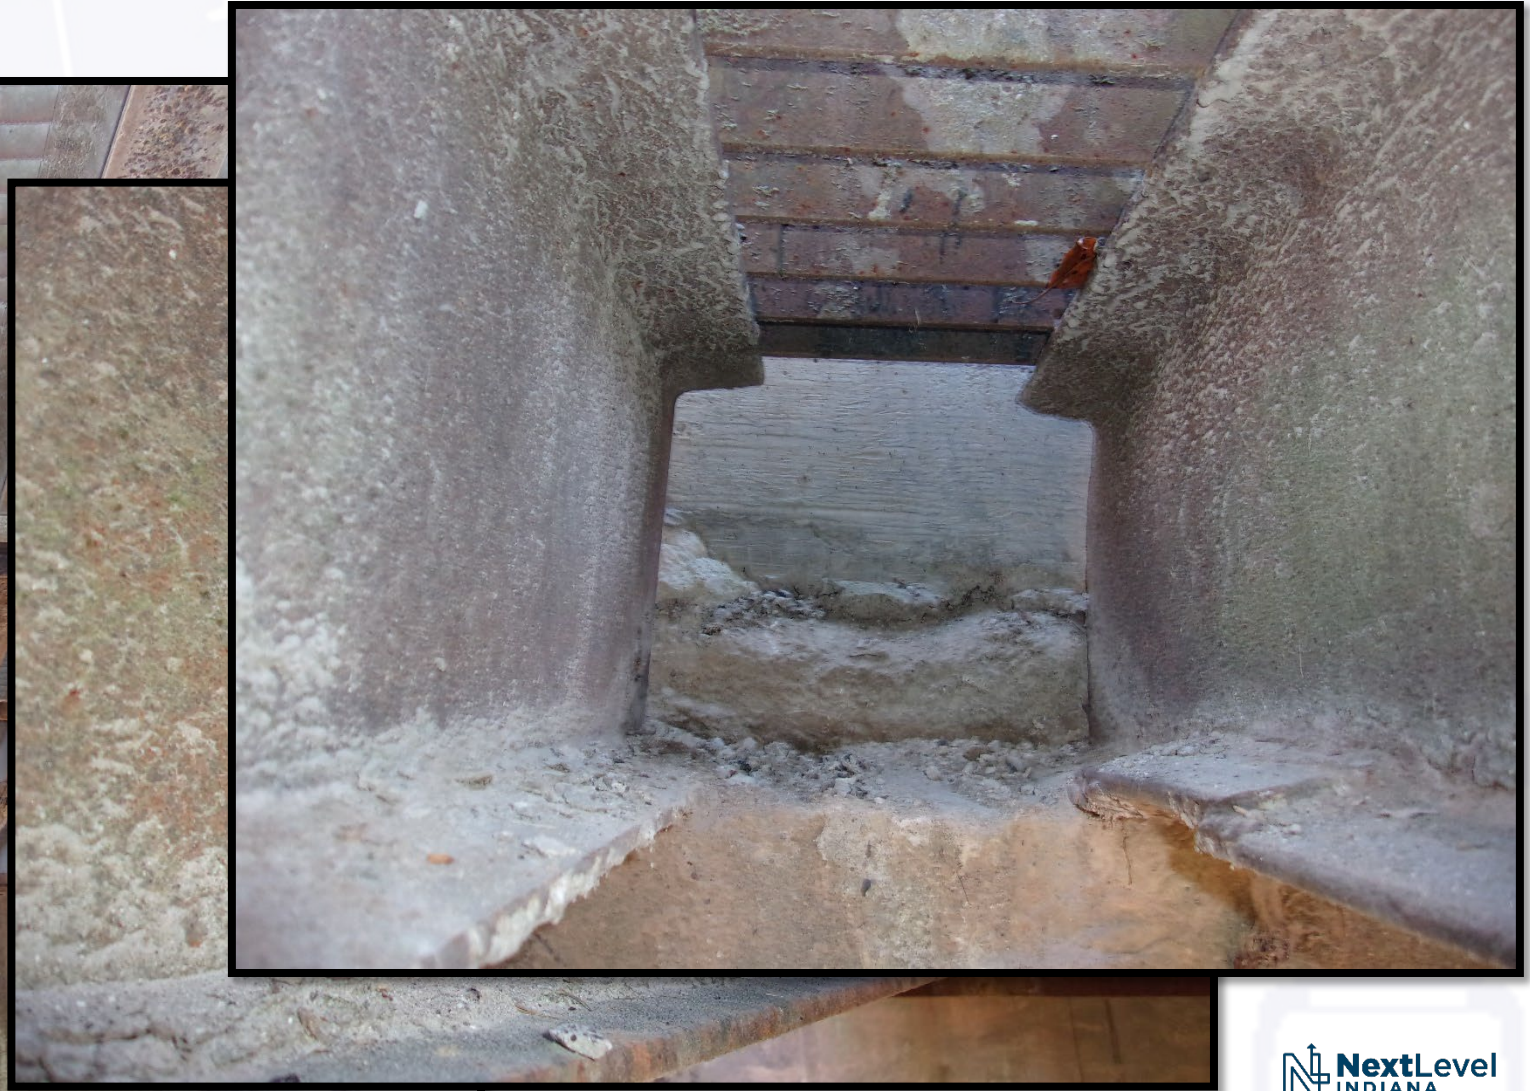
- Superstructure (59) – B.C.02

C. Surface rusting throughout with moderate pitting on bottom beam flanges. Heavier pitting on beam webs at abutments with approximately 10% section loss on beam webs.

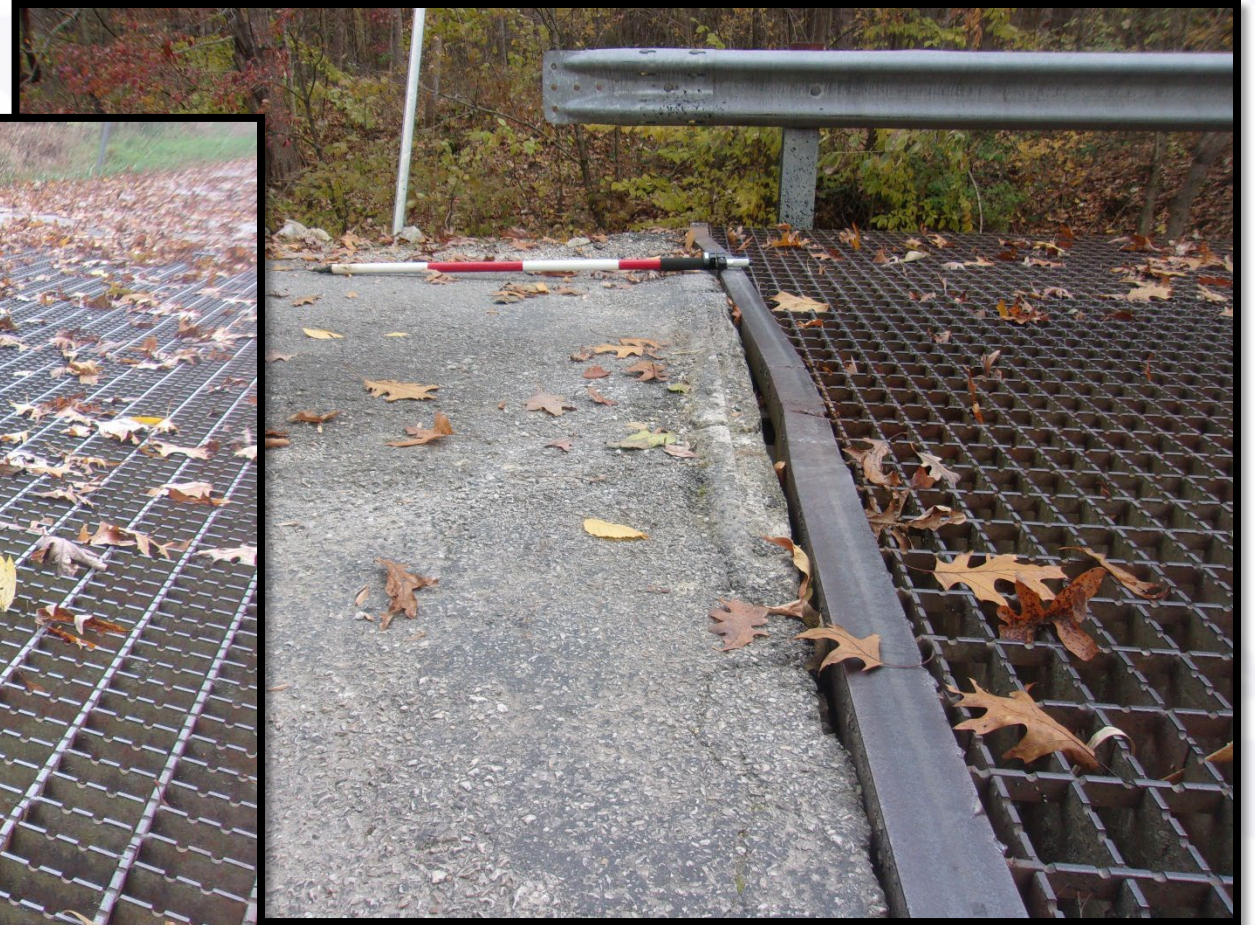
4" Steel Grid Deck with surface rust throughout and damage at the east end of the deck

- Table in Appendix C for Steel Defects
- Deficiency notes “Surface rust throughout and damage at the east end of the deck”

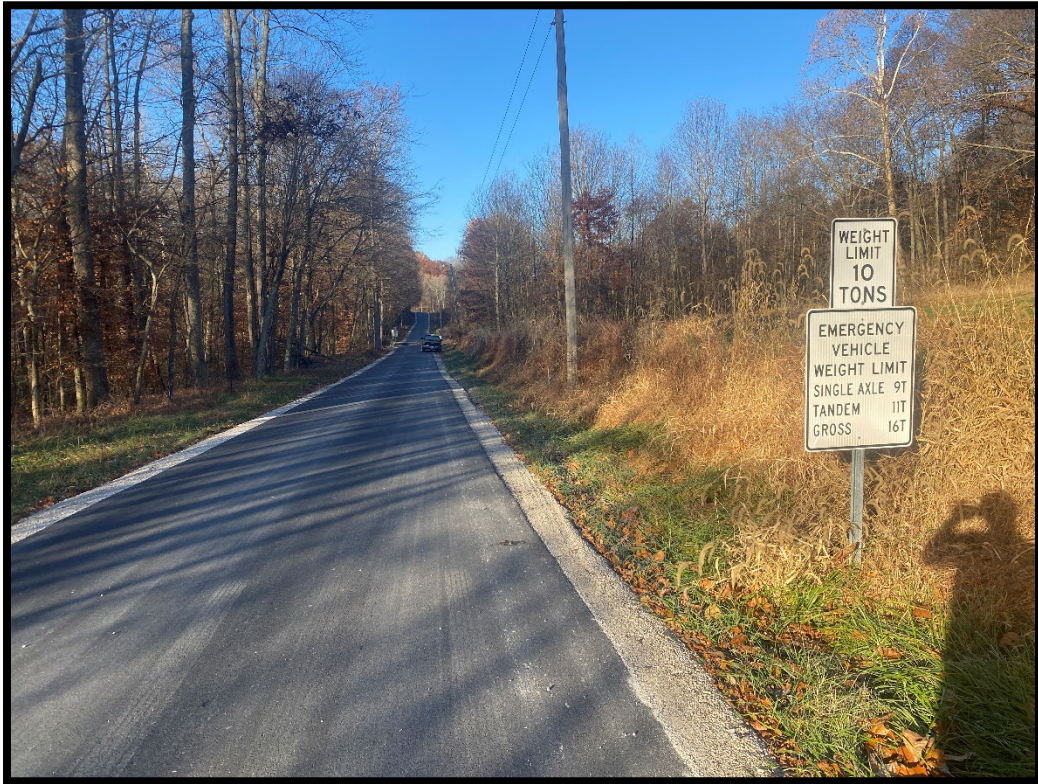
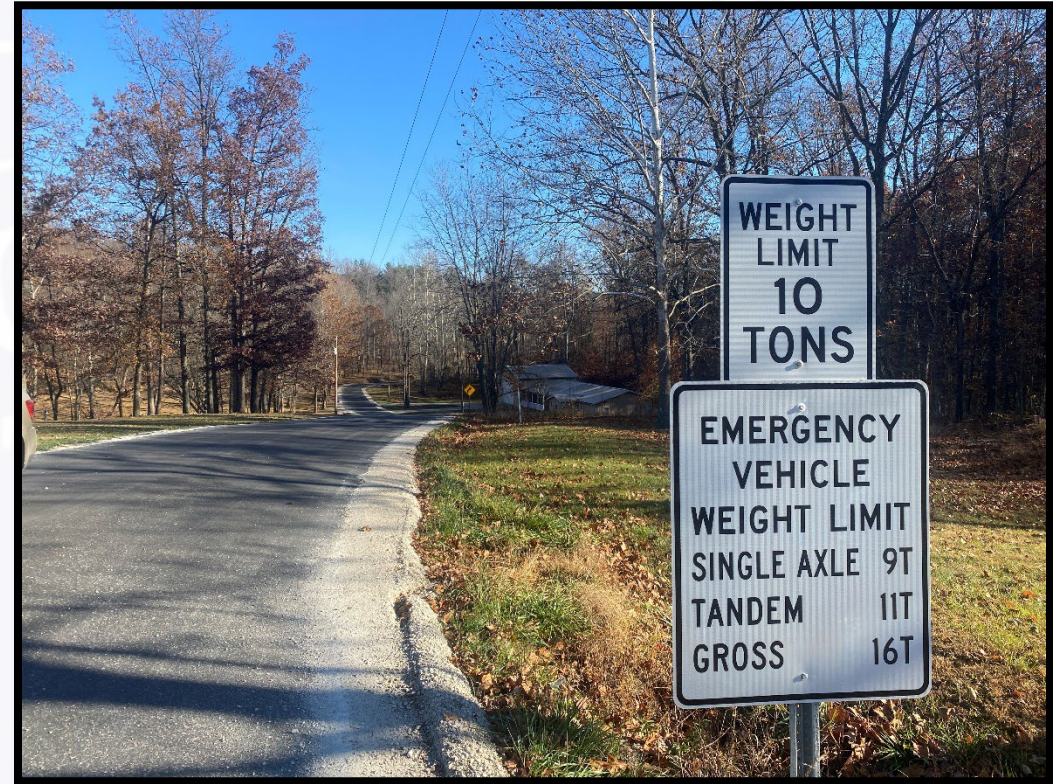
- Reminder that load posting signs are required in advance of the bridge
- Per Memo 24-01, Missing advance signage is a critical finding
