January 2023 to December 2023

ANNUAL STATE OF THE ITR REPORT

This 2023 Indiana Toll Road (ITR) *Annual State of the ITR Report* has been prepared in accordance with the Amended and Restated *Concession and Lease Agreement* (CLA) for the Indiana Toll Road.

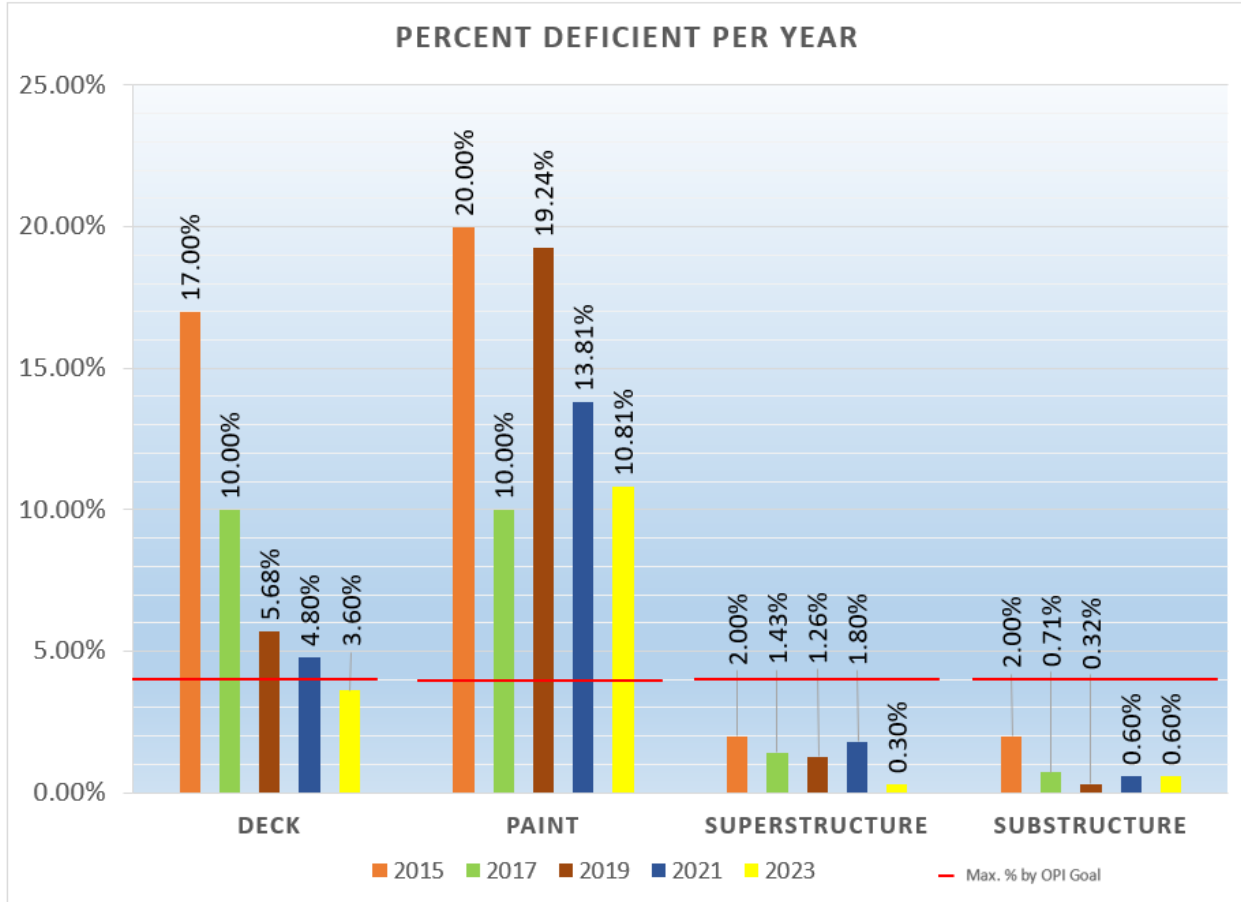
Figure 1.1: Bridge Condition Ratings

The 2023 inspections for the state of the ITR structures have shown lower deficiency ratings for Wearing Surface, Deck, Paint, and Superstructure. The substructure rating has remained the same. PUSH 3.0 was delivered in 2021 and included six bridge deck replacements with bridge widening, two bridge deck overlays, nine structures with substructure patching and joint replacement, and bridge paintings on multiple structures.

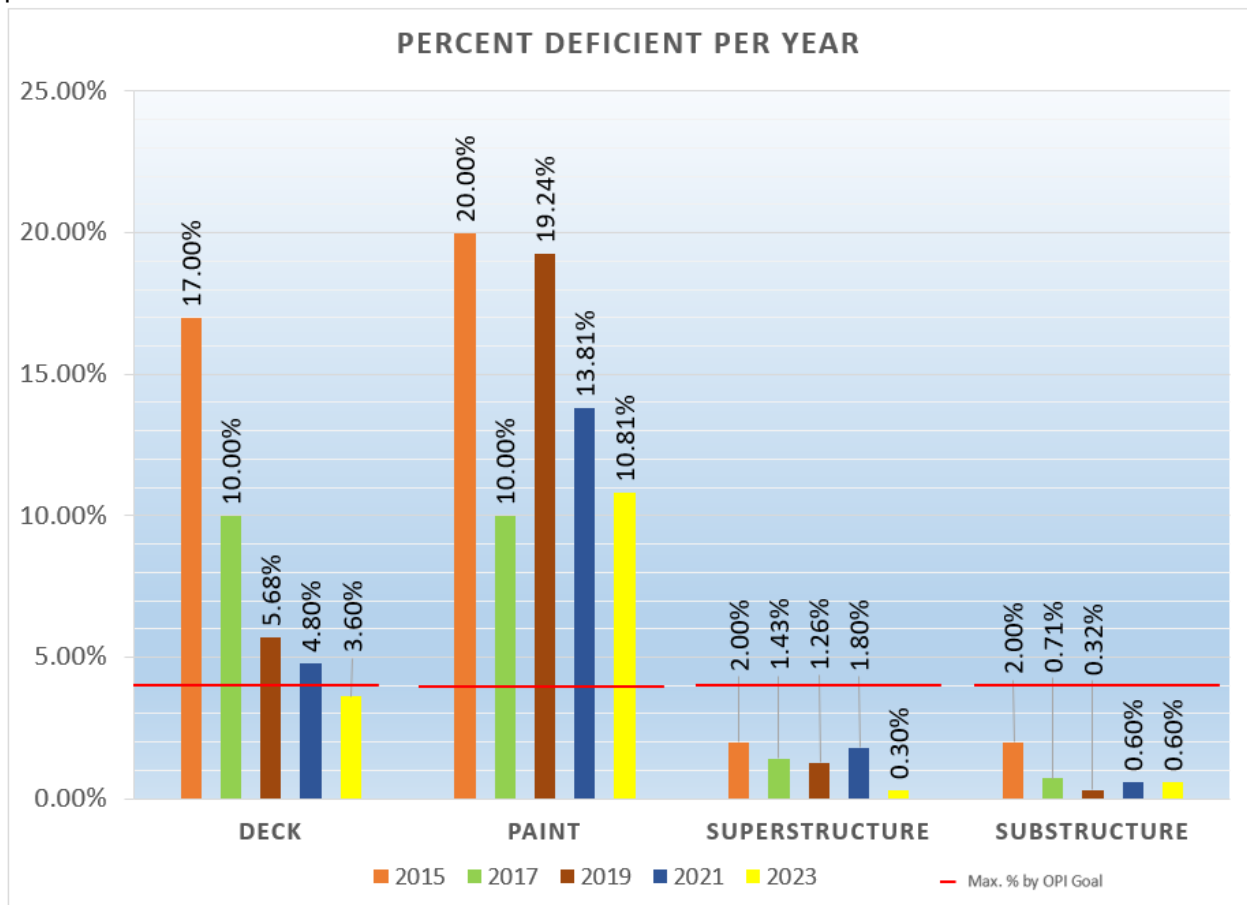
Figure 3.0: Bridge Condition Ratings illustrates that there has been an overall decrease in deficiencies in several of the individual items compared to previous years. Decreases in deficiencies for Deck and Paint are due to the implementation of the PUSH projects and additional job order contracts. The three phases of PUSH have addressed over 25% of the structures within the ITR corridor.

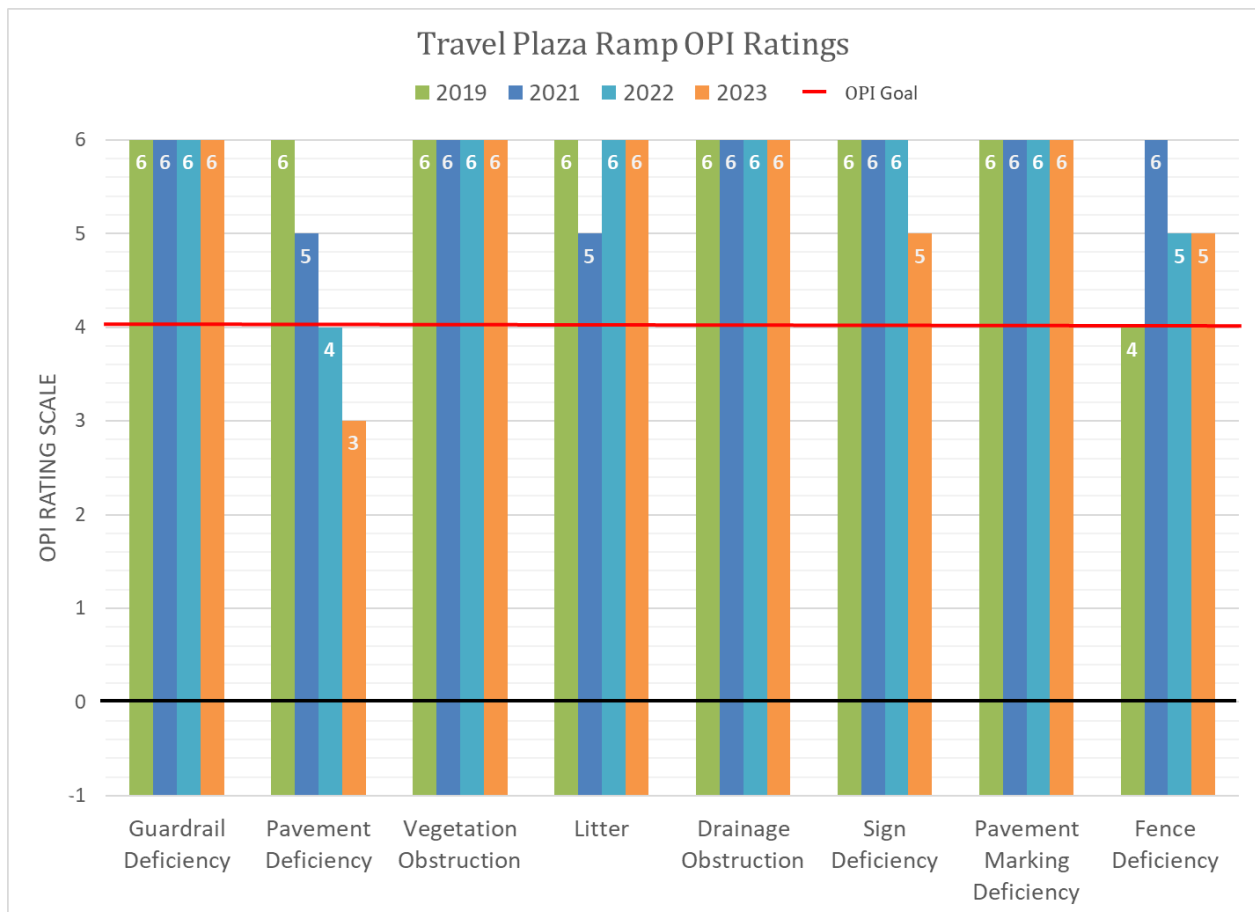
Table 5.14: Travel Plaza and Truck Parking Maintenance Items for ITR provides the total accumulated deficiencies for the entirety of the travel plazas. Tables 5.15 – 5.19, located in Appendix E, represent each maintenance district, and list the number of deficiencies, deficiency rates, and OPI ratings for the eight travel plaza maintenance items. The ratings range from 0 to 6, with 6 being the highest. Figure 5.3: Travel Plaza Ramp OPI Ratings illustrates the Toll Plaza Ramp Maintenance OPI rating progression over the past three years in comparison to the 2023 ratings.

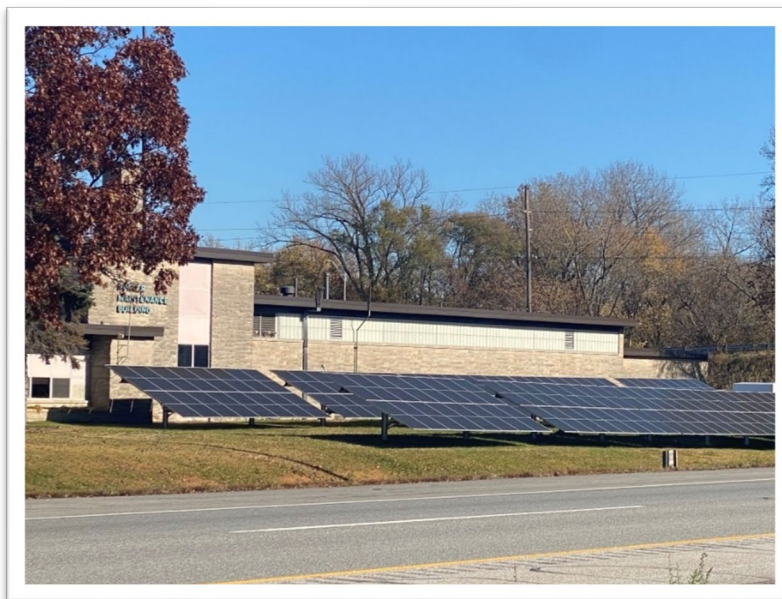
Image 5.1: Maintenance Unit 1 Solar Panel Layout

As part of a larger undertaking to reduce greenhouse gas emissions, in 2023 ITRCC kicked off Project Soleil, the deployment of solar field arrays at 14 facility locations across the corridor. This \$3m project will offset a significant percentage of operational electrical usage at the facilities and is expected to reduce ITRCC's carbon footprint by 900 metric tons of carbon annually.
